HAMILTON WENTWORTH DISTRICT SCHOOL BOARD
FEASIBILITY STUDY AND CONCEPT DESIGN

SALTFLEET DISTRICT HIGH SCHOOL
108 Highland Rd. West, Stoney Creek, ON

MAY 10, 2016

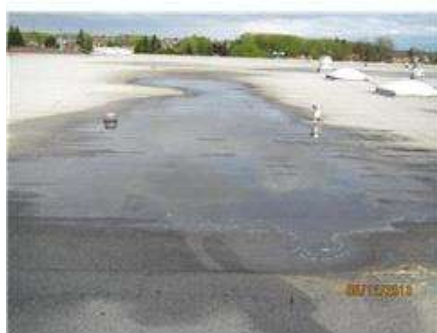
May 2013- Evidence of water ponding on the surface of the roof covering.

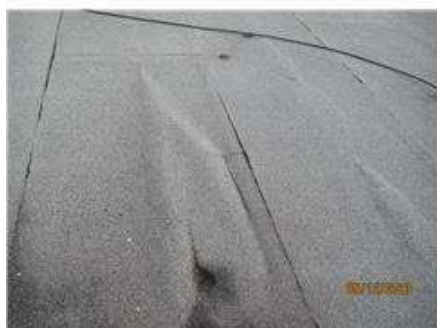
May 2013- Sign of blisters in majority of the roof covering area.

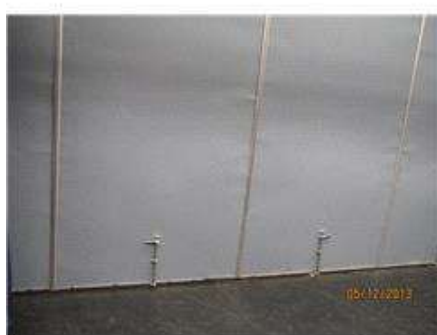
2013 - The moveable partition in the gymnasium, cafeteria is showing signs of damage, and have approaching their expected useful life. Replacement planning is recommended.

May 2013- Stage movable partition wall.

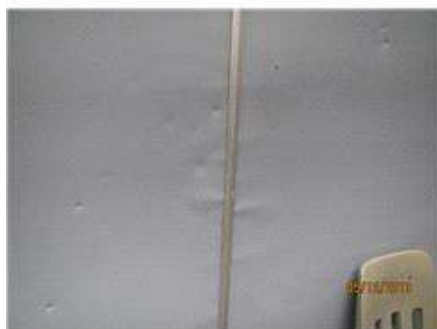
May 2013- Evidence of wear and tear.

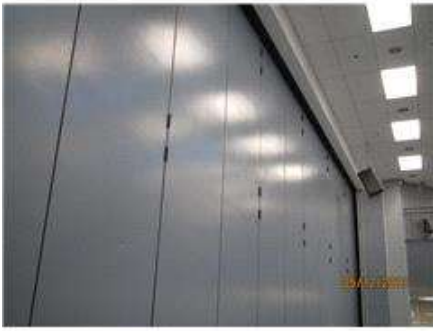
May 2013- Movable partition in the cafeteria.

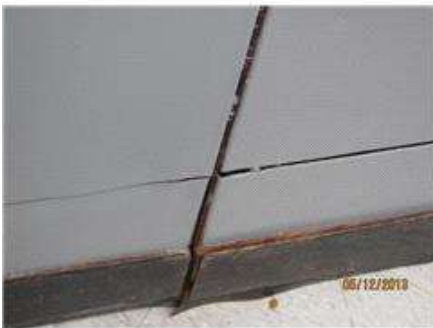
May 2013- Evidence of damaged on the cafeteria movable partition wall.

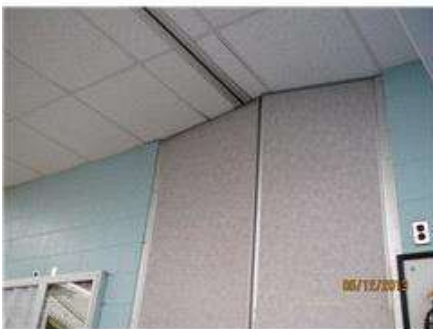
May 2013- GYM movable partition wall.

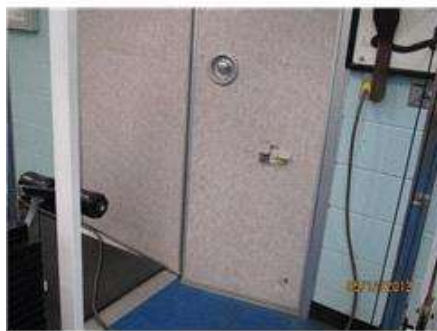
May 2013-Damaged on the movable partition wall in the GYM.

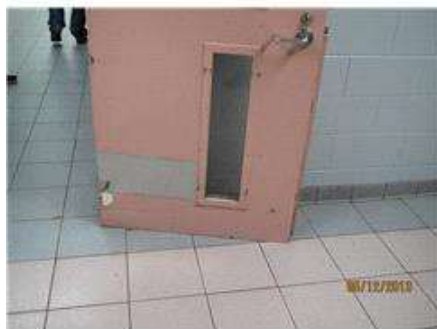
2013 - The interior doors are approaching their useful life. Replacement plan of the interior doors is suggested.

May 2013- Typical interior doors in the school.

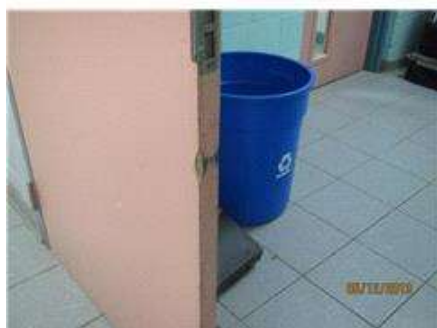
May 2013- Worn interior door.

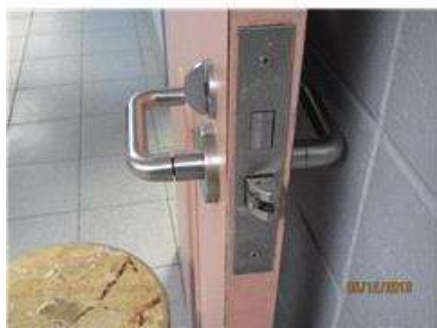
2013 - The hardware was observed to be aged and worn beyond useful life. Replacement of interior door hardware in conjunction with door replacement is suggested.

May 2013- Typical interior door lock set.

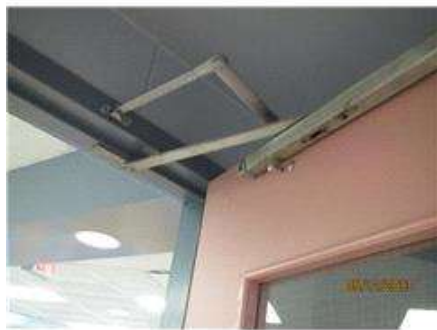
May 2013- Typical interior door closer.

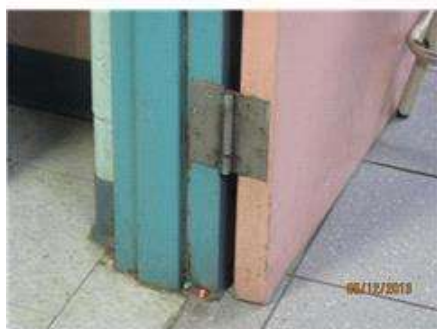
May 2013- Typical interior door hinges.

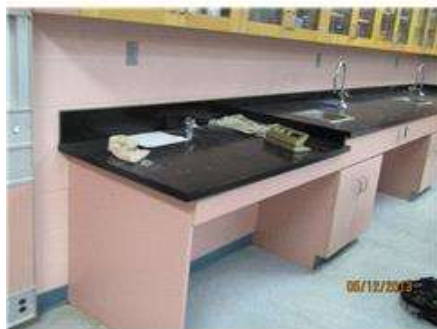
2013 - As all the cabinetry, millwork items, counters and countertops are approaching their expected useful life and are in fair condition the recommendation is planning to replace them in close future.

May 2013- Typical classroom millwork.

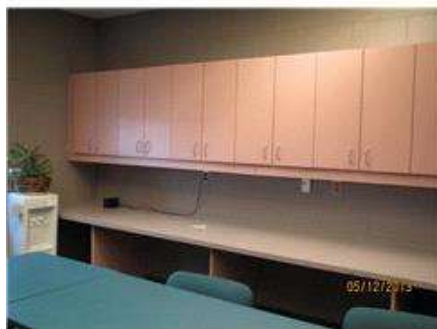
May 2013- Millwork fitting in the staff room.

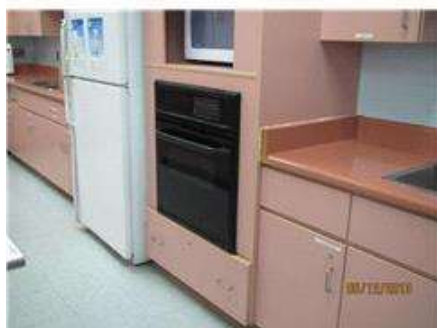
May 2013- Worn millwork fitting in the family study classroom.

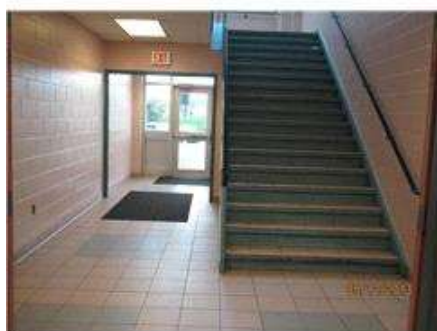
May 2013- Typical stair case in the school.

2013 - Replacement of initial flight of the interior stairs including the rubber covering is recommended

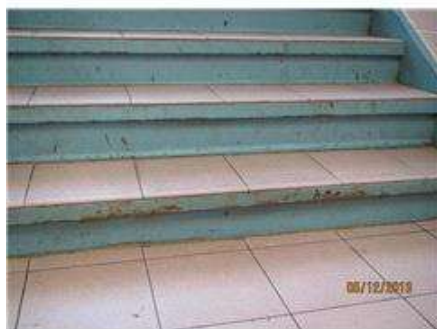
May 2013- Rusted and, corroded stair frame.

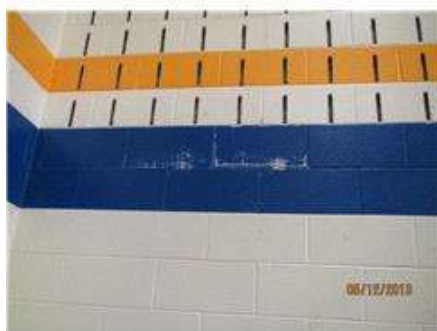
May 2013- Faded paint wall covering in the GYM.

2013 - The aged and worn interior painted wall finishes are suggested to be refinished.

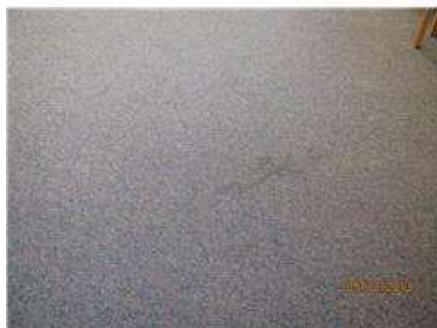
2013 - The carpet located in the Resource Center is subjected to frequent foot traffic. Excessive wear was evident throughout the Resource Center. Replacement of carpet is recommended.

May 2013- Worn and stained carpet floor covering in the library.

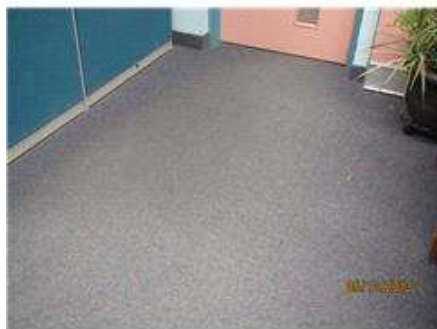
May 2013- Worn carpet flooring in the resource room.

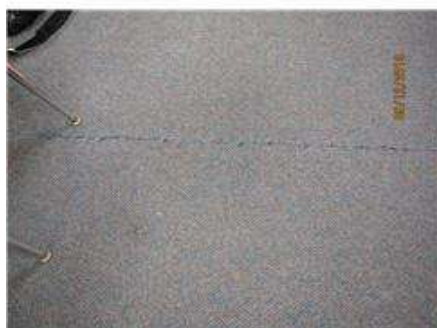
May 2013- Worn Carpet flooring in the resource room.

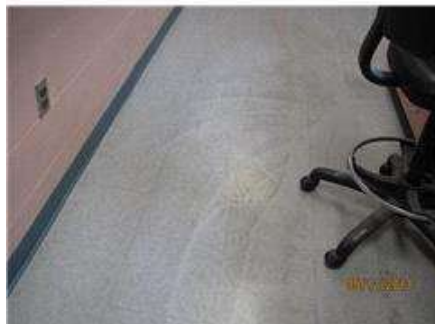
2013 - The vinyl composite floor tile and vinyl base is exhibiting signs of wear and has exceeded its effective rated design life. Replacement planning recommended.

May 2013- Typical worn VCT in the classrooms.

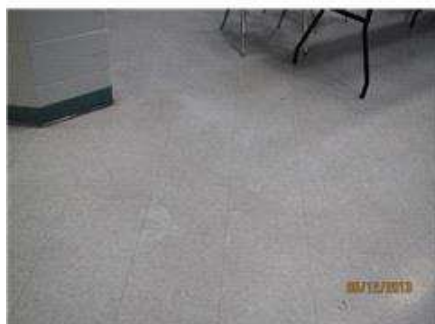
May 2013- Worn VCT floor covering in the cafeteria.

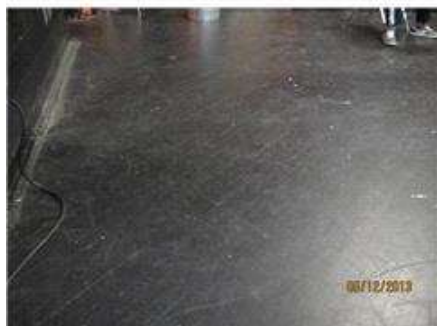
2013 - The hardwood strip flooring on the stage and in GYM area are in fair condition. Refinishing or replacement of the hardwood flooring recommended.

May 2013- Painted hardwood flooring on the stage.

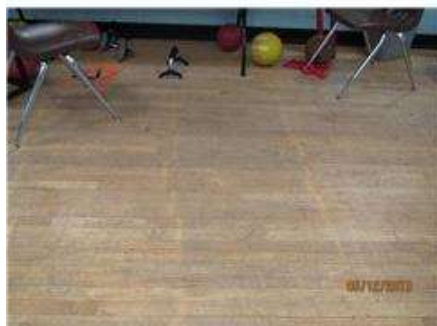
May 2013- Worn and discolored hardwood flooring in the gym area.

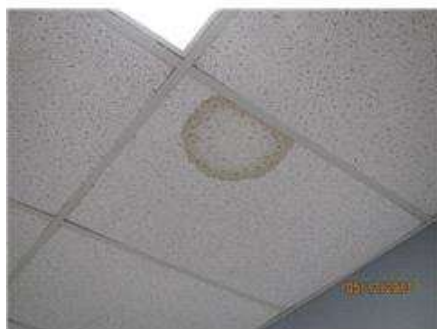
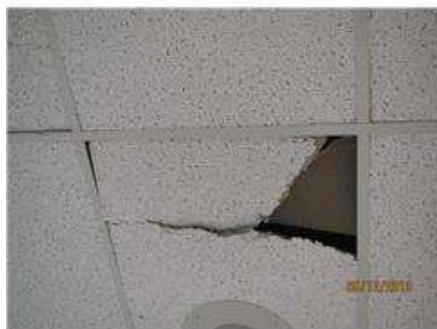
May 2013- Damaged acoustic tile in the school.

Recommendation 2013 - Recommend the replacement of stained, damaged acoustical ceiling tiles.

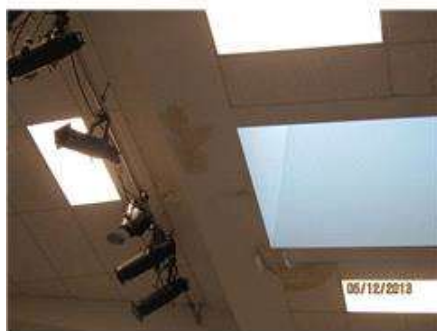
May 2013- Damaged gypsum board ceiling in the cafeteria.

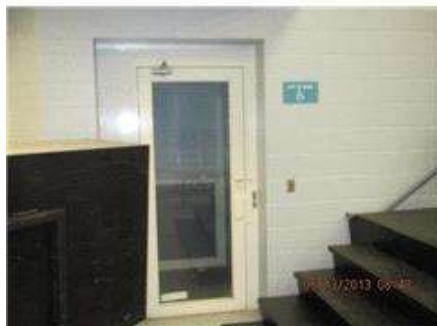
May 2013 - The Chair Lift for the Stage is Not Operational

2013 - Repair of the handicap accessible chair lift for the stage is recommended as soon as possible. The associated cost is an estimate as repair or replacement may be recommended by an elevator inspector.

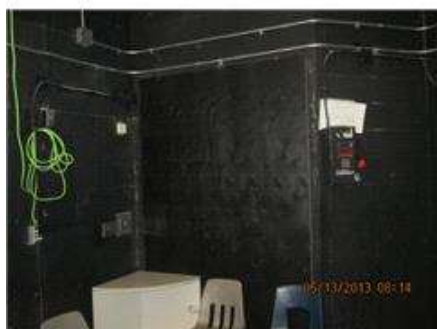
May 2013 - The Entrance of the Chair Lift From the Stage is Boarded Up

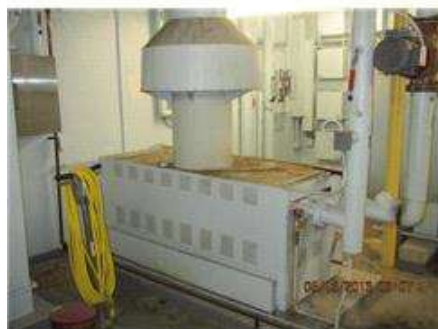
May 2013 - Original Domestic Water Boiler

2013 - Replacement of the original domestic water heater is recommended based on age and condition.

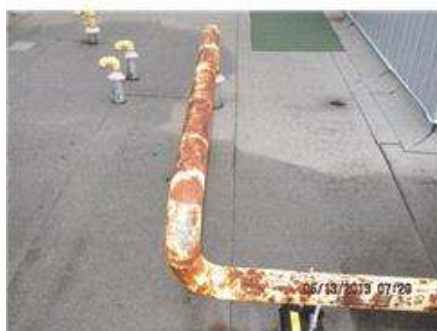
2013 - The exterior section of the natural gas distribution piping is deteriorating faster than expected and replacement of repair is recommended.

May 2013 - Corrosion of the Exterior Natural Gas Piping - Roof

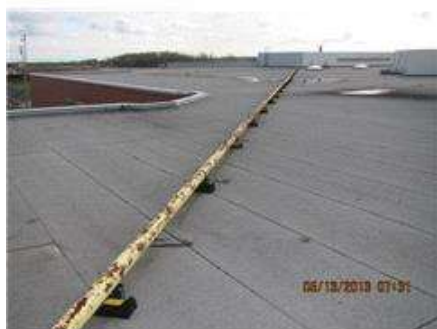
May 2013 - Corrosion of the Exterior Natural Gas Piping - Entire Pipe Run

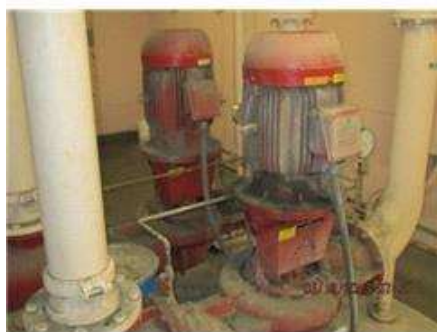
2013 - Based on the age and condition of the four main HVAC pumps replacement is recommended. The HVAC pumps are reaching the end of their expected useful life, which is generally 25 years. Replacement of the HVAC pumps is recommended to minimize the potential impact on the heating system.

May 2013 - Aged Hot Water Heating Pumps

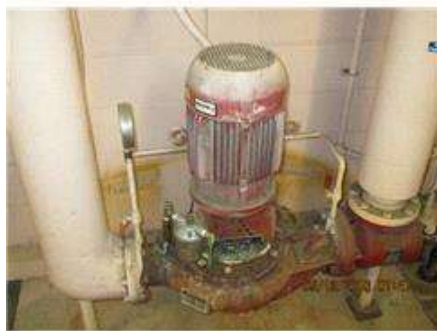
May 2013 - Aged Hot Water Heating Pump

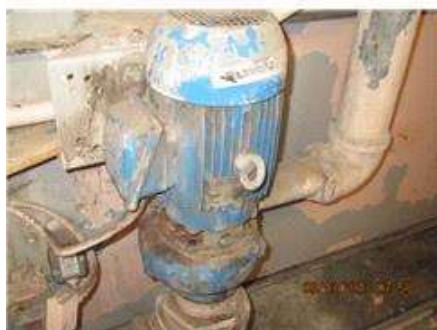
May 2013 - Aged Cooling Tower Pump

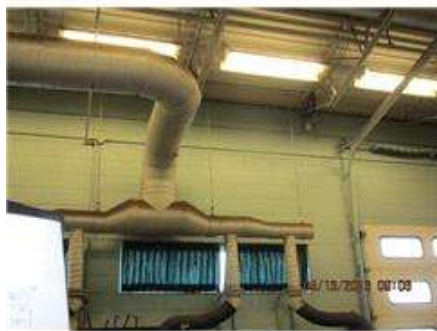
May 2013 - Existing Automotive Shop Exhaust System

2013 - Replacement and or upgrading of the existing automotive shop's exhaust system is recommended to ensure that the fumes do not travel to adjacent classrooms.

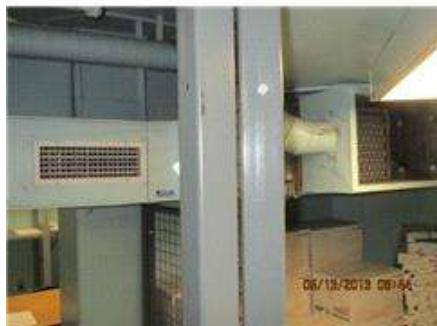
May 2013 - Original Heat Pumps

2013 - Replacement of the original heat pumps is recommended in the next 5 years based on age and condition.

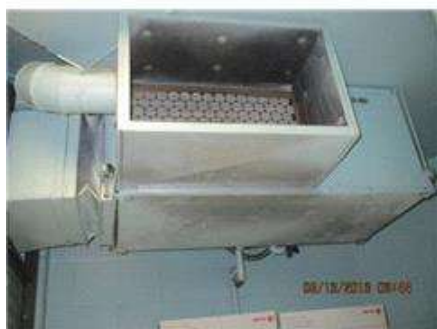
May 2013 - Original Heat Pumps

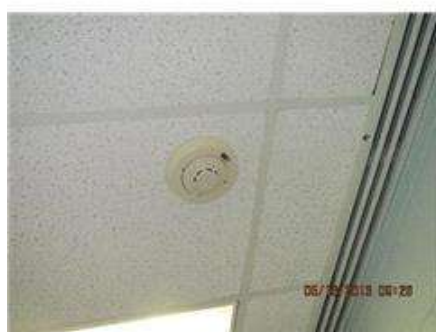
May 2013 - Non Operational Ventilator Units Above Ceiling

2013 - Replacement of the unit ventilators in the vestibule areas is recommended with a heating system which allows for appropriate maintenance and repairs to be conducted.

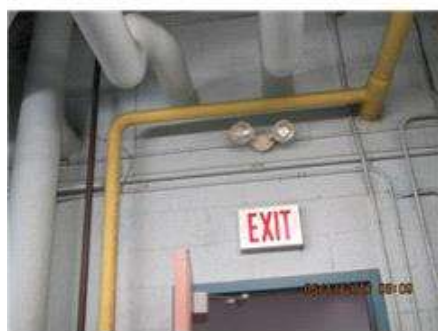
May 2013 - Original Emergency Lighting Fixtures

2013 - Replacement of the original lighting fixtures and batteries is recommended based on age and condition.

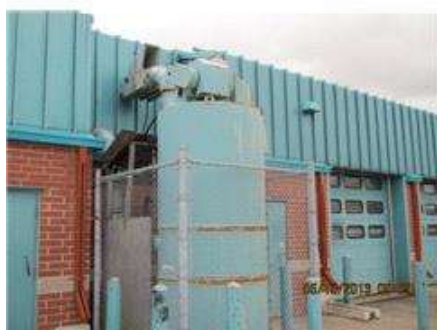
May 2013 - Aged and Corroding Dust Collector

2013 - Replacement of the original dust collector is recommended based on age and condition.

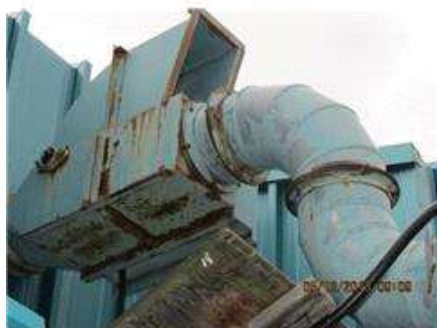
May 2013 - Aged and Corroding Dust Collector

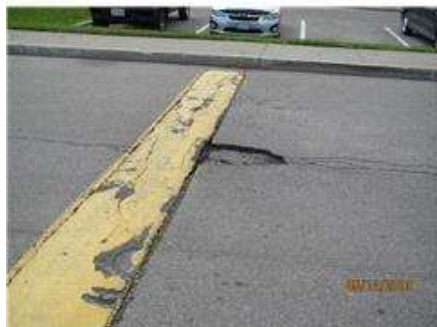
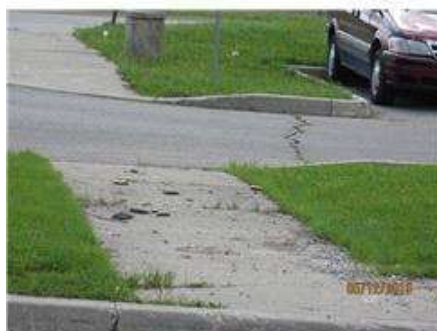
2013 - The asphalt paved roadway is showing signs of pot hole and cracking. Reconstruction planning warranted.

May 2013- Evidence of pot hole on the main roadway in front of the building.

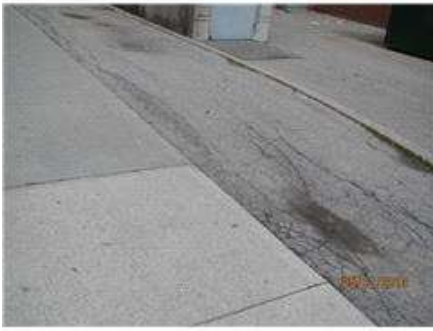
May 2013- Asphalt paved pedestrian showing sign of alligator cracking.

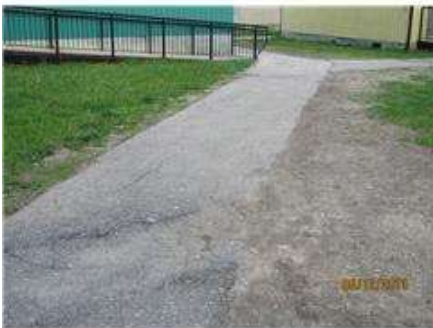
May 2013- Worn asphalt paved sidewalk.

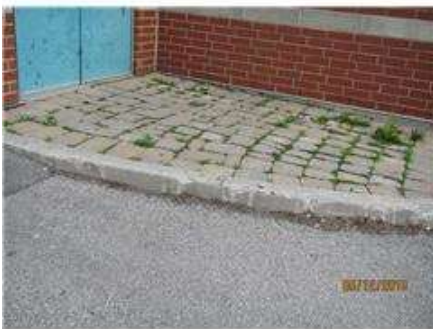
May 2013- Worn Inter lock with vegetation growth.

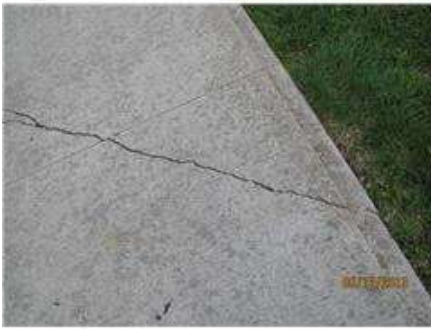
May 2013- Cracked surface on concrete paved pedestrian.
