HAMILTON WENTWORTH DISTRICT SCHOOL BOARD
FEASIBILITY STUDY AND CONCEPT DESIGN

ANCASTER HIGH SCHOOL
374 Jerseyville Rd West, Hamilton, ON

MAY 18, 2016

Condition Assessment

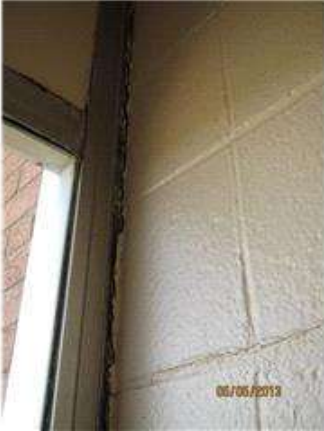
May 2013- wall crack in the Special needs classroom on the 1st floor of east wing.

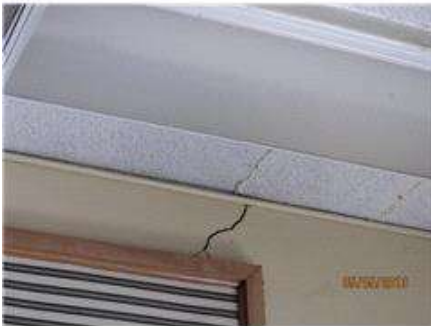
May 2013- wall crack in the Special needs classroom on the 1st floor of east wing.

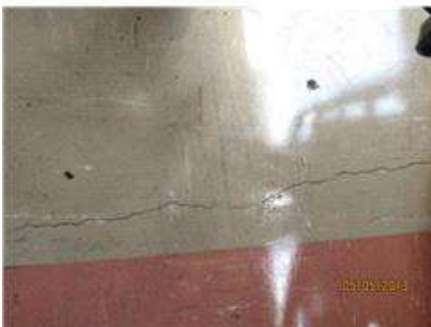
May 2019- Floor crack in the classroom of first floor east wing.

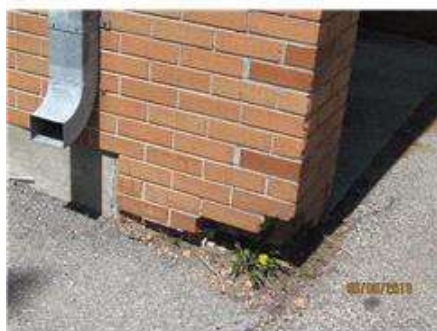
May 2013- Evidence of Deteriorating brick wall on the south side of the building

Recommendation 2013 - The exterior brick veneer walls are showing signs of deterioration on all facades of the building. Repointing and brick replacement is necessary as to maintain the integrity of the building envelope.

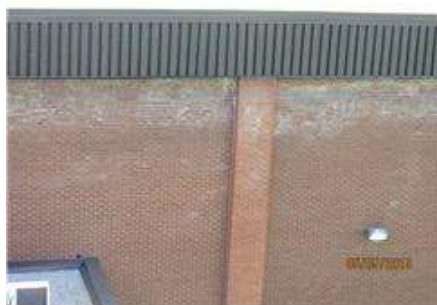
May 2013- Sign of efflorescence on the surface of the exterior wall bricks.

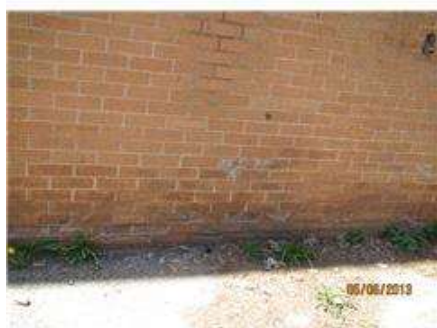
May 2013- Spalling bricks.

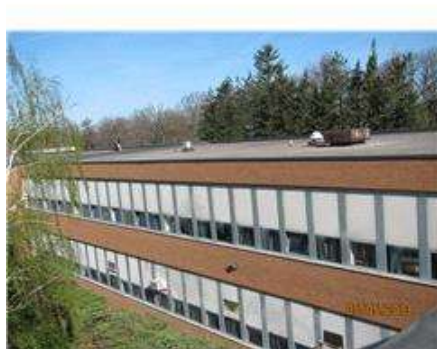
May 2013- original exterior windows.

2013 - Due the condition of the exterior windows it is recommended to be replaced.

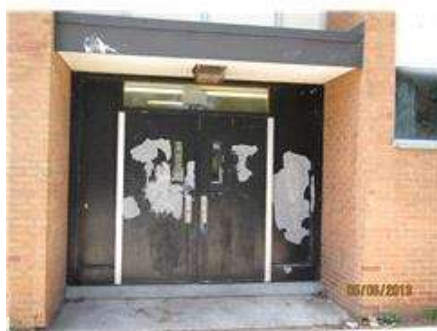
May 2013- Typical exterior door.

2013 - The majority of the exterior door assemblies are original and have exceeded their effective design rated life. Replacement of the door assemblies is recommended.

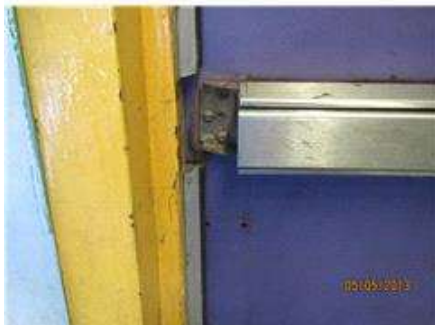
May 2013- Worn exterior door hardware.

2013 - It is recommended that the exterior door hardware should be replaced at the time the exterior doors are replaced.

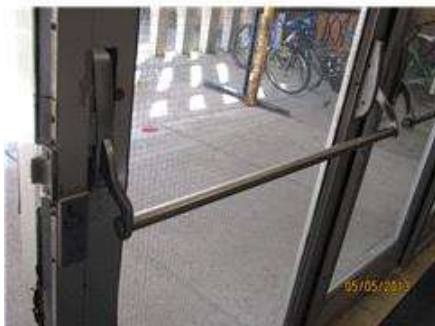
May 2013- Worn exterior door hardware.

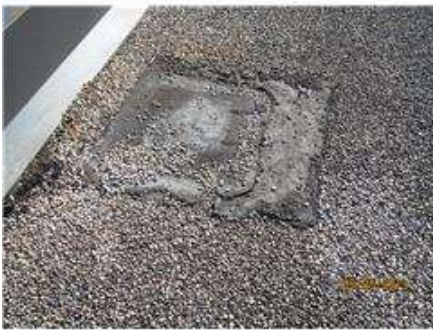
May 2013- Evidence of temporary repair of the BUR roof.

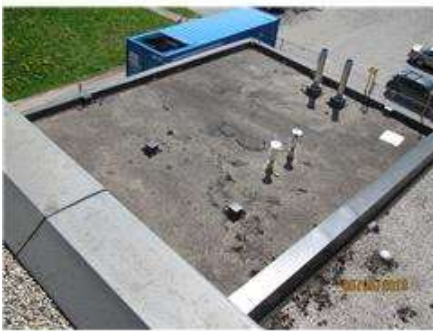
May 2013- Deteriorating Roof covering.

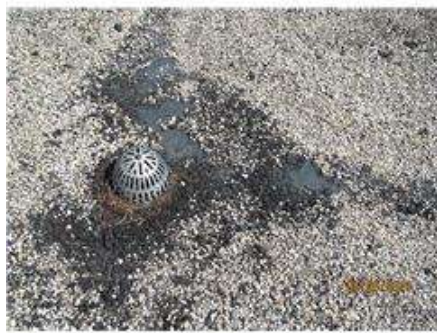
May 2013-Signs of displaced ballast

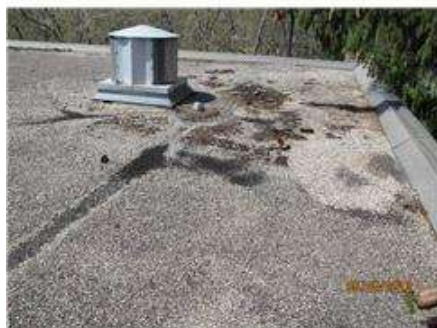
May 2013- Sign of displaced ballast and Potential future damage.

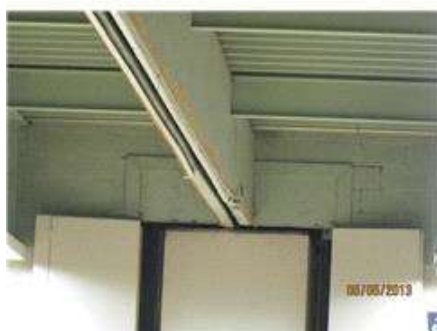
May 2013- Deteriorated track of movable partition in the GYM.

2013 - The moveable partition in the gymnasium is peeling, damaged, and has surpassed its expected useful life. Replacement is recommended.

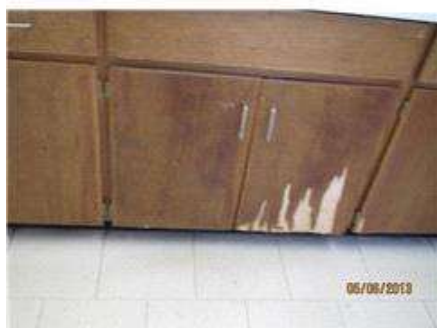
May 2013- Damaged millwork.

2013 - Recommend that the original millwork and cabinetry to be replaced.

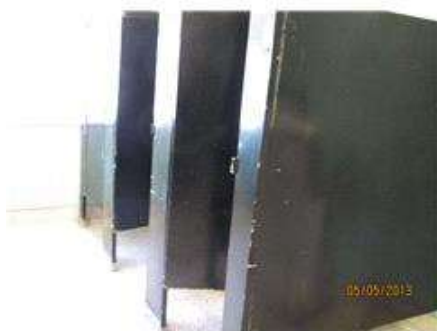
May 2013- Worn washroom partition.

2013 - The original floor mounted painted toilet partitions have exceeded their expected useful life. Replacement is recommended.

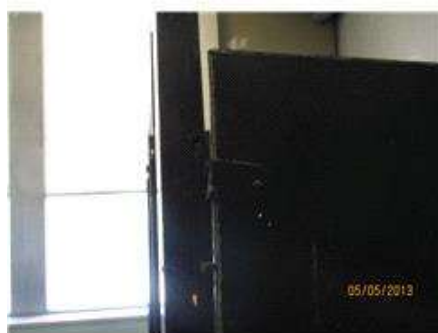
May 2013- Worn washroom partition.

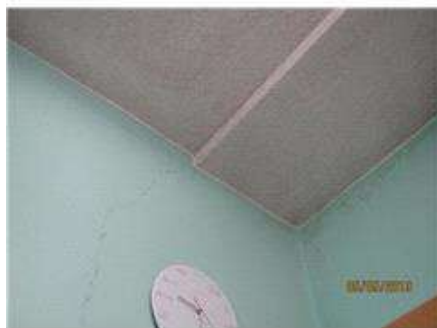
May 2013- Stained and peeling paint wall covering.

2013 - Recommend all interior wall finishes to be repainted as the finishes are fading and showing signs of age.

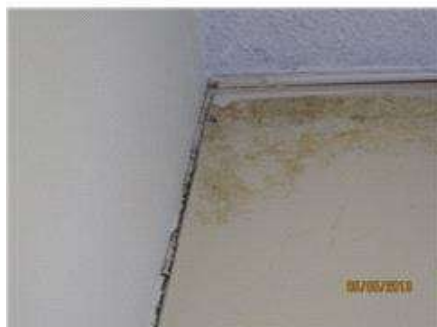
May 2013- Stained paint wall covering.

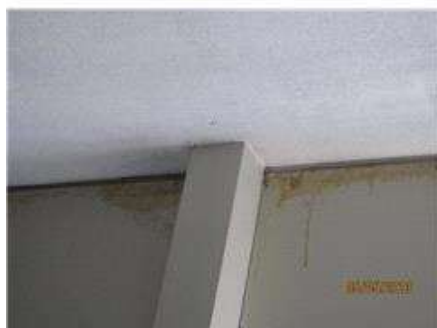
May 2013- Stained paint wall covering.

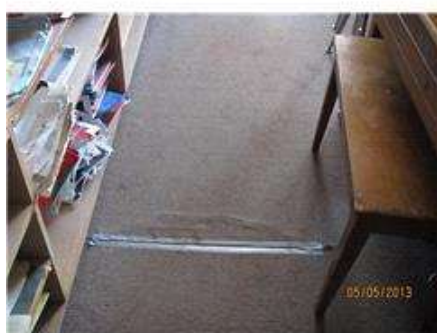
May 2013- Deteriorated carpet flooring in the music room.

Recommendation 2013 - Replacement is recommended based on the observed condition

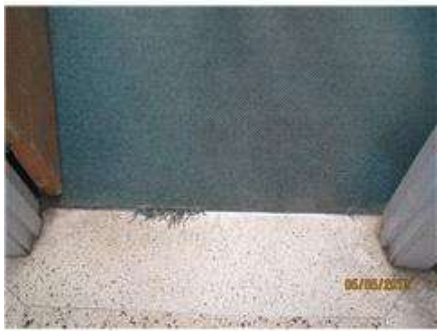
May 2013- Stained carpet flooring in the office area.

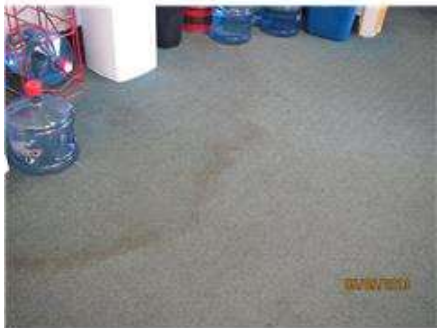
May 2013- Stained carpet flooring in the office area.

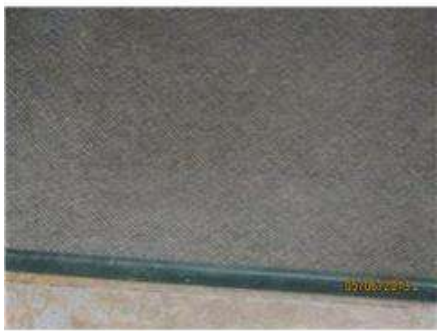
May 2013- Stained carpet flooring in the auditorium.

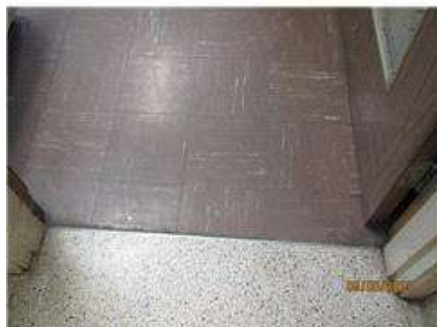
May 2013- Worn VAT floor covering in Isolated classrooms and corridors.

2013 - The VAT floor finish has exceeded its effective design rated life and is in fair to poor condition. Replacement of the VAT floor finish is recommended as to update the appearance and mitigate any potential health concerns.

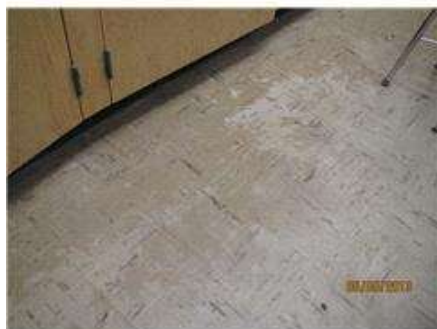
May 2013- Worn VAT floor covering.

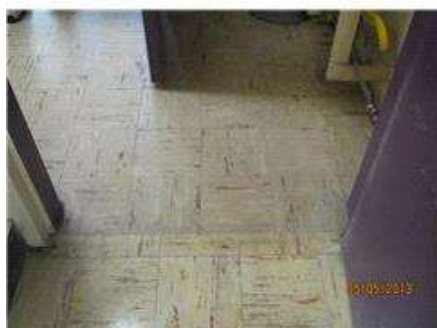
May 2013- Worn VAT floor covering.

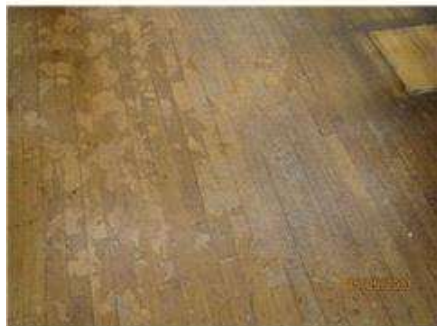
May 2013- Worn out hard wood flooring in the GYM area.

2013 - The hardwood strip flooring on the stage is in poor condition. Refinishing or replacement of the hardwood flooring is recommended.

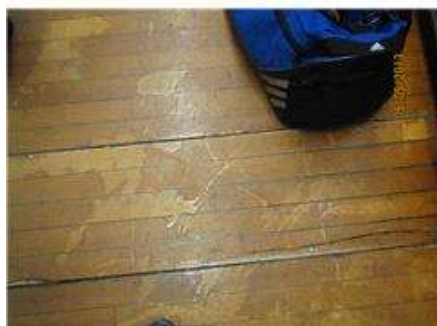
May 2013- Deteriorated hardwood flooring in the some frist floor classrooms.

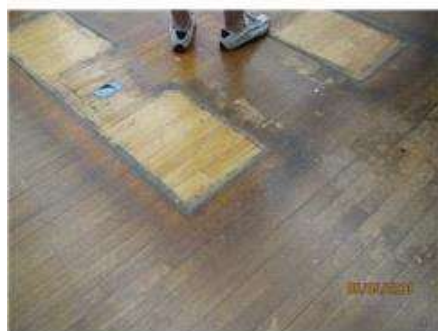
May 2013- Worn hardwood flooring in the exercise room

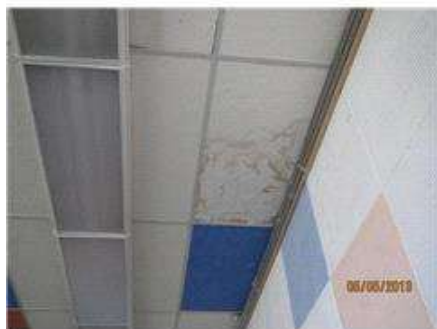
May 2013- Stained ACT.

Recommendation 2013 - The acoustical suspended ceiling tile system is showing signs of wear. Replacement is recommended.

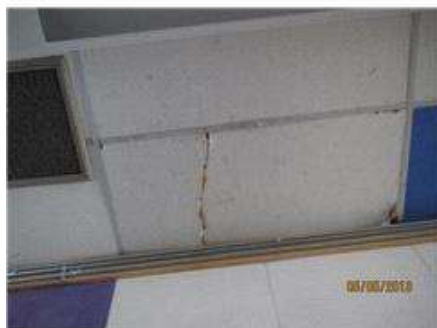
May 2013- Broken ACT in the music room.

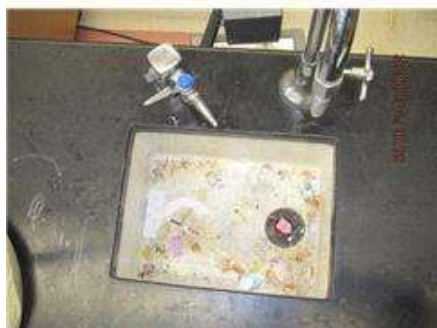
May 2013 - Aged Science Lab Sinks

2013 - The science room lab sinks are aged, show signs of staining and are due for replacement.

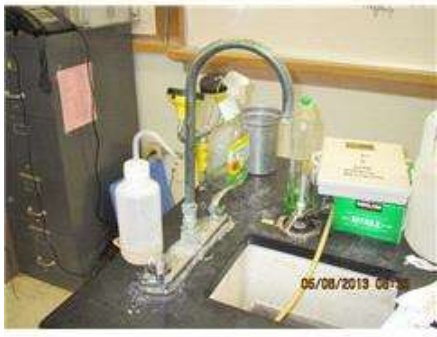
May 2013 - Aged Science Lab Sinks

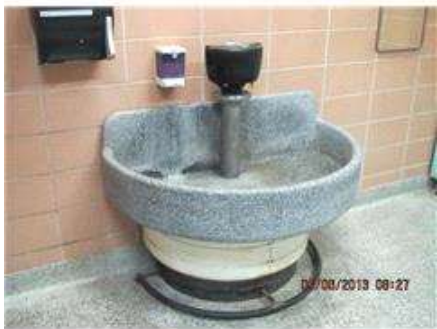
May 2013 - Aged Bradley Basin

Recommendation 2013 - Replacement of the original and aged plumbing fixtures in the building (85%) is recommended based on the age, condition and remaining useful life.

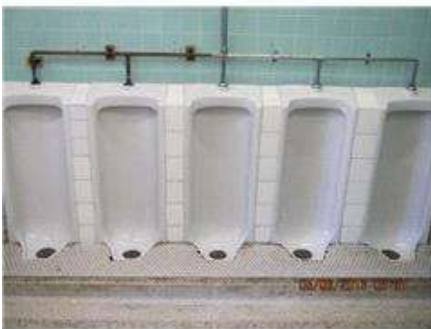
May 2013 - Original Floor Mounted Urinals

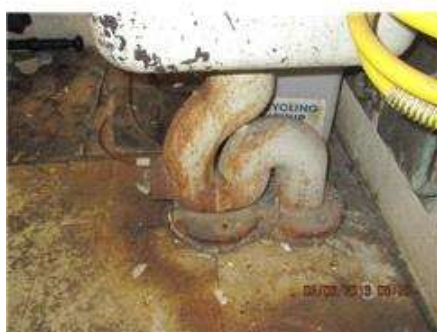
May 2013 - Original Sanitary Waste Piping

2013 - Planned replacement of the waste water distribution system is recommended based on age and condition.

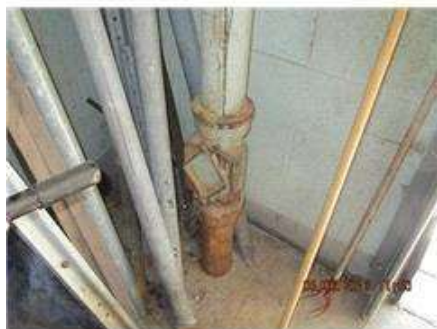
May 2013 - Original Rain Water Drainage Piping

Recommendation 2013 - Planned replacement of the rain water drainage system is recommended based on age and condition.

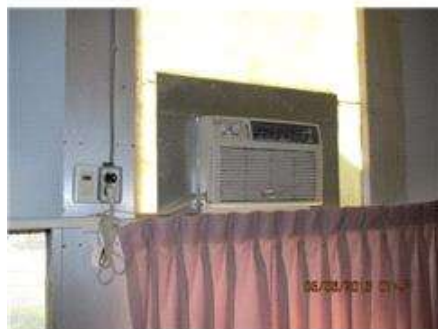
There are approximately 18 window A/C units that are aged and worn. They are noisy and difficult to maintain. Replacement is recommended.

May 2013 - Aged Window AC

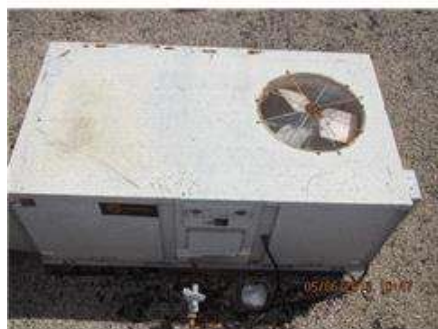
May 2013 - Aged Rooftop Unit

2013 - Replacement of the aged rooftop unit is recommended based on age and condition.

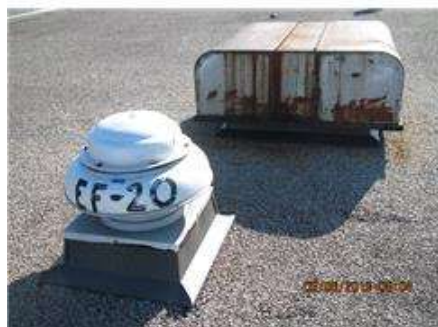
May 2013 - Aged and Weathered Rooftop Exhaust Fans

2013 - The exhaust fans are operating past their expected useful lives and will likely require replacement as most are in poor condition.

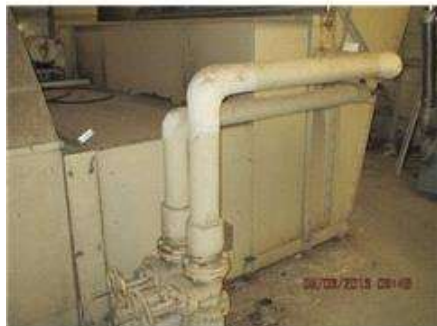
May 2013 - Aged Air Handling Units

2013 - Due to age and mechanical wear, the central air handlers should be replaced within the next 5 years for reliability.

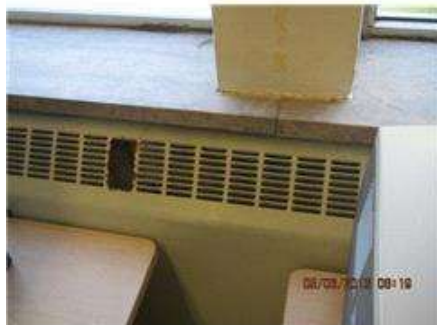
May 2013 - Original Fin Tube Radiators

2013 - Replacement of the aged heating terminal units is recommended based on condition and theoretical life.

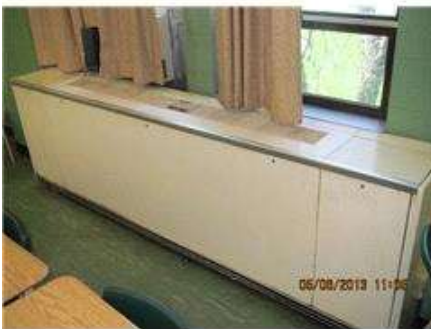
May 2013 - Aged Unit Ventilators

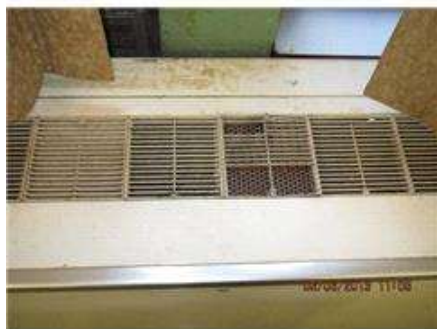
May 2013 - Aged Unit Ventilators - Minor Damage

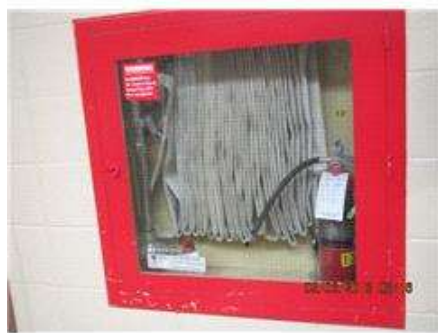
May 2013 - Original Standpipe Systems

2013 - Replacement of the standpipe system is recommended based on the age and theoretical useful life of the system. Planning for renewal is recommended to maintain functionality during and emergency.

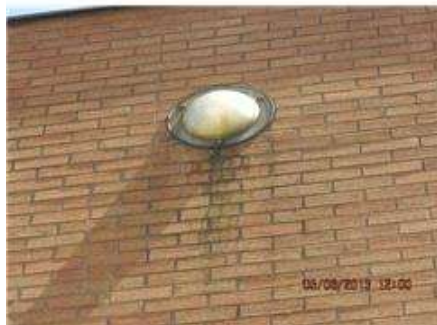
May 2013 - Original Incandescent Lighting Fixtures

2013 - The exterior lighting fixtures are original and appear to be functional at this time, but have surpassed their anticipated service life. Replacement of existing aged lamps and fixtures with higher efficiency lamps and fixtures is recommended.

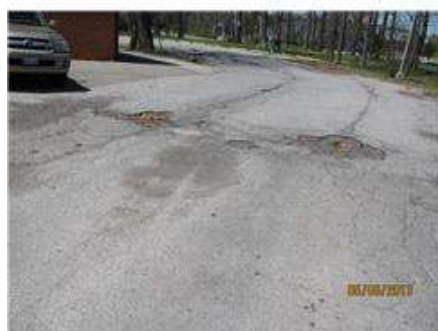
2013 - The asphalt paved roadway is showing signs of alligator cracking. Replacement is recommended.

May 2013- Evidence of Pot hole and, alligator cracking on the surface of the road.

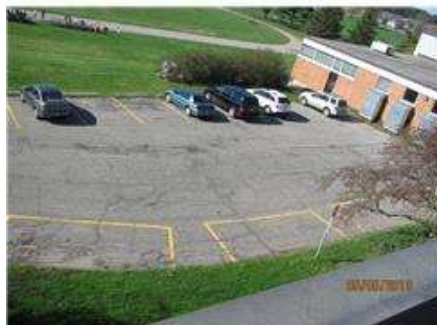
Mar 2013- Parking lot on the south side of the building.

2013 - The asphalt paved parking lot is in poor condition with pot holes and alligator cracking. Reconstruction of the parking lot is recommended.
