HAMILTON - WENTWORTH DISTRICT SCHOOL BOARD  
CONCEPT DESIGN AND FEASIBILITY STUDY

**GLENDALE SECONDARY SCHOOL**

145 RAINBOW DRIVE, HAMILTON

Grguric Architects Incorporated  
Glendale SS Facility Conditions Assessment Report  
June 26, 2015

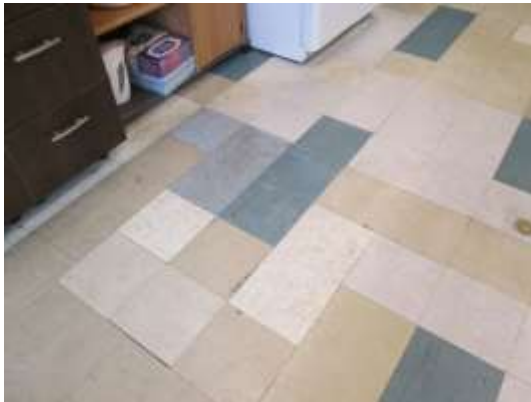
Photo 2.1.A - Classroom 1009 (Room 107)

- Random patterns of replacement tiles (Photo 2.1.A)
- Surface wear through scuffing and rubbing (Photo 2.1.B)
- Delaminated or missing sections of rubber base (Photo 2.1.C)
- Chipped edges at floor joint trims and differing tile types in same corridor (Photo 2.1.D)

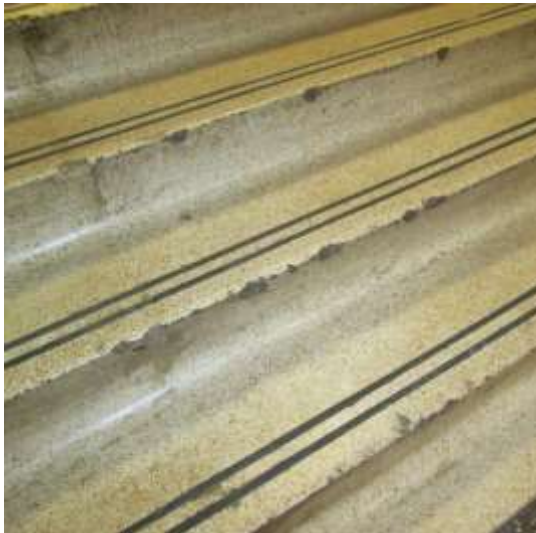
Photo 2.1.E – Vestibule 1046

**Terrazzo:** The existing terrazzo flooring finish is found predominately in the corridors, entrances and stair wells, as well as, in the washrooms, change rooms and showers. The terrazzo finishes remain in good condition and only require regular maintenance upkeep. The floor transition stairs in Corridor 1047 have several incidences of chipped terrazzo finishes at the stair nosings (Photo 2.1.E). The surface finish in the change rooms shower areas has extensive water based and rust staining between shower source and the floor drain (Photo 2.1.F).

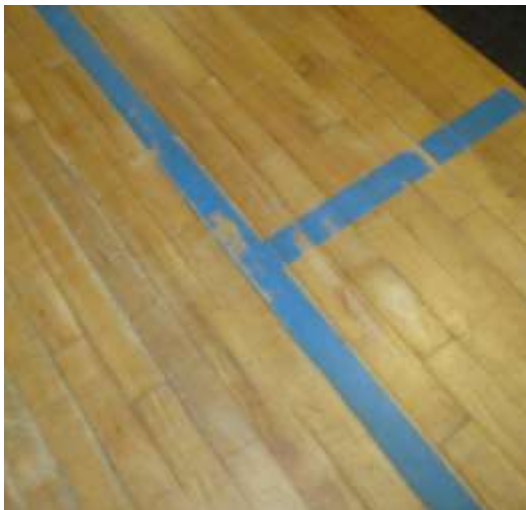
Photo 2.1.G – Gymnasium 1052

**Gymnasium Wood Flooring:** The existing hardwood flooring in the gymnasium is exhibiting signs of advanced surface wear to the finish. In some areas, the finish coat is worn down to the bare wood. Surface deterioration includes the paint coat markings (Photo 2.1.G). Along the west side of the court is a small area of recently replace hardwood flooring strips. There is an obvious distinction between the newer and older flooring finishes appearance (Photo 2.1.H).

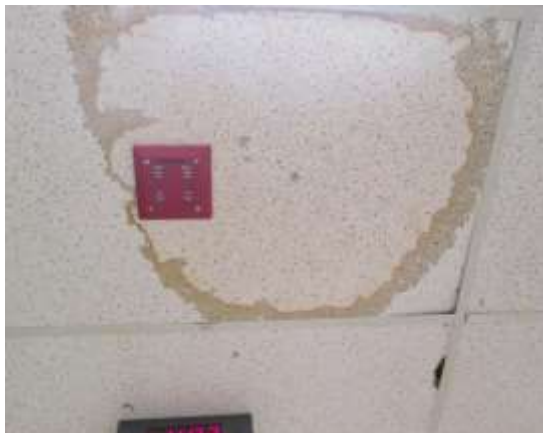
Photo 2.2.A – Corridor 1011

The corridors throughout the facility have acoustic ceiling tiles and they were generally found to be in good and serviceable condition. There are examples of water damage and broken or chipped edges (Photo 2.2.A). The T-bar grids in the facility are original and exhibit signs of surface discoloration. Other than the ground floor shop classrooms, the classrooms in the facility are typically finished with a metal lathe and plaster ceiling finish and surface mounted 12x12 perforated acoustic tile arranged in linear panels. In most cases, classrooms were found to have several missing 12x12 tiles (Photo 2.2.B). For the most part these ceiling types remain in good condition requiring paint refinish and some repairs. There are several classrooms along with the stairwell ceilings that are continuously finished in the 12x12 perforated tile surface mounted to the plaster ceiling. Before completing renovation to this ceiling finish the 12x12 tiles should be tested for ACM. Photo 2.2.C below, illustrates a segment of missing expansion joint trim found in the ceiling finish of the Music Classroom 1039. Generally the plaster ceiling finish in the washrooms remain in good condition, however in the Girls Washroom 1019, the plaster ceiling has some areas where the paint finish has sustained moisture related damage and exhibits signs of surface bubbling and finish peeling (Photo 2.2.D).

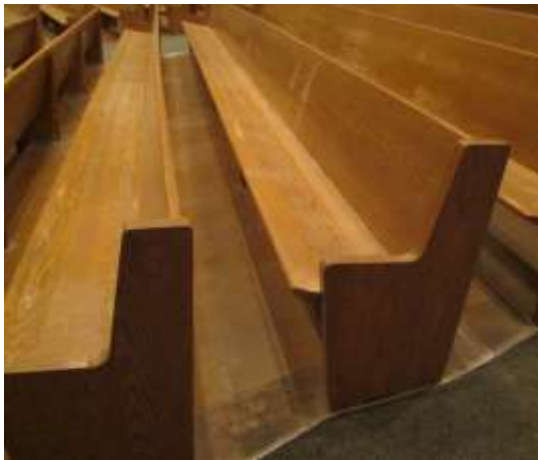
Photo 2.3.A – Auditorium

The equipment and finishes in the auditorium exhibit an advanced state of wear and in most cases have exceeded normal life cycle usage. The existing wood bench seating type is outdated for current theatres and auditoria that are typically outfitted with individual seats, offering better comfort and superior acoustic properties. Several of the existing benches have extensive surface finish wear, down to the original wood (Photo 2.3.A).

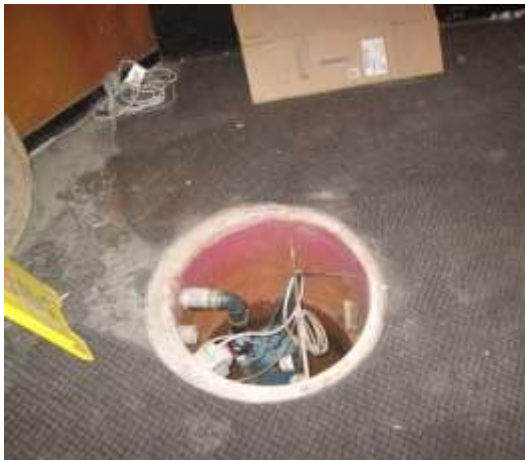
Photo 2.3.E – Orchestra Pit Sump Pump

- Orchestra pit sump pump: the adjacent carpet flooring is still damp from a recent surface flooding. This points to an operational problem with the pump that will need to be addressed (Photo 2.3.E).
- Stage Back Room wood flooring requires refinishing or replacement.
- The existing A/V System should be reviewed for upgrades: example – the older type of stage lighting could be replaced with current and more efficient LED Systems (Photo 2.3.F).
- The 2-piece washroom does not conform to current codes and would need be revised (Photo 2.3.G).
- Oversized doors: the existing steel plate exterior doors are difficult to operate and latch close and offer no insulation value (Photo 2.3.H).

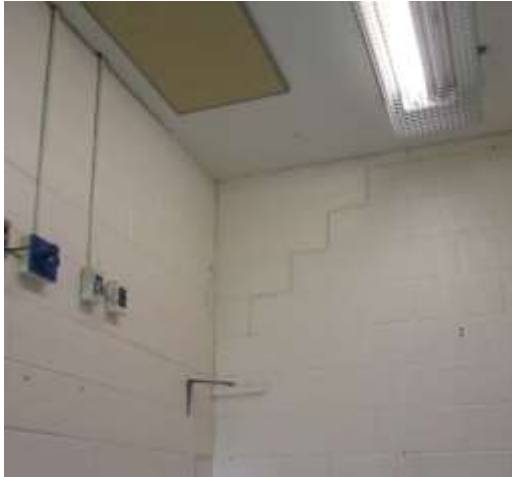
Photo 2.4.A – Classroom 1009 (Room 107)

Masonry painted wall finishes generally remain in good condition. There are a few examples of movement cracks along the masonry joints (Photo 2.4.A and 2.4.B). These areas should be monitored for any signs of further cracking.

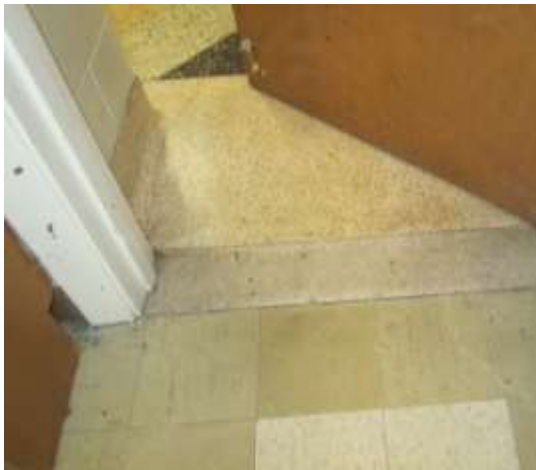
Photo 2.4.C – Classroom 1009 (Room 107)

The solid core wood doors and wood frames, typical for this facility, generally remain in good condition. The typical stained veneer door finish, show signs of surface wear and discoloration and will require refinishing. Some of these solid core wood doors have a painted finish. The wood frames include decorative wood trims on both sides and have a white painted finish. These door frames and trims are in need of repainting as they are exhibiting signs of surface finish wear (Photo 2.4.C). There are a few doors that rub with the floor resulting in difficult operations. These doors should be undercut.

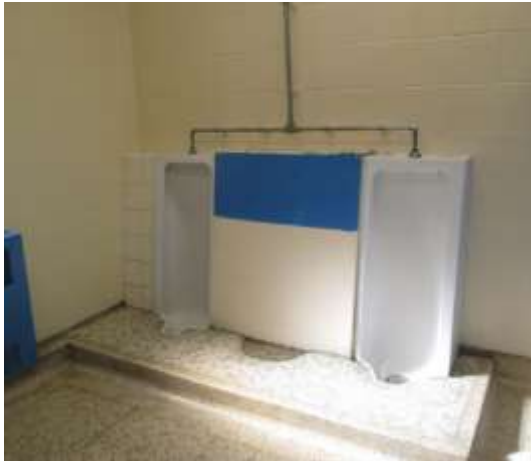
Photo 2.4.G – Boys Washroom 2040

The existing Boys and Girls washroom facilities generally remain in fair to good condition, however, they are equipped with inefficient fixtures and other aging equipment such as the toilet partition and accessories. The tall style urinals in the Boys washrooms sit on a raised curb (Photo 2.4.G). The older style Bradley wash fountains exhibit signs of wear (Photo 2.4.H). These facilities will eventually be in need of upgrading to replace the aging Bradley wash fountains, toilet partitions and plumbing equipment with newer efficient fixtures (Photos 2.4.I and 2.4.J) and given that there are no barrier free access provisions in these existing Boys and Girls washroom groups, these upgrade works can be combined.

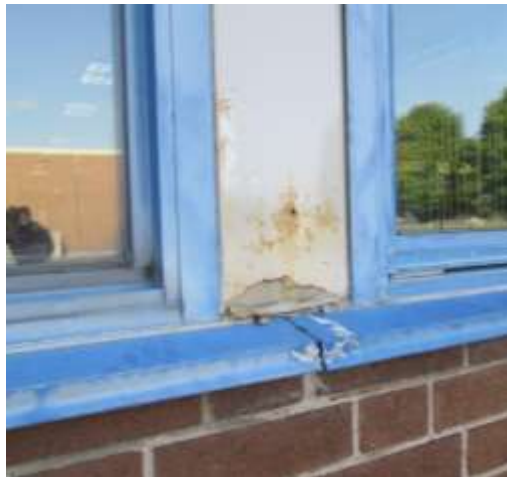
Photo 3.2.A

- Prefinished surface colour is wearing and fading. The column metal colour trim has deteriorated at the base revealing the insulation behind (Photo 3.2.A).
- The column metal cover trim is rusting at base resulting in punctures in the cover. This is due to moisture infiltration and accumulation behind the cover (Photo 3.2.B).

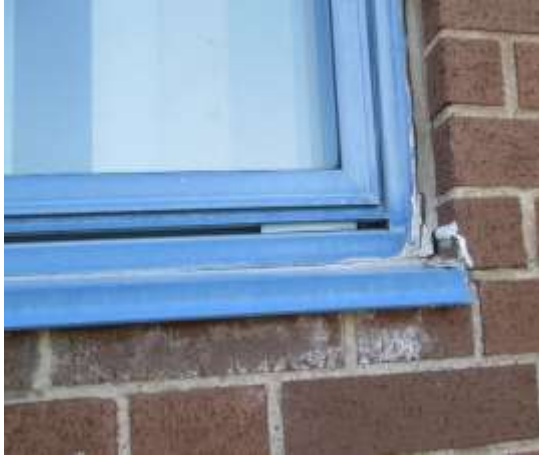
Photo 3.2.C

- In this example, located at the Cafeteria Servery west exterior wall, the caulking has deteriorated and detached from the frame at the corner base of the window. This area is exposed to water infiltration. The probable cause of the effervescence on the brick face would be from surface moisture accumulation on the brick. A potential source originating from the above sill could be due to moisture infiltration occurring below the sill flashing (Photo 3.2.C).
- In this example, the lower limit of the interior spandrel panel finish is exhibiting water staining caused by exterior water infiltration between the mullion and spandrel panel outside (Photo 3.2.D).

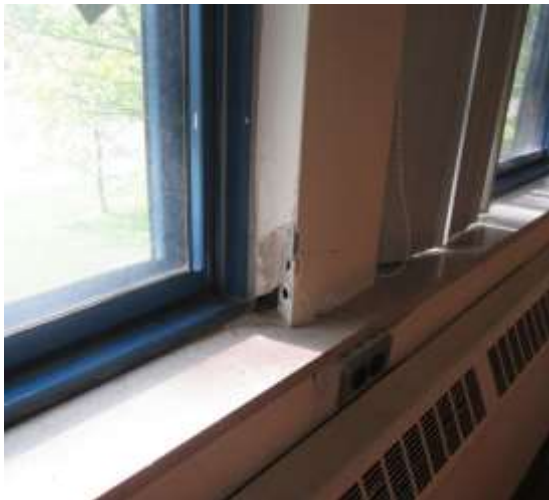
Photo 3.2.E – Science Lab 2070 (Room 211)

- The interior gypsum board finish around the column has sustained moisture related damage at the sill level. The source of this moisture originated from an improperly closed slider window during precipitation events. There may have also been some impact type damage at this location (Photo 3.2.E).
- This example may partly explain image “E”. The slider tracks have accumulated debris and moisture leading to difficult slider operation and in some cases, blockage. As in image “E”, the adjacent gypsum board finish is exposed to external moisture and starting to sustain some damage. In this same image the interior caulking between sill and window frame has broken away exposing some gaps (Photo 3.2.F).

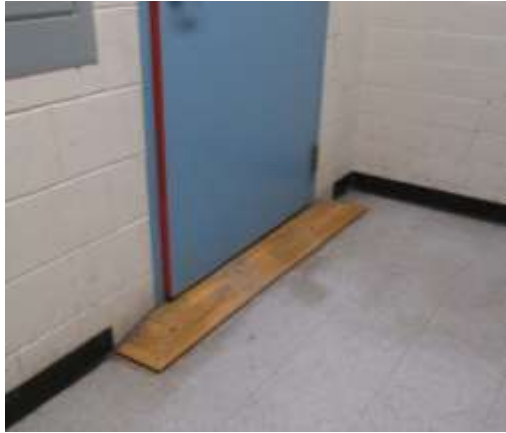
Photo 2.1.A – Boys Change Room 1052B

Due to the greater thickness of the existing gymnasium flooring system, there is a minor difference in floor levels at the vestibules to the change rooms. This difference is currently accommodated with a sharp sloped transition down to the change room floor level (Photos 2.1.A & 2.1.B below). Should the change rooms be updated to accommodate barrier free provisions, it is recommended that a landing and floor slope transition be added within the vestibules.

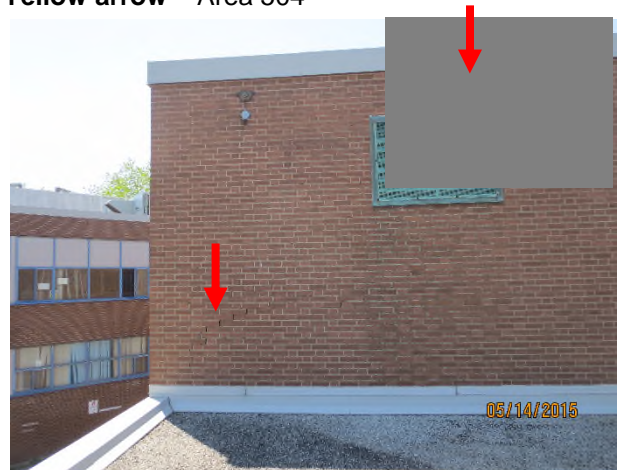
**Photograph 4** – South-east corner on Area 303  
 (North-east wall of Area 502)  
**Red arrow** – cracked mortar joints and loose/dislodged bricks

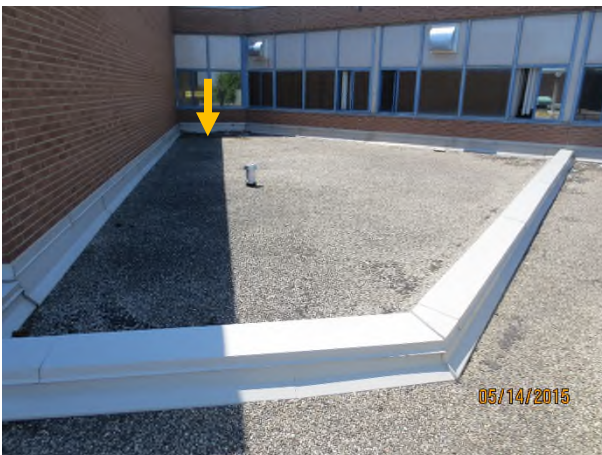
**Photograph 5** – West view of Area 301  
**Yellow arrow** – debris/vegetation on roof surface and around drain

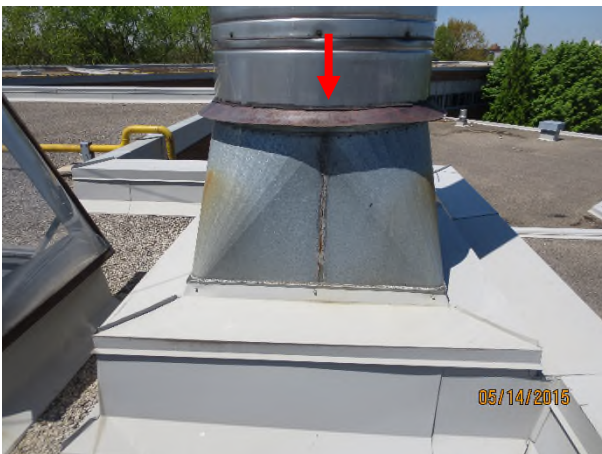
**Photograph 17** – East side of stack in Area 502  
**Red arrow** – cracked caulking

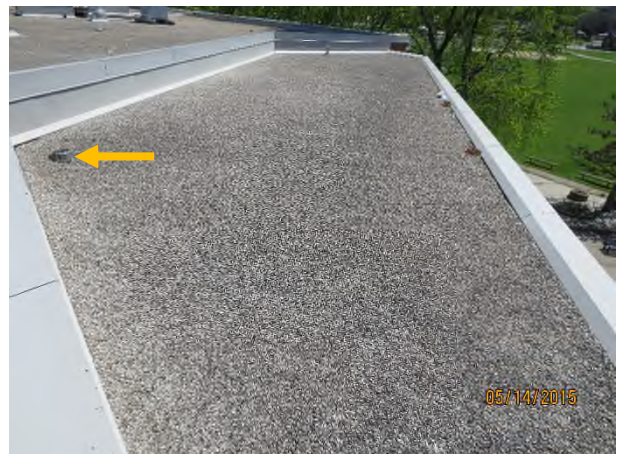
**Photograph 18** – S/E view of area 401  
**Yellow arrow** – damaged drain cover

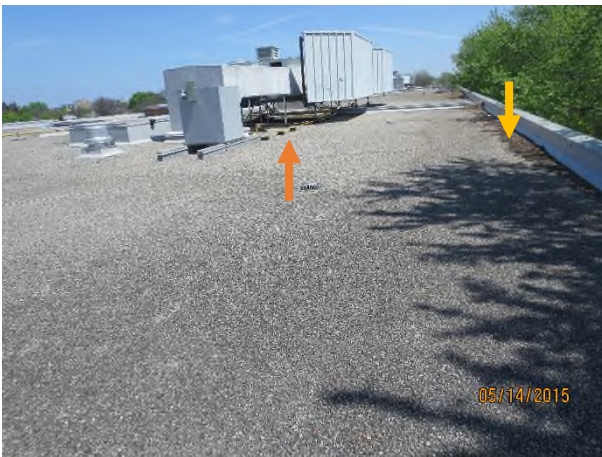
**Photograph 19** – N/E view of Area 502  
**Yellow arrow** – excessive vegetation growth along east wall (tree line)  
**Orange arrow** – vegetation growth under platform

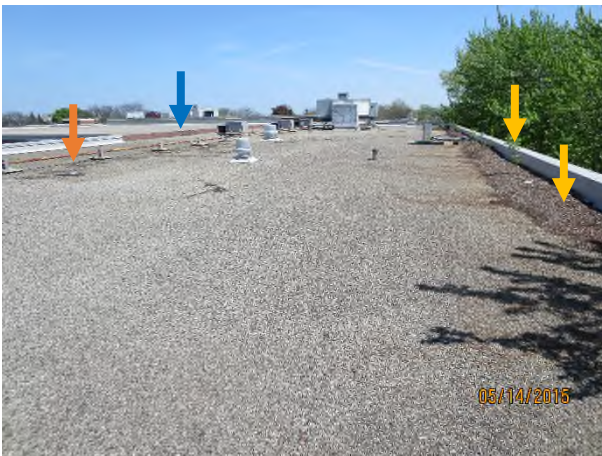
**Photograph 21** – East view of Area 503  
**Yellow arrows** – vegetation and tree growth  
**Orange arrow** – clogged drain  
**Blue arrow** – failed transition between Areas 601 and 503

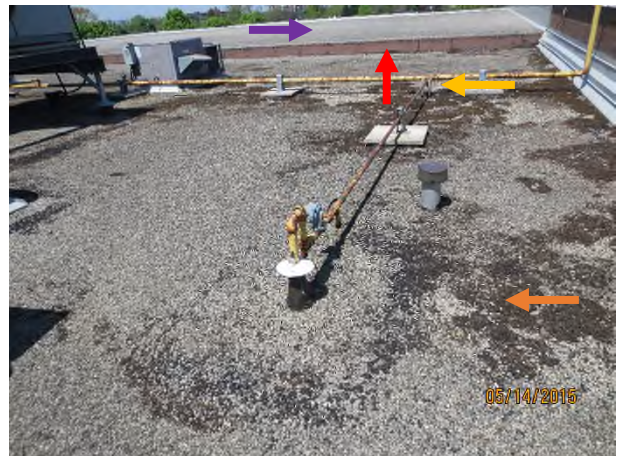
**Photograph 22** – North view from Area 503  
**Orange arrow** – dry vegetation, **Yellow arrow** – missing gas line support, **Purple arrow** – Area 601  
**Red arrow** – cap sheet slippage, blistering, open laps at transition between 503 & 601

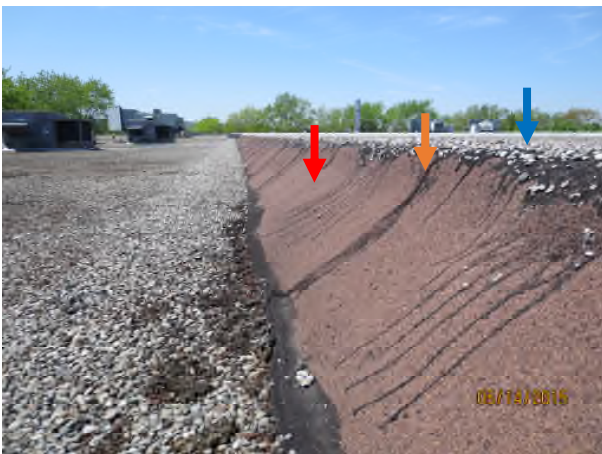
**Photograph 23** – Close up view of in Photo#21/22  
**Orange arrow** – open side overlap  
**Red arrow** – slippage and blistering along entire joint  
**Blue arrow** – no gravel stop on Area 601

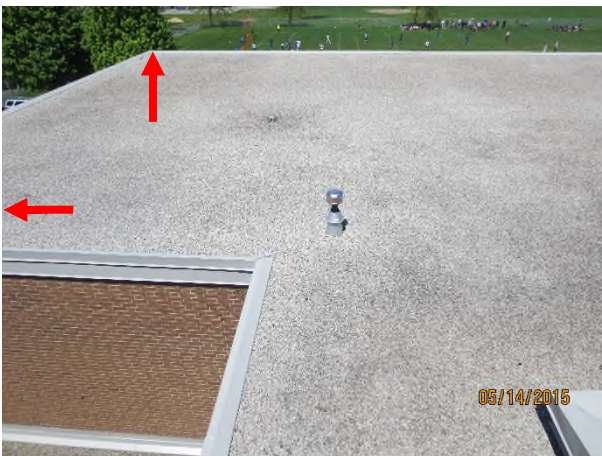
**Photograph 27** – North view of Area 402  
**Red arrow** – wind scouring at corners, otherwise roof surface in good condition and drains well

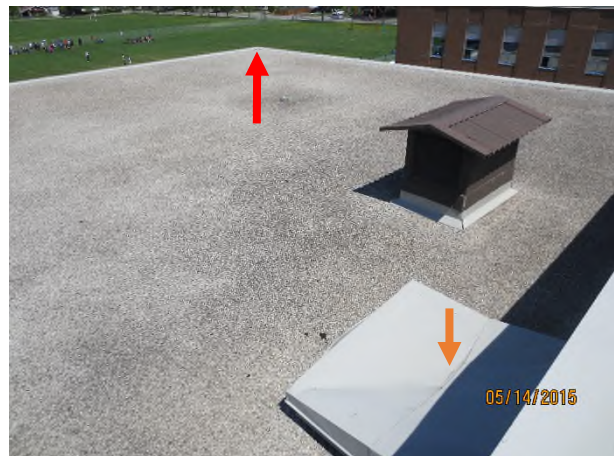
**Photograph 28** – N/E view of Area 402  
**Red arrow** – wind scouring at corner  
**Orange arrow** – damaged fan hood

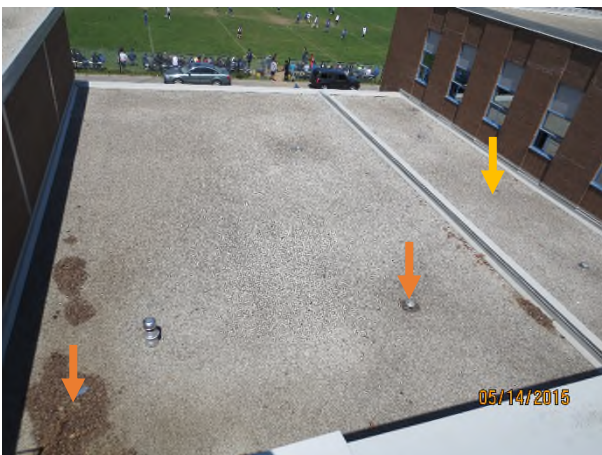
**Photograph 29** – N/E view of areas 305(Left) & 306(Right)  
**Orange arrows** – debris/vegetation on Area 305 and drain area clogged  
**Yellow arrow** – Area 306 – in good condition

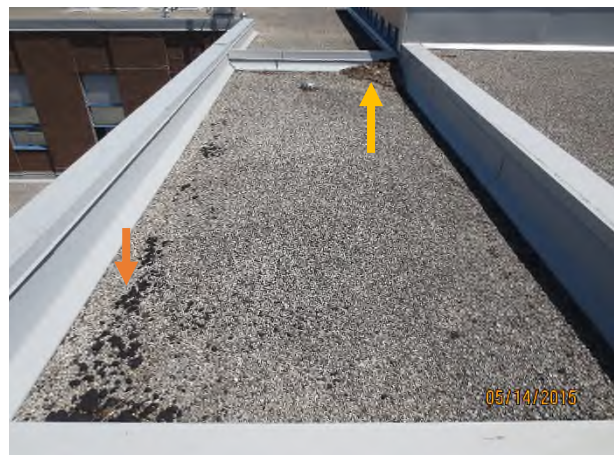
**Photograph 30** – East view of Area 505  
**Yellow arrow** – debris/vegetation  
**Orange arrow** – some asphalt bleed through – not a concern at this time

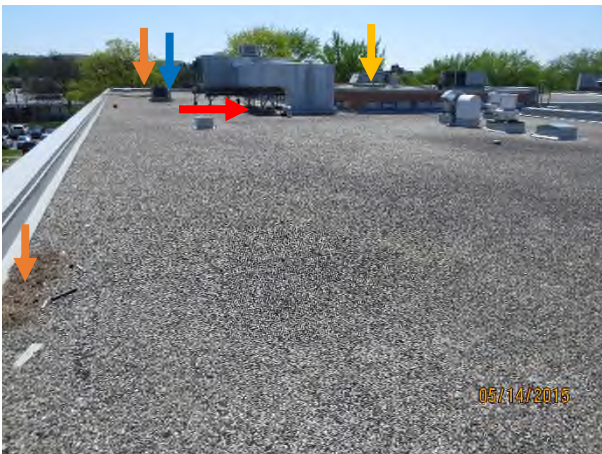
**Photograph 31** – S/W view of Area 504  
**Orange arrows** – debris/vegetation, **Yellow arrow** – Area 701, **Red arrow** – vegetation under mechanical platform, **Blue arrow** – insulation pad under A/C unit deteriorating

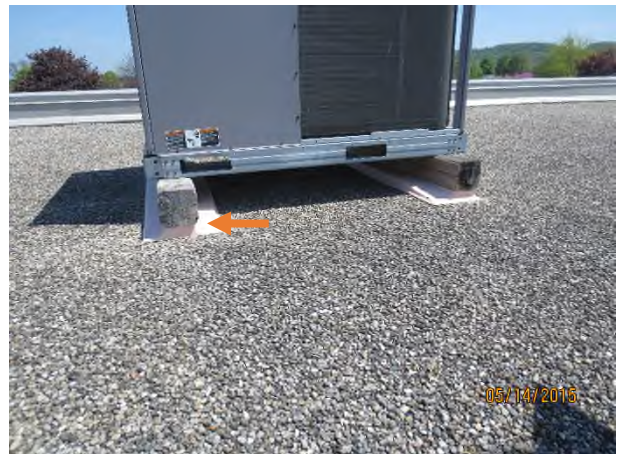
**Photograph 32** – East view of A/C unit on Area 504, Photo#31  
**Orange arrow** – deteriorated insulation under wood sleepers

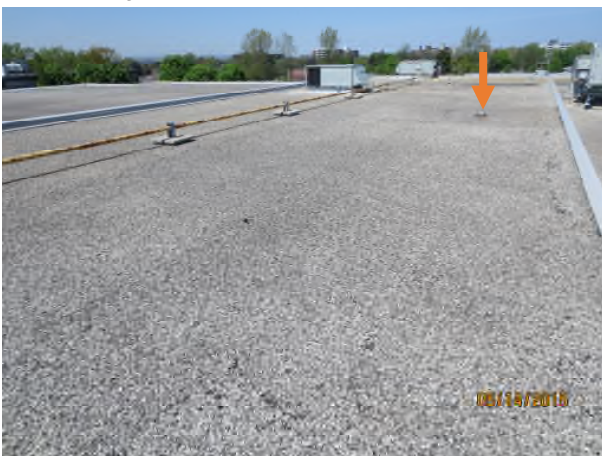
**Photograph 33** – North view of Area 701  
**Orange arrow** – minor debris around drain,

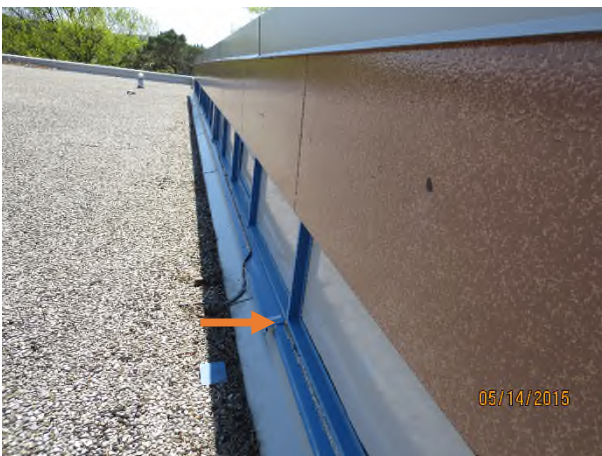
**Photograph 35** – South view of east wall of Area 701 in Photo#33  
**Orange arrow** – loose metal flashing at window sill, not weather tight below and failed sealant

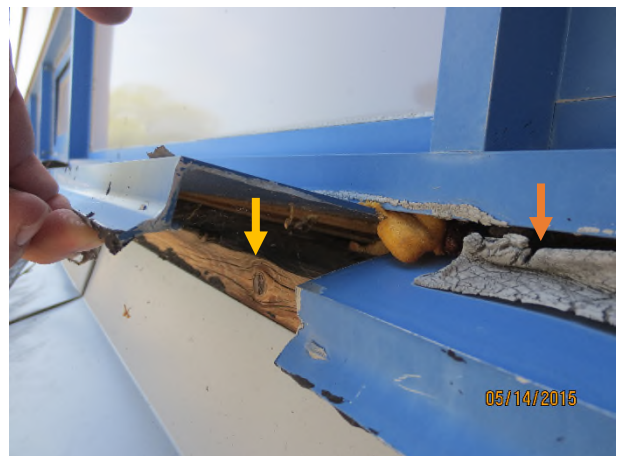
**Photograph 36** – Close up view of window sill in Photo#35  
**Yellow arrow** – no membrane flashing on wood  
**Orange arrow** – failed/cracked sealant

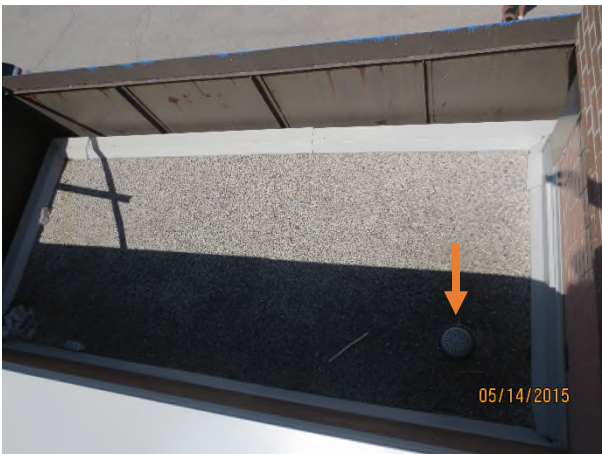
**Photograph 37** – North view of Area 204  
**Orange arrow** – minor debris around drain, roof in good condition

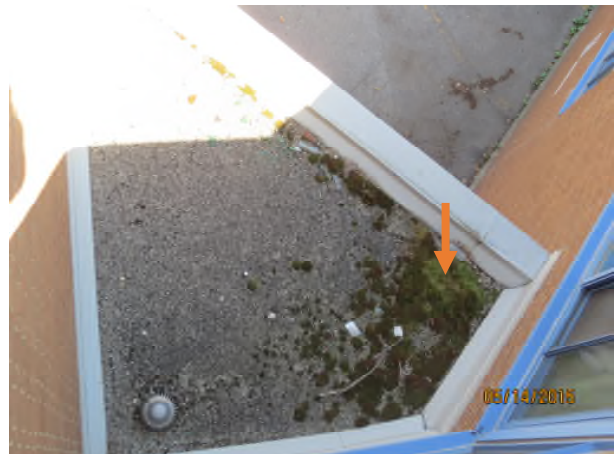
**Photograph 38** – North view of Area 201  
**Orange arrow** – moss growth on roof surface

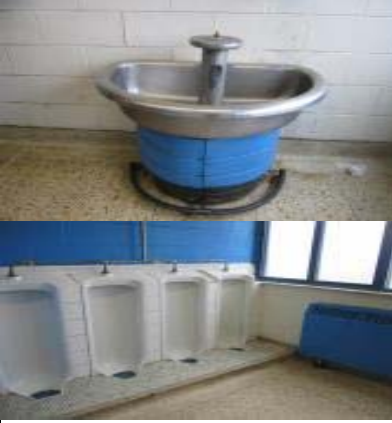
Washrooms on the Ground floor small washrooms have been renovated within the past 20 years. The plumbing fixtures are generally new within the past 20 years except for the north washrooms.	Many of the plumbing fixtures are in good condition and should be retained. On the ground floor north washrooms, the fixtures are original and should be replaced. The original plumbing fixtures are high water flow units. Replacement with new low flow fixtures will reduce water consumption however, with the age condition of the sanitary sewer system, these changes should be considered carefully due to possible operational problems with low flow fixtures.	40		4	\$200,000

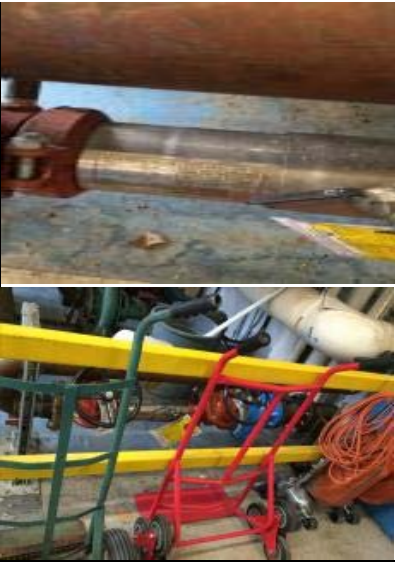
<p>The 4" main city / fire water service enters from the street into the basement at the front entrance of the School. A main 4" supply runs in the tunnel system from there to the Boiler room. The 4" potable meter and water service is original and a new 4" Watts St.St. 757 double check assembly backflow preventer has been installed in the Boiler Room on the potable water system.</p>	<p>The potable water piping systems are copper pipe and fittings. The plumbing mains passing through the ground floor ceiling space were replaced with new copper type L mains in 1996 when the Corridors were renovated. This constitutes over 90% of the plumbing supply piping within the building. For existing piping greater than 25 years old, there is likely a component of leaded solder on the joints and fittings. Any sections of main cold water supply that are more than 25 years old should be replaced. Annual testing of the backflow preventer is required by Code.</p>	40		3	\$80,000

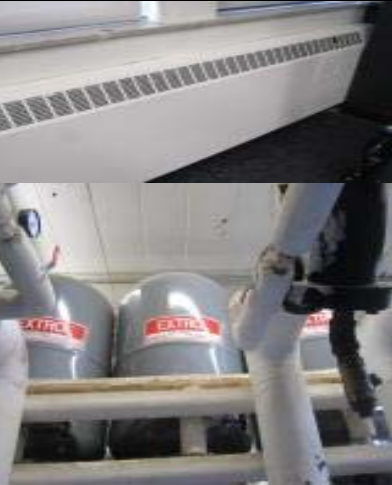
The School contains a significant amount of hydronic heating and relies heavily on the tunnel mounted piping loops for the distribution of the heating energy. Typical rooms include 2 row 24 sloped top wall fin heating elements and pneumatic control valves. Entrance heaters at the stairwells and main entrances do contain hydronic heaters and these units should be repiped with new piping. The hydronic heating piping appears to be original 1956 vintage piping material and is steel with screwed joints. The piping has exceeded its service life and requires replacement. Some piping risers are located in uninsulated exterior walls, making them susceptible to freezing. The majority of the heating piping is contained within the perimeter subgrade tunnels that encompass the building. Racks on the walls of the tunnels contain the heating supply, return and reverse return piping. The piping risers to the perimeter wall fin heaters occurs in each classroom at the exterior wall. Valving from 1956 will be on the heating systems in the tunnels and will not be servicable. Direct buried piping for the Technical wing runs from the Boiler room. The buried 4" steel piping dates from 1962 and is due for replacement.	Replacement of the hydronic piping and horizontal mains in tunnels to the Boiler Room will be extremely expensive. Architectural finishes and pipe routing will dictate the type of replacement heater and the possible pipe routing to the heaters. An alternate heating system should be considered for the school due to the very high cost of repairing / replacing the existing hydronic heating piping systems. Tunnels are still contaminated with asbestos insulation and a confined space entry zones which will raise the cost of any work in the tunnels. Concerns over asbestos in the confined space will make the work very slow.	60	5	2	\$1,500,000

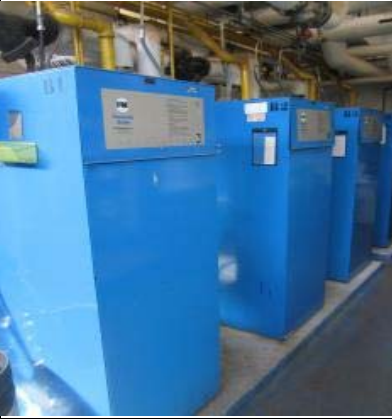
The heating boilers located in the School Boiler Room provide the primary heating of the hydronic heating loop for the School. Four PK Thermiflow non-condensing boilers range in age from 1992 to 1996. The four boilers vent to the original vertical masonry chimney through a gas liner. The Heating loops are rest for outdoor air temperature however the boilers are non-condensing type boilers and the radiation heating requirement does not allow for temperautre rests below 150 DegF HWS.	The boilers have a service life of 25 years as are due for replacement. Major changes to the School may consider alternate heating systems from the hydronic system and these options should be reviewed and evaluated prior to replacing the boilers.	25	5	2	\$300,000

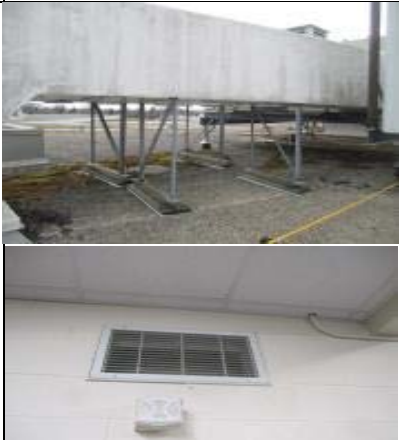
The ventilation air ductwork from the custom AHUs is insulated with 2" thick isocyanate insulation covered with Sarnofil roofing membrane. This is a heavy duty and expensive membrane that is excellent condition after 19 years of operation above the roof level.	The concealed air distribution ductwork within the corridor ceiling spaces supplies and returns air from the teaching rooms to the rooftop HVAC units. The supply air ductwork is thermally insulated in the ceiling spaces of the Ground and Second floor and is suitable for low pressure supply air up to 1" WG.	35	15	3	\$250,000
M5.5	EXHAUST FANS

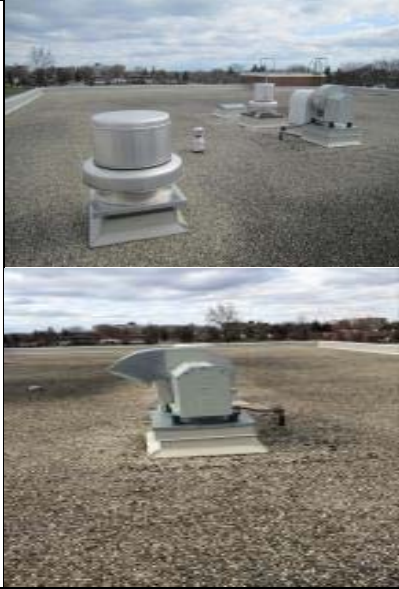
Aluminum exhaust fans serve washroom areas, are curb mounted and were new in 1996. Belt drives are servicable for many years. The original large centrifugal aluminum exhaust fans were removed during the 1996 renovation. Curbs were removed and roof deck in-filled.	The exhaust fans are suitable for long term use. Fan capacities are adjustable if required. Most of the low pressure fans are 120 volt, single phase power supplies and are BAS controlled for occupied / unoccupied cycles.	30	10	3	\$40,000

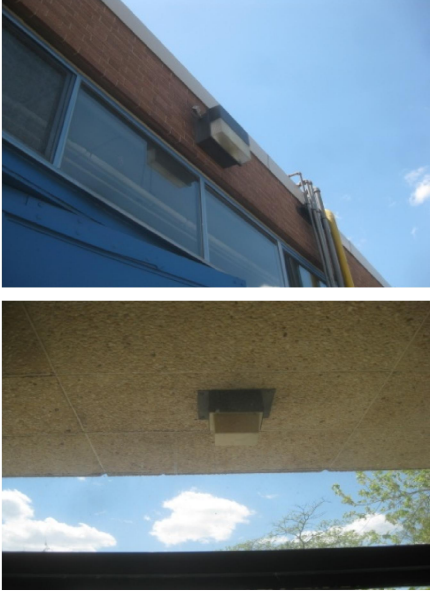
Older high pressure sodium wall pack fixtures around the building exterior mounted at approximately 20ft. Older high pressure sodium canopy fixture at main entrance. Some with broken lenses	Recommend replacing all fixtures with new LED wall pack fixtures and canopy light fixtures. Recommend new exterior lighting control system.	\$75,000.00	Original fixtures have reached service life.
3.1.2	Parking Lot / Roadway Fixtures

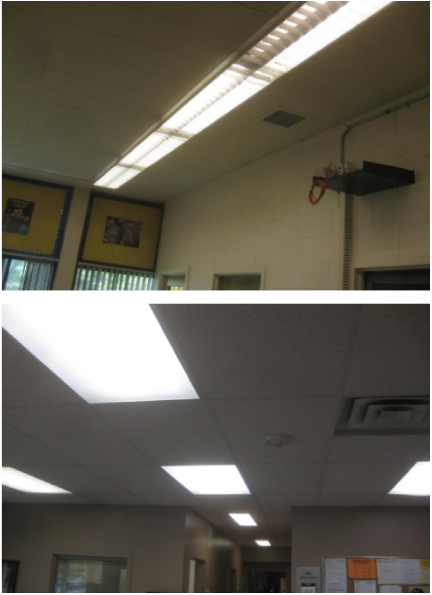
<p>Most classrooms have original 1x4 surface "Kawartha" light fixtures upgraded to T8 lamps 20 years ago. 10% of classrooms have new 1x4 T8 Troffer fixtures installed in the last couple of years. Most office areas have newer 1x4 &amp; 2x4 T8 Troffer light fixtures installed in the last couple of years or during the 1979 renovations.</p>	<p>Recommend replacing all existing fixtures with new LED equivalents. New occupancy sensors should be provided.</p>	\$250,000.00	Original fixtures have reached service life.

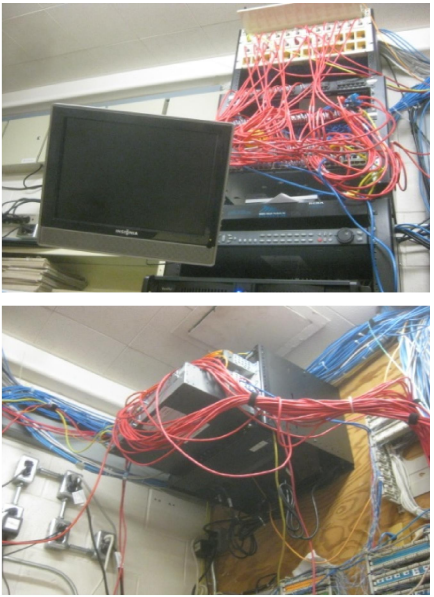
Existing main Data Server equipment is located in Server Closet in Bookstore Room. Numerous remote DAP's throughout building. Equipment appears to be 10 + years old.	Recommend reviewing all data wiring within building and upgrading as required.	\$40,000.00	5 years
5.2.4	Data / Telephone Outlets

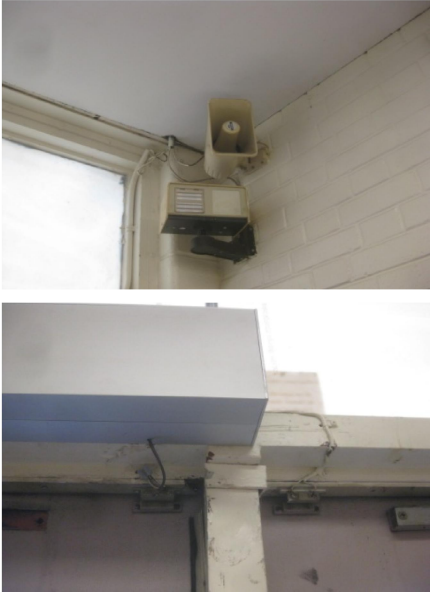
DSC security devices including door contacts & motion detectors throughout. Equipment appears to be 10+ years old.	Recommend new devices to replace existing plus additional to provide sufficient coverage & all new wiring.	\$30,000.00	Original equipment has reached service life.

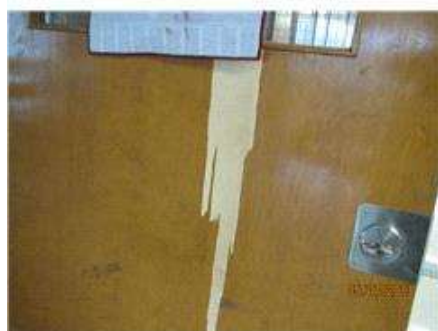
May 2013- Damaged interior wood door.

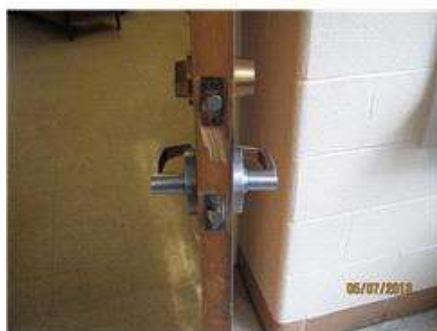
May 2013- Typical interior door closer.

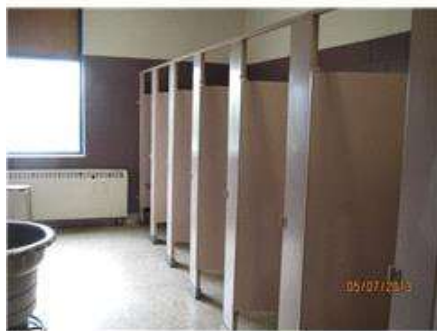
May 2013- Worn and stained washroom partition.

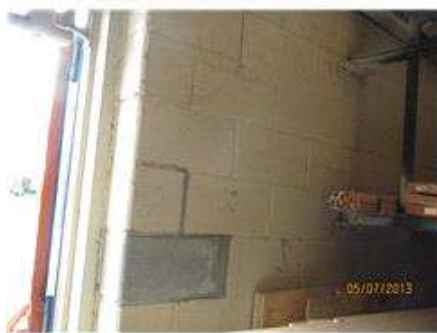
May 2013- Interior wall covering.

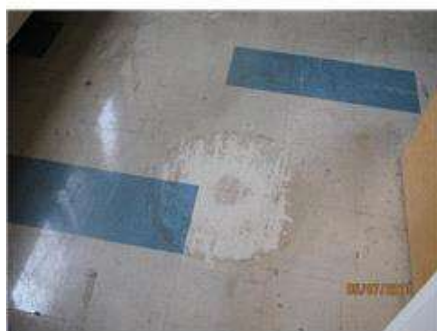
May 2013- Worn VAT floor covering.

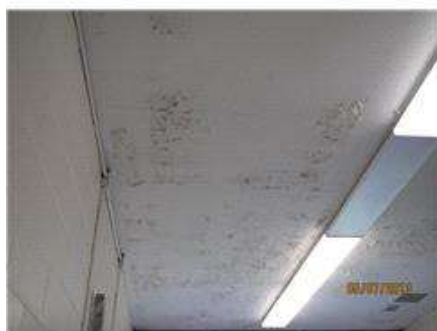
May 2013- Peeling paint ceiling covering in the girls washroom.

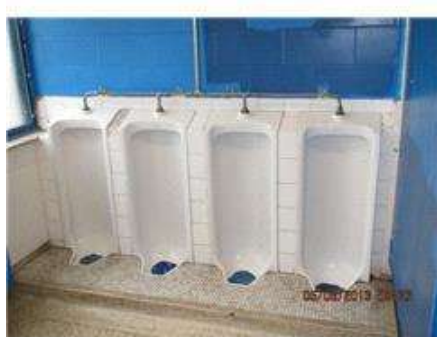
May 2013 - Aged Water Closet

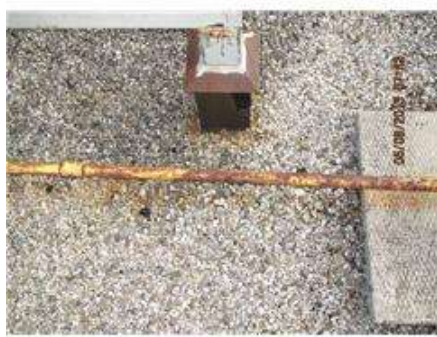
## May 2013 - Natural Gas Supply Piping - Exterior Section is Corroded

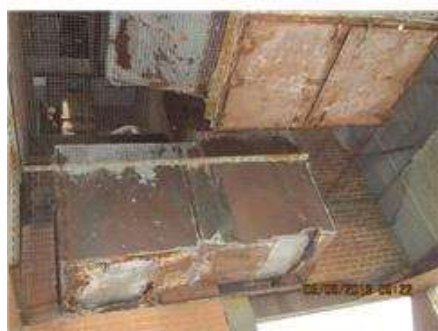
May 2013 - Original Dust Collector - Excessive Rusting
