## HAMILTON – WENTWORTH DISTRICT SCHOOL BOARD CONCEPT DESIGN AND FEASIBILITY STUDY

## SIR ALLAN MACNAB SECONDARY SCHOOL

145 MAGNOLIA DRIVE, HAMILTON

Grguric Architects Incorporated:  
Sir Allan MacNab High School Facility Conditions Assessment - June 26, 2015 (63 pages)

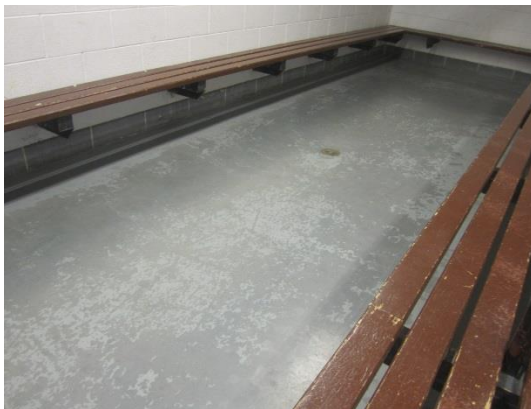
Photo 2.1.G – Boys Change Room 1071A

Both the Boys and Girls Change Rooms have a coloured hardener finished concrete floor. The finish is in an advanced state of wear exposing the original concrete subfloor below. (Photos 2.1.G and 2.1.H)

Due to the existing advanced state of wear and deterioration of the original finishes and equipment in the boys and girls change rooms and showers, we are recommending renovations and upgrades to bring these facilities up to current Board standards. As indicated on the plan, proposed scope of work includes male and female change rooms, showers, staff change room and washroom/showers and the adjacent washrooms. The existing adjacent staff office will be combined with the adjacent storage space to provide one large open staff office space. The design solutions will require further development, however, we indicate the related approximate estimated values in the cost summary.

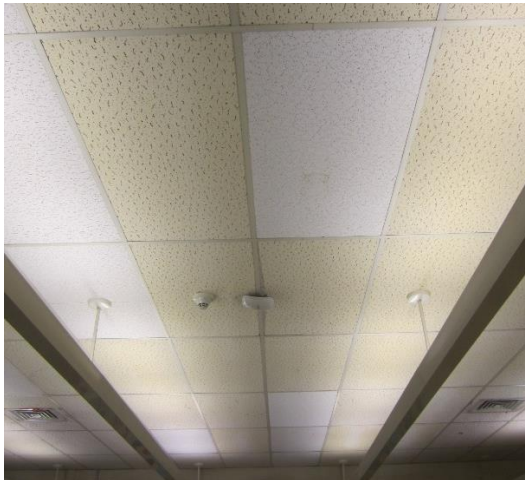
Photo 2.2.A - Classroom 2061 (Room 267)

- Partial tile replacement resulting in non-uniform ceiling finish (Photo 2.2.A)
- Tiles stained by insufficiently filtered diffuser air supply (Photo 2.2.B)
- Tiles stained from water source (Photo 2.2.C)
- Tiles sustaining surface impact related damage (Photo 2.2.D)

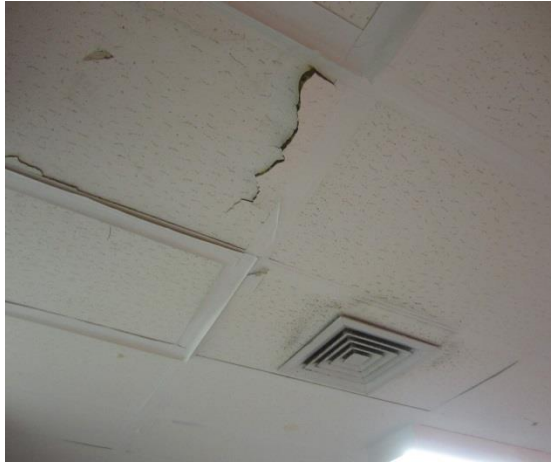
Photo 2.2.E – Girls Change Room 1078D

The Girls Change Room has a suspended acoustic tile ceiling with continuous taping along the T-bar grid sealing the tile perimeters together to the T-bar grid. The ceiling tiles including the taping are painted out. It appears this ceiling was taped to control moisture migration. The tape is delaminating in certain areas and there are signs of tile cracking due to pressure differential. (Photos 2.2.E and 2.2.F)

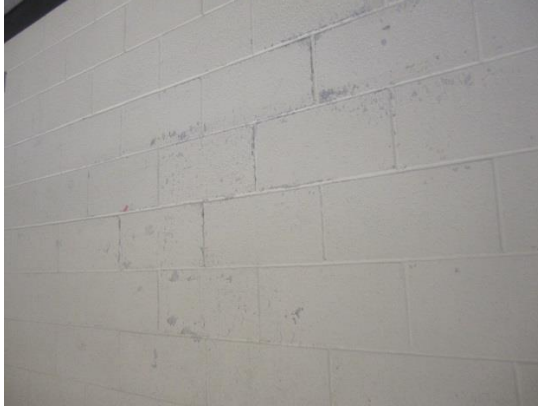
Photo 2.3.A – Classroom 2035 (Room 233)

Masonry walls and finishes generally remain in good condition. There are several areas with deteriorating finishes that require repair (Photo 2.3.A). The glazed block in the Boys Showers has water stains below the shower units. Gypsum board partition dividers between some classrooms generally remain in good condition, however, there are a few examples of surface damage or deterioration (Photo 2.3.B).

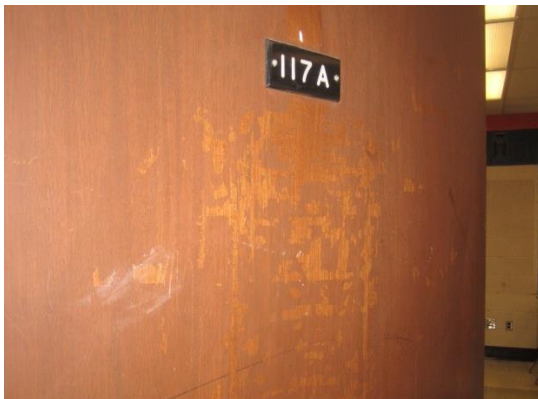
Photo 2.3.C – Classroom (Room 117A)

The solid core wood doors, typical for this facility, generally remain in good condition. However, advanced surface wear of the stained veneer finish is common for most doors. Door frames are in need of repainting. (Photos 2.3.C and 2.3.D)

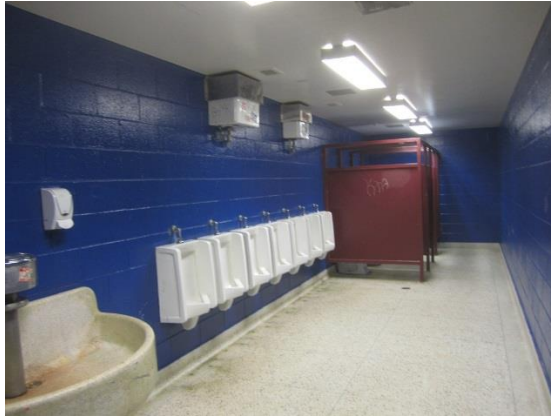
Photo 2.3.E – Boys Washroom 1027

There have been recent washroom renovations to the north wing including the Girls and Boys main washrooms on the second level. All other existing washrooms in the facility are in similar need of updating to replace the existing aged Bradley's, toilet partitions and the older plumbing equipment with new efficient fixtures. (Photos 2.3.E and 2.3.F)

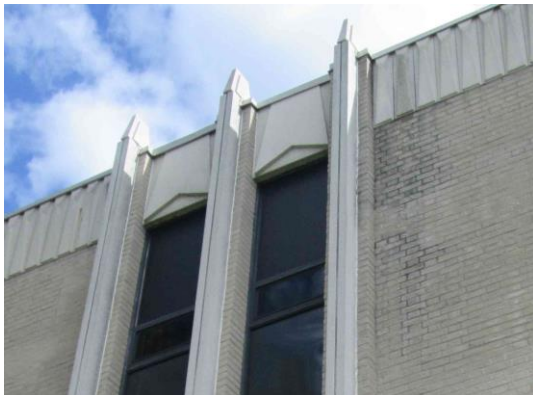
Photo 3.1.A

- Water based stain related to blocked or improper flashing, inadequate venting and drainage out (Photos 3.1.A and 3.1.B)
- Brick cladding at base of wall has absorbed moisture. It appears that the potential source is external; ongoing monitoring would confirm this. (Photo 3.1.C)
- Water based stain due to improper roof drainage from accumulated vegetation debris (Photo 3.1.D)

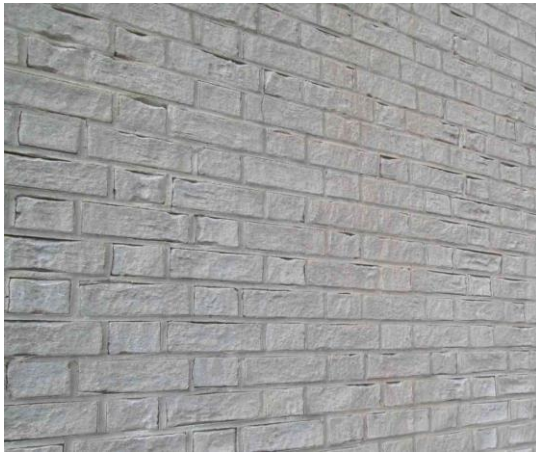
Photo 3.1.E

- South elevation – there were a few areas of brick deterioration due to weathering (Photo 3.1.E)
- Rust spots on precast concrete frieze. Possible causes: exposed rebar or metallic component in aggregate. (Photo 3.1.F)
- Crack and separation in poured concrete foundation wall (Photo 3.1.G)
- Concrete surface finish discoloration (Photo 3.1.H)

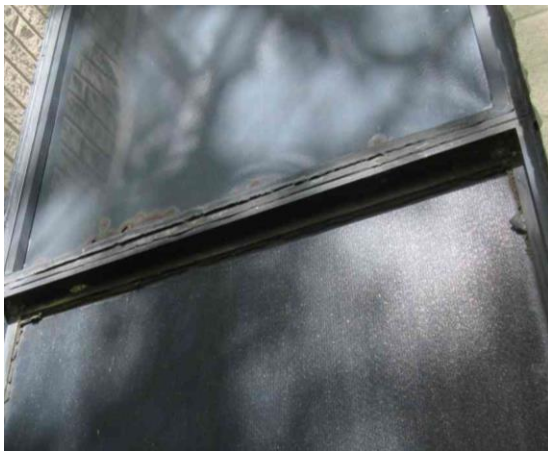
Photo 3.2.A

- Some existing frames are showing signs of corrosion. Corrosion also visible at the spandrel panel edge joint. (Photo 3.2.A)
- Common throughout is the deterioration and delaminating perimeter caulking. In some areas large gaps have been exposed allowing water infiltration. (Photo 3.2.B)
- Hopper window operation is difficult and weatherstripping has deteriorated or is missing (Photo 3.2.C)
- Several windows found permanently closed and taped around hopper window (Photo 3.2.D)

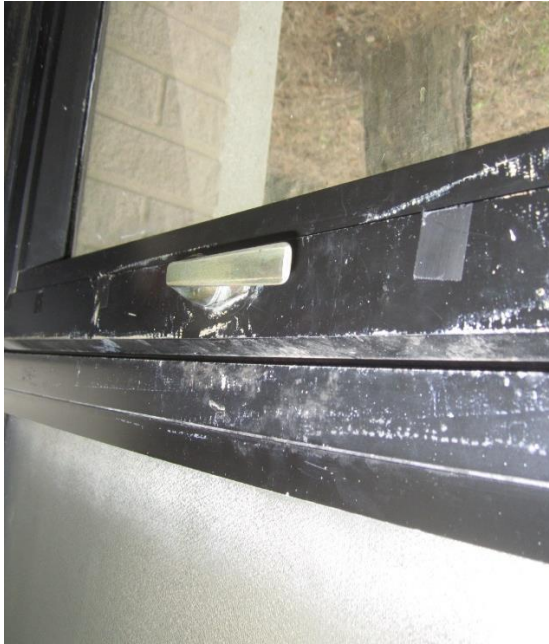
Photo 3.2.E – Classroom 1014 (Room 113A)

- Aluminum finish showing surface wear (Photo 3.2.E)
- Several of the plastic window panes encountered were painted out, having an unsightly appearance (Photo 3.2.F)
- Spandrel panel finish in advance state of wear
- Music Room window bottom sill covered in soil and preventing proper drainage (Photo 3.2.G)
- Exterior entrance doors showing surface wear (Photo 3.2.H)

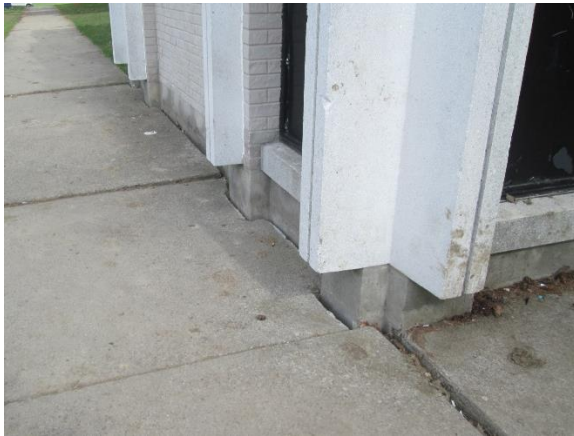
Photo 4.0.A

- Sidewalk settlement along building perimeter poses a tripping hazard and watershed flows back toward building, north elevation of north wing (Photo 4.0.A)
- Concrete retaining wall feature exhibiting surface wear and staining. Existing guard rail is not to current code standards (Photo 4.0.B)
- Walkway continues over sod and exposed soil leading to erosion (Photo 4.0.C)
- Segments of depleted sod to be replaced (Photo 4.0.D)

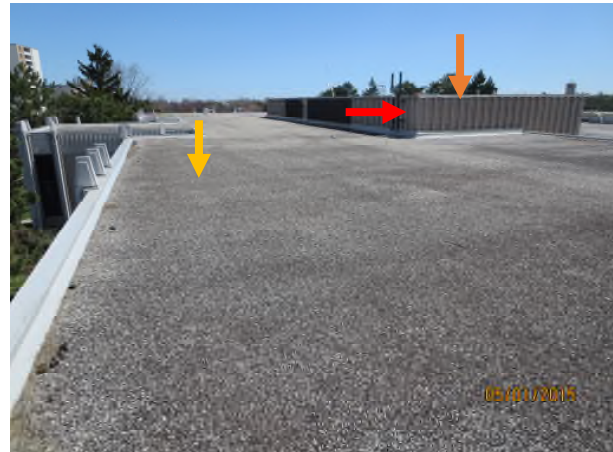
**Photograph 2** – S/E view from north-west corner of Area B1  
**Orange arrow** – Area A1, **Blue arrow** – Area B1  
**Red arrows** – masonry failure requires remedial work

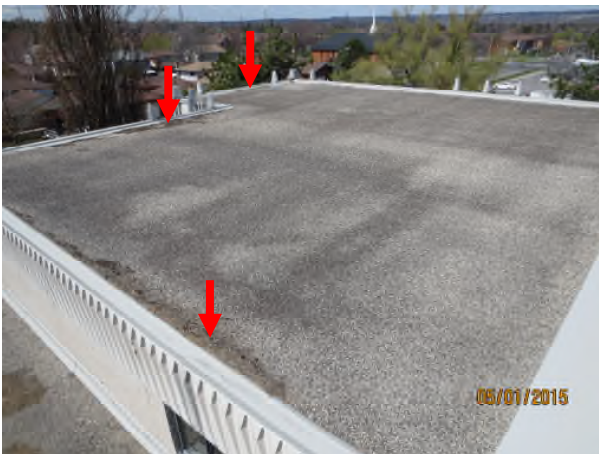
**Photograph 3** – N-W view of Area B1  
**Red arrows** – vegetation/debris on roof surface

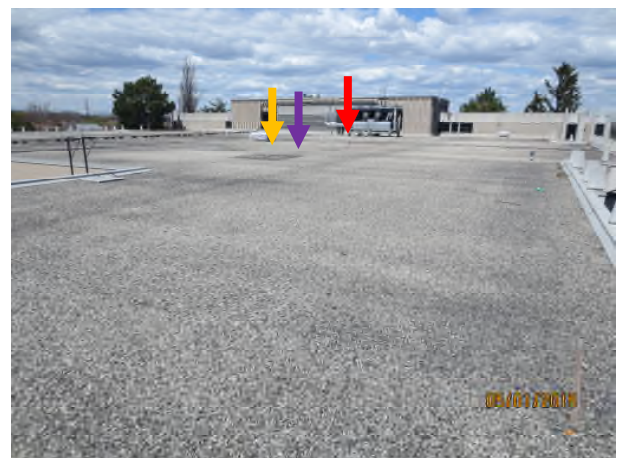
**Photograph 6** – N/W view from Area C3  
**Yellow arrow** – drain area with debris  
**Purple arrow** – exposed membrane felt  
**Red arrow** – damaged vent sleeves

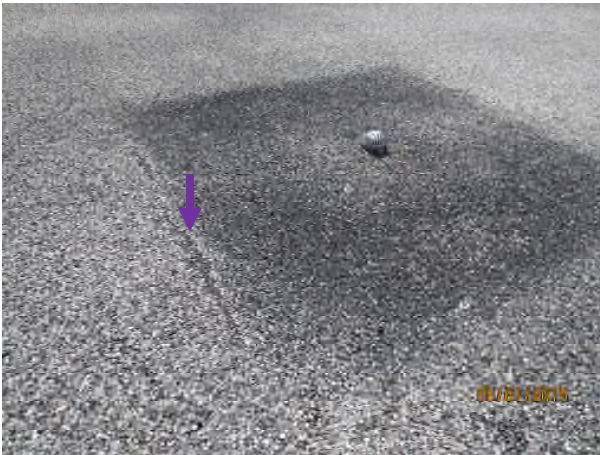
**Photograph 7** – Close-up view of drain area in Photo# 6 from Area C3  
**Purple arrow** - exposed membrane felt at transition to sump

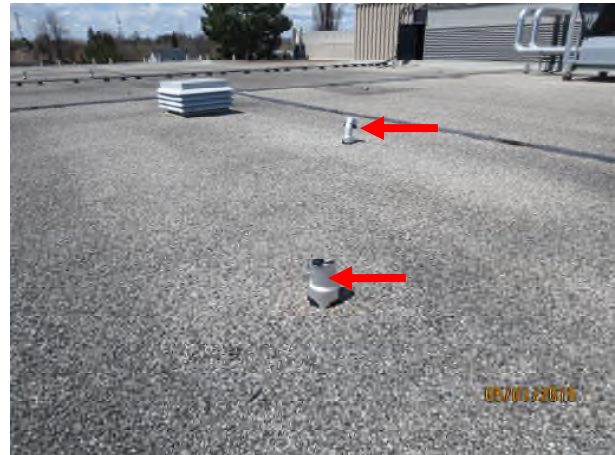
**Photograph 8** – View at north side Area C3  
**Red arrows** – damaged vent sleeves

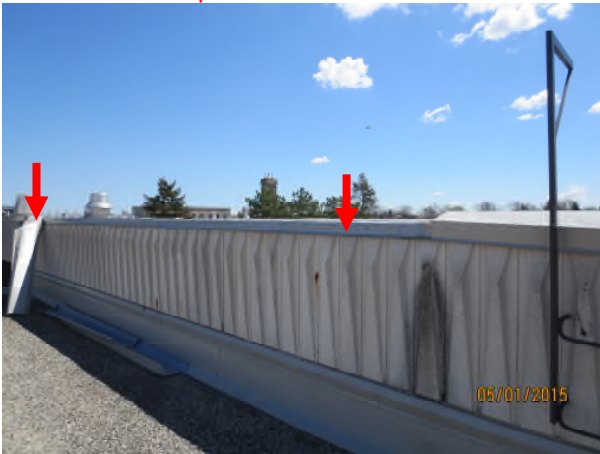
**Photograph 9** – View of north perimeter Area D3  
**Red arrows** – metal cap flashing blow-off / damaged/missing

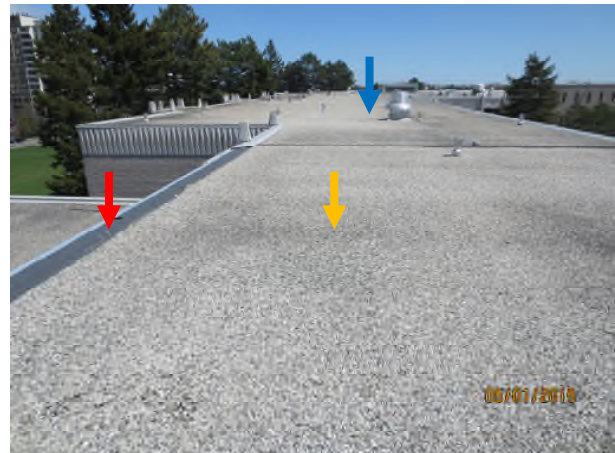
**Photograph 10** – East view from area D3  
**Yellow arrow** – Area D3, **Blue arrow** – Area D2  
**Red arrow** – metal flashing blow-off

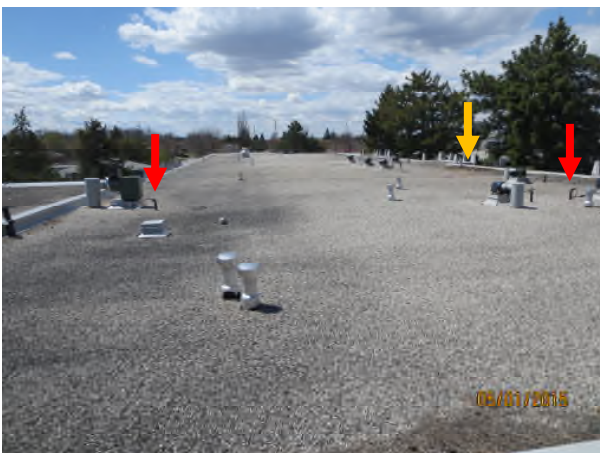
**Photograph 11** – West view of Area D2  
**Yellow arrow** – vegetation  
**Red arrows** – conduit sleeves not sealed or mastic cracked

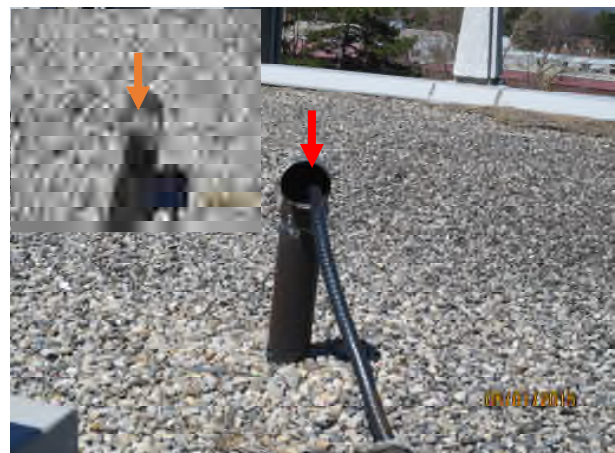
**Photograph 12** – Close-up view of typical conduit sleeve on Area D2  
**Red arrow** – no sealant, open to moisture  
**Orange arrow** – sealant cracked

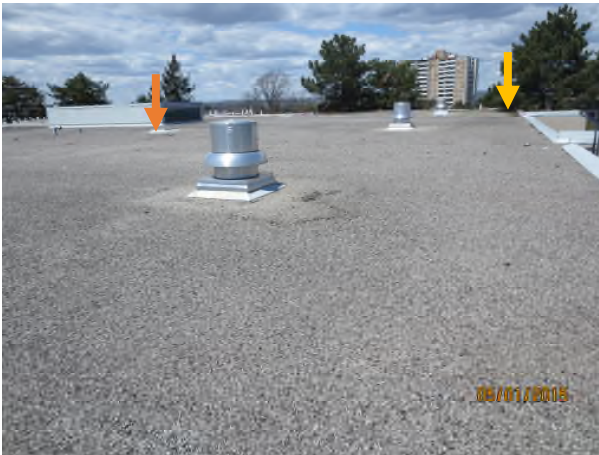
**Photograph 13** – N/W view of Area D1  
**Yellow arrow** – vegetation  
**Orange arrow** – abandoned curbs

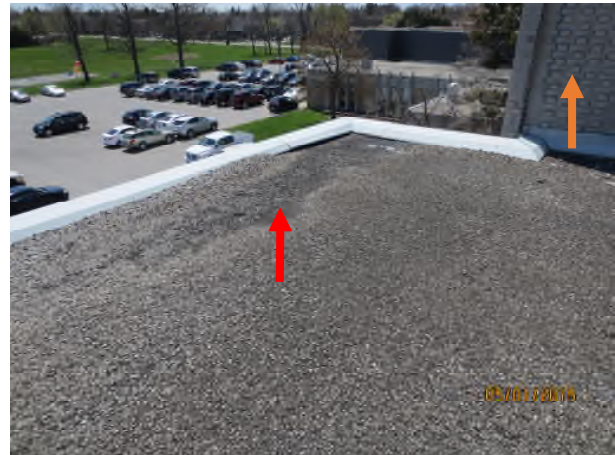
**Photograph 14** – View at S/W corner of Area D1  
**Red arrow** – excessive gravel scouring and exposed bituminous felt  
**Orange arrow** – masonry chimney required repairs

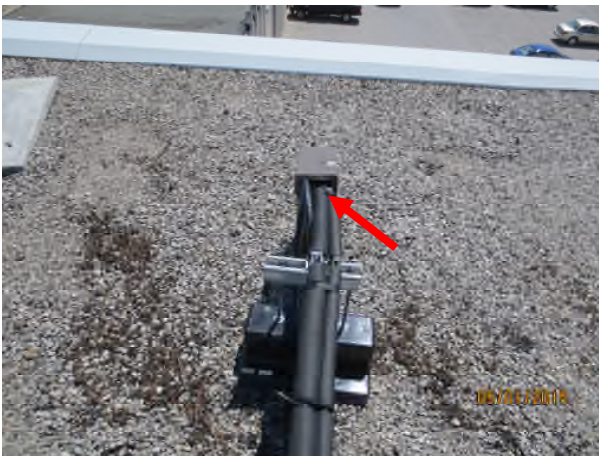
**Photograph 15** – View at south side of Area D1  
**Red arrow** – conduit sleeve open to moisture infiltration

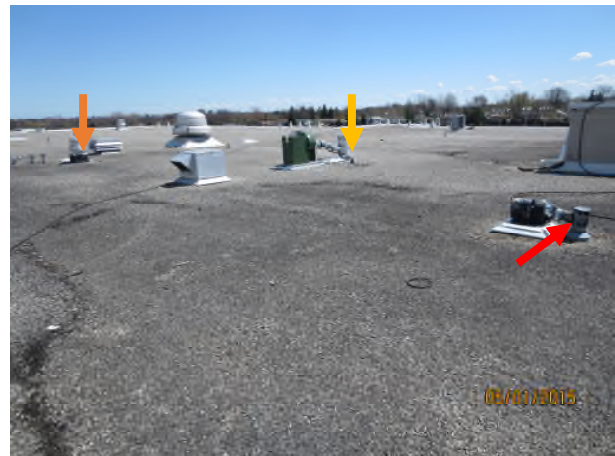
**Photograph 16** – S/E view of Area D1  
**Orange arrow** – membrane flashings required repairs at seams  
**Red arrow** – abandoned unit  
**Yellow arrow** – mastic in pitch-pan failing

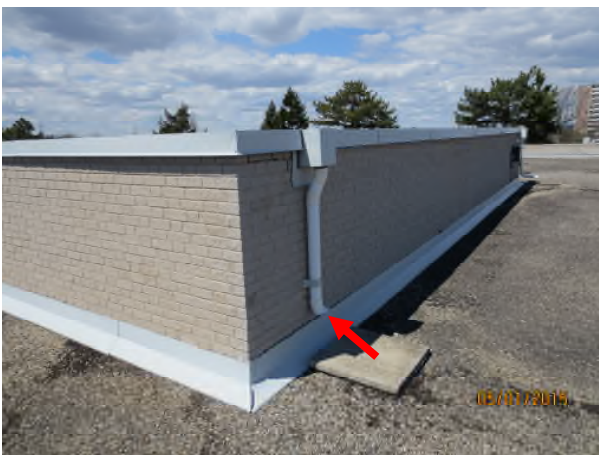
**Photograph 17** – N/W view of Area D4  
**Red arrow** – damaged downspout

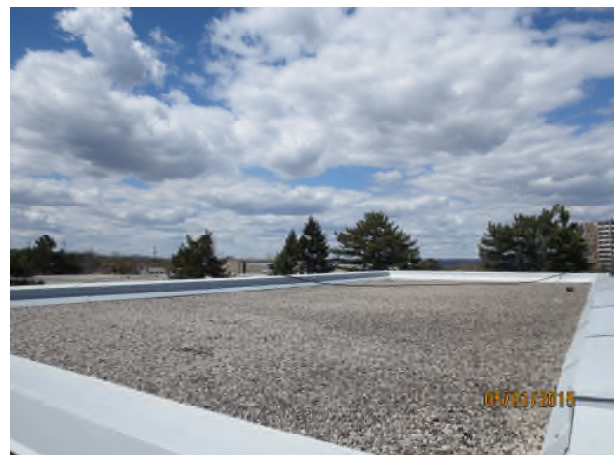
**Photograph 18** – N/W view of area D4, in fair-to-good condition

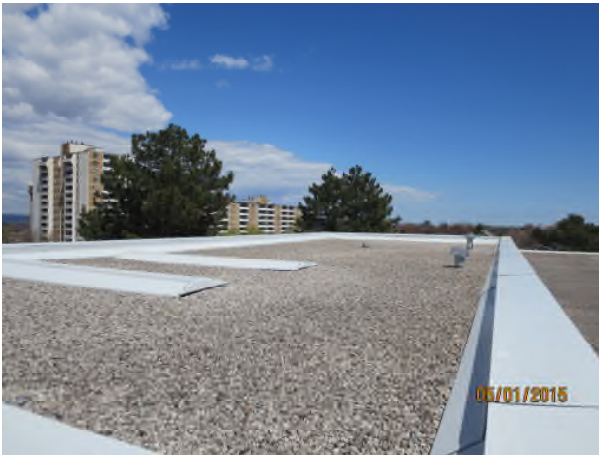
**Photograph 19** – North-east view of Area D5  
 Roof system in fair-to-good-condition

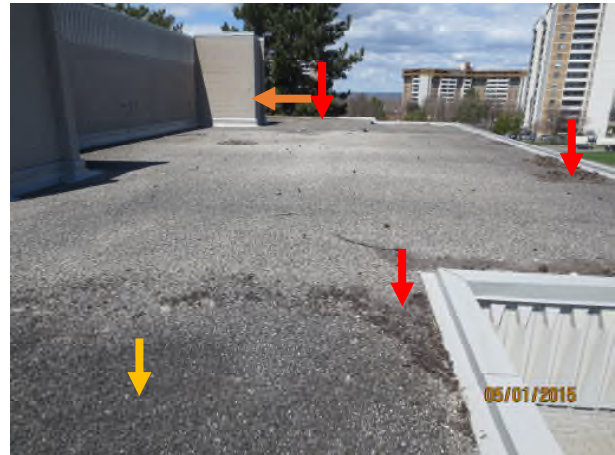
**Photograph 20** – North view of Area J1  
**Red arrow** – minor vegetation/debris  
**Yellow arrow** – evidence of water ponding

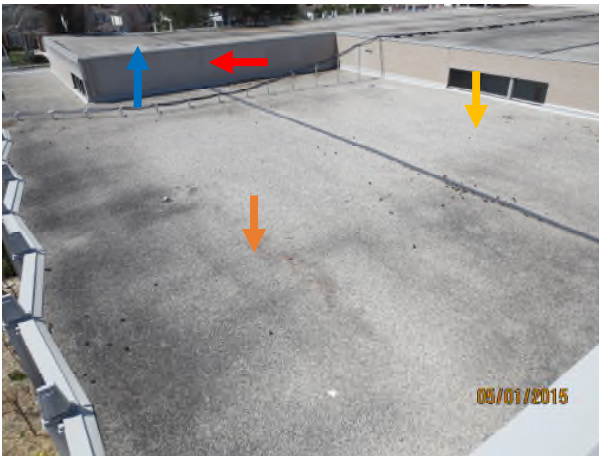
**Photograph 21** – N/W view from Area D3  
**Orange arrow** – Area E2, **Yellow arrow**– Area E1  
**Red arrow** – joint failure, also on east wall  
**Blue arrow** – Area C5

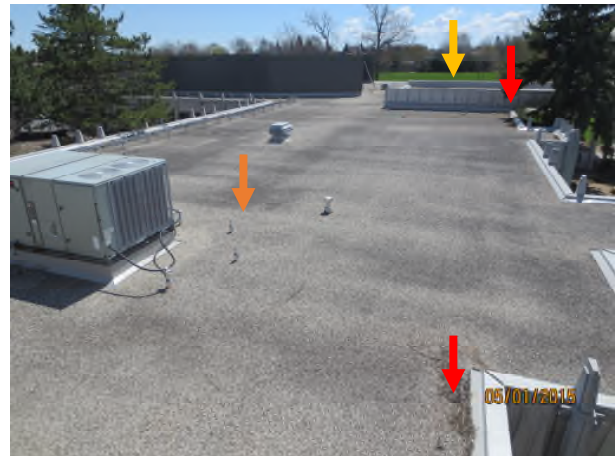
**Photograph 22**–South view, Area E2, west section  
**Orange arrow** – Area E2, **Yellow arrow**– Area F1  
**Red arrow** – vegetation

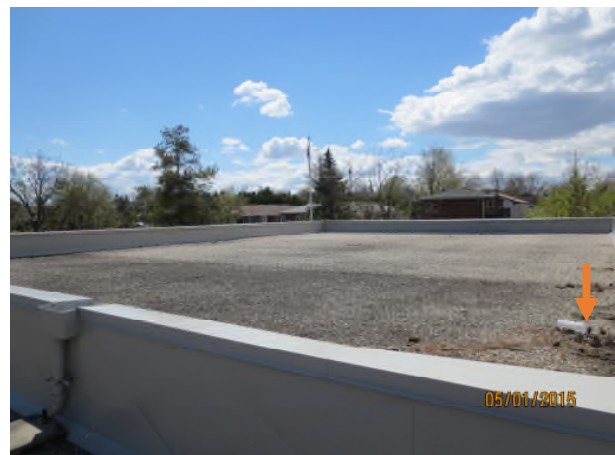
**Photograph 24** – S/W view of Area F1  
 Roof system in fair condition  
**Orange arrow** – vegetation/debris to bed removed

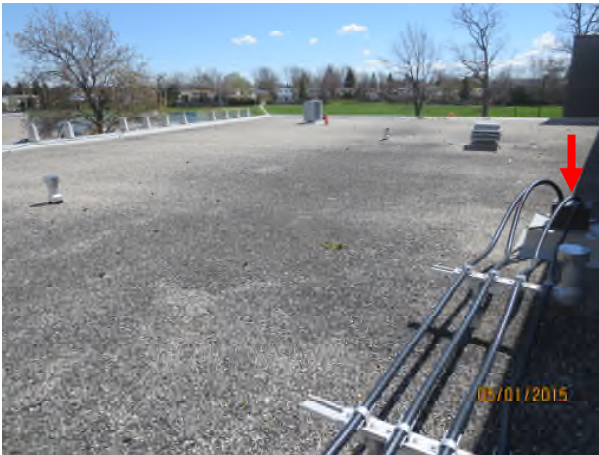
**Photograph 25** – S/E view Area E2, east section  
**Red arrow** – sealant at conduit penetration failing

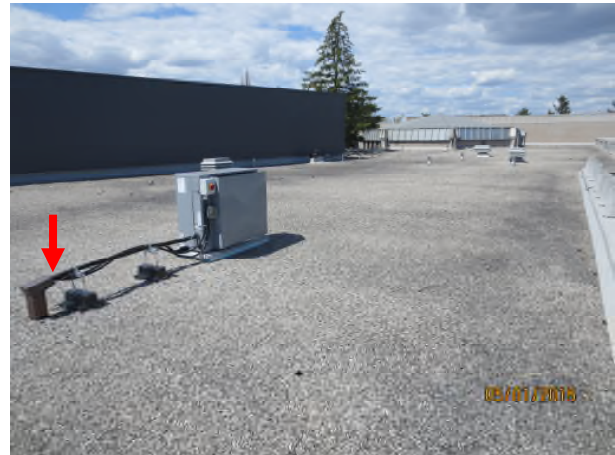
**Photograph 26** – N/W view Area E2, east section  
**Red arrow** – conduit penetration not sealed

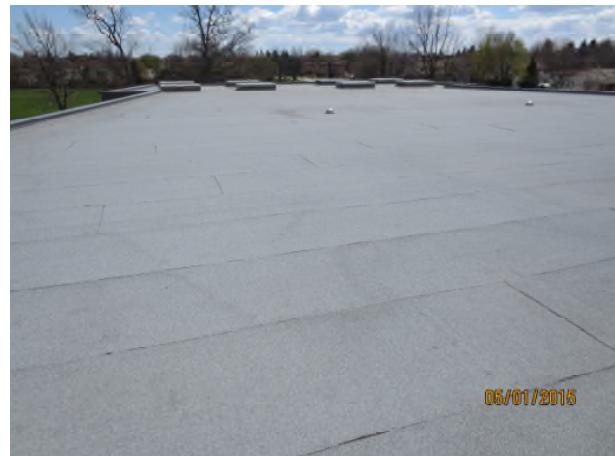
**Photograph 28** – S/W view of area G1  
 Roof system in good condition

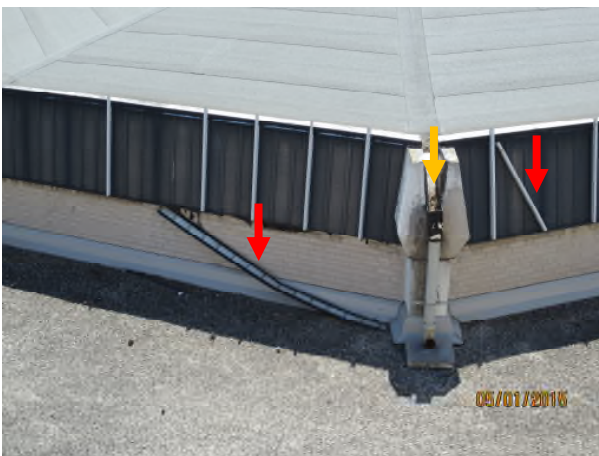
**Photograph 29** – View at north side Area K1  
**Red arrows** - damaged soffit, metal cap  
**Yellow arrow** – vegetation in scupper

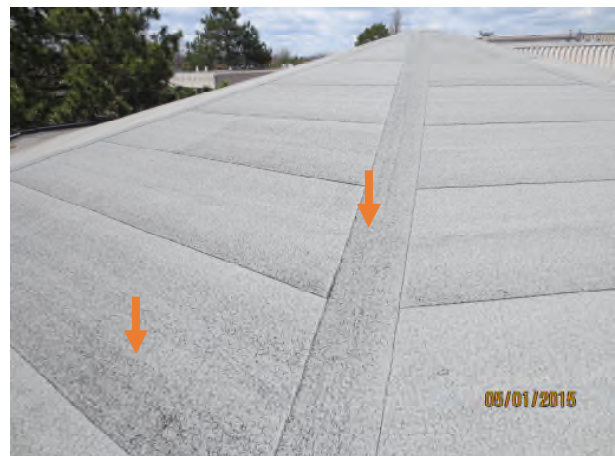
**Photograph 30** – N/W view of Area K1  
**Red arrows** – mod. bit. membrane weathered, with 'alligating' n bitumen surface

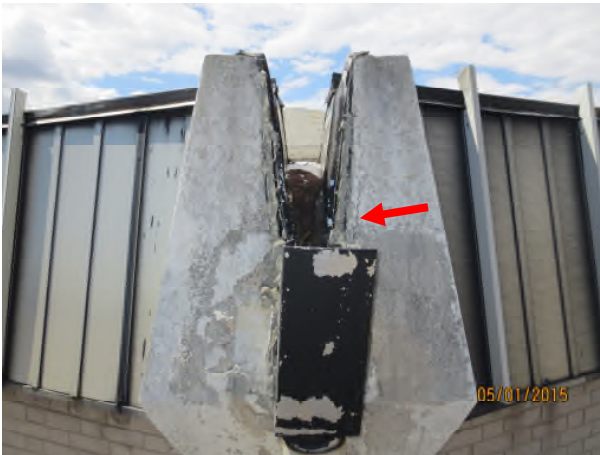
**Photograph 31** – View at scuppers locations on Area K1  
**Red arrow** - concrete spalling at several locations and will require repairs

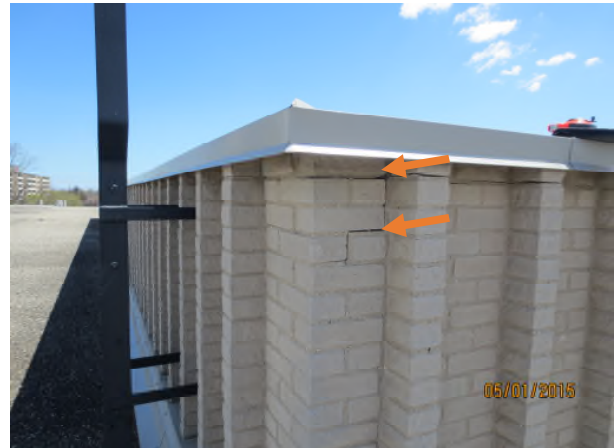
**Photograph 32** – North-west corner of Area A1  
**Orange arrows** - cracked mortar joints and dislodged masonry units

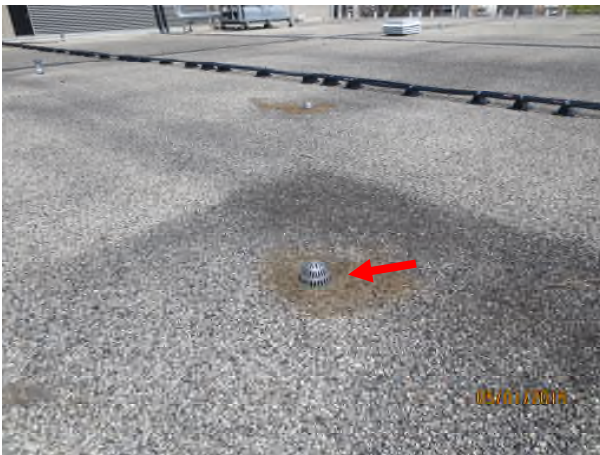
**Photograph 33** – View of typical drain clogged with vegetation

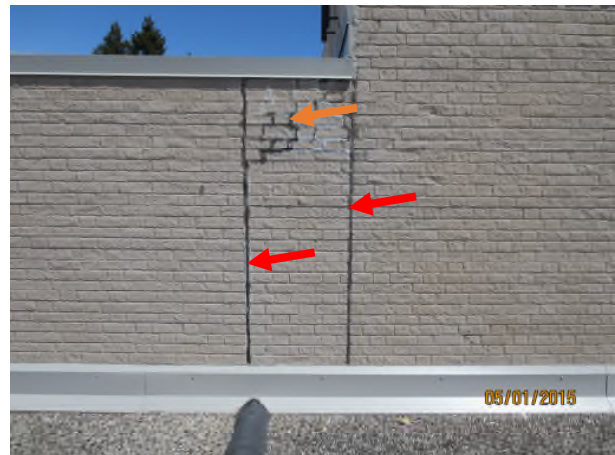
**Photograph 34** – View of failed joint on east wall between Area E1 & E2  
**Orange arrows** - cracked mortar joints  
**Red arrows** – failed sealant joints

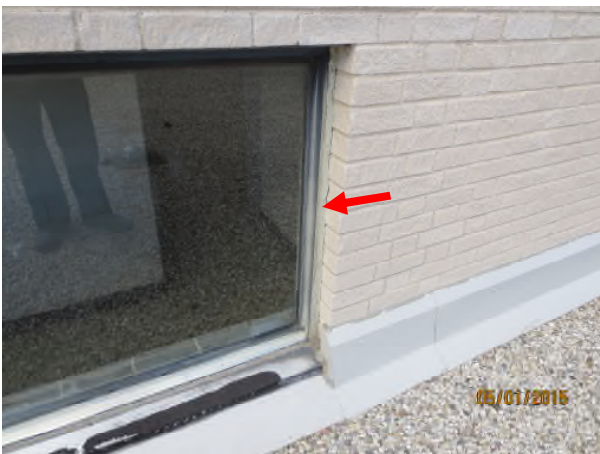
**Photograph 35** – Sealant failure at windows above Area E1

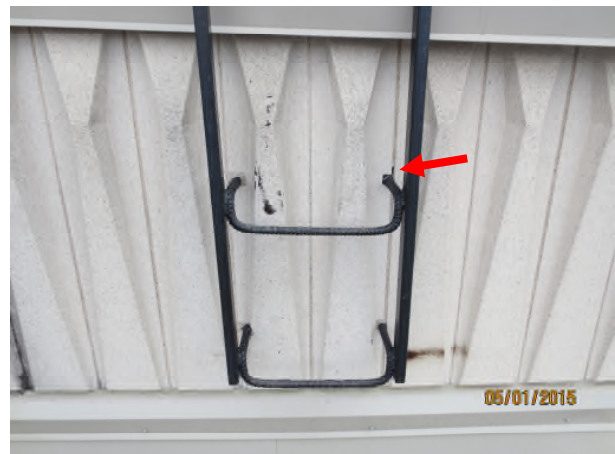
**Photograph 36** – Penetration through precast walls not sealed
