HAMILTON WENTWORTH DISTRICT SCHOOL BOARD
FEASIBILITY STUDY AND CONCEPT DESIGN

DUNDAS VALLEY SECONDARY SCHOOL
310 Governors Road, Hamilton, ON

MAY 18, 2016

CS&PArchitects

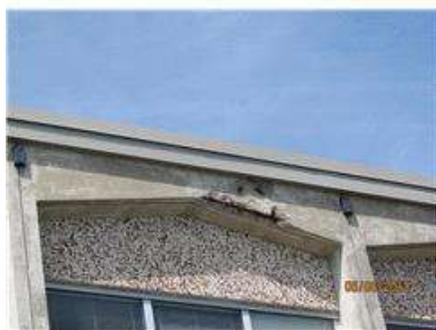
May 2013- Damaged exterior precast concrete exterior wall.

Recommendation 2013 - Recommend repairing is carried as soon as possible to avoid any damage to the building envelope

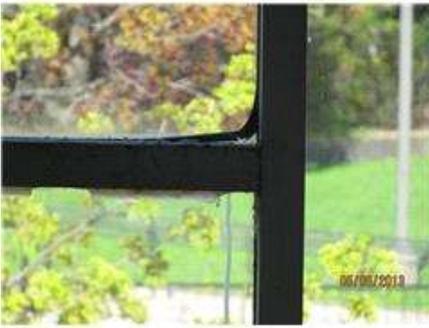
May 2013- Loss seal exterior window.

Recommendation 2013 - Due the condition of the exterior windows it is recommended that they be replaced.

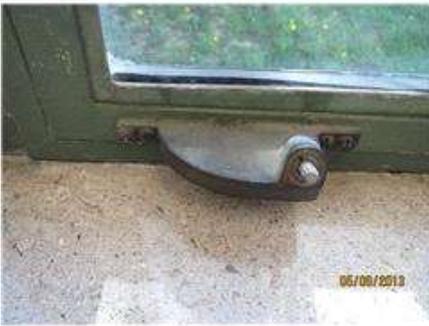
May 2013- Worn exterior window with missing hardware.

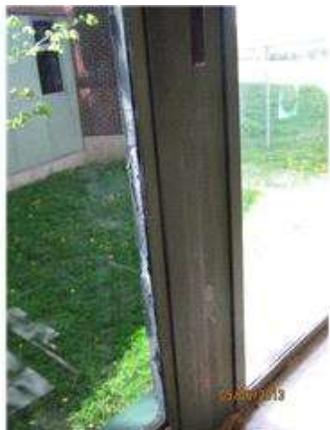
May 2013- Worn exterior window with Deteriorated seal.

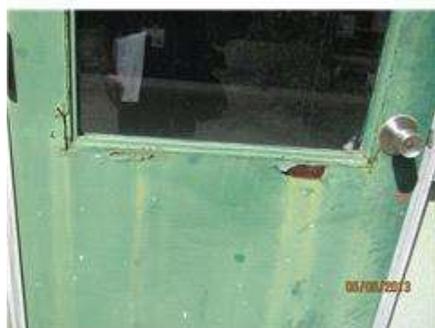
May 2013- Deteriorating exterior door.

Recommendation 2013 - The exterior door assemblies were observed to be aged and worn beyond useful life. Replacement of the door assemblies is suggested.

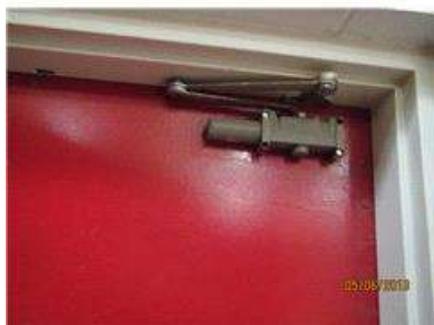
Mar 2103- worn extrior door closer.

2013 - The aged and worn exterior door hardware is suggested be replaced in conjunction with exterior door replacement.

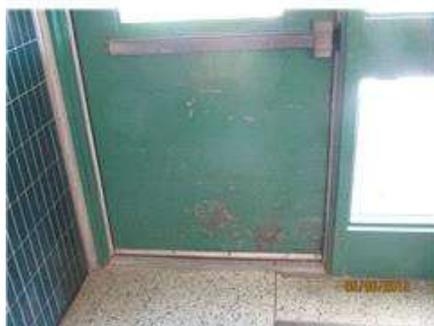
May 2013- worn exterior door push bar.

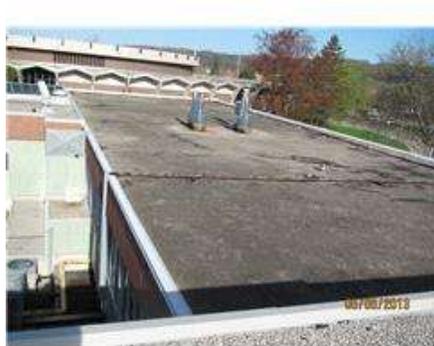
May 2013- Roof covering of section 402 of the building roof.

Recommendation 2013 - The BUR assembly of section 402 is aged and worn with displaced ballast and bleed through noted. Replacement of the roof is suggested.

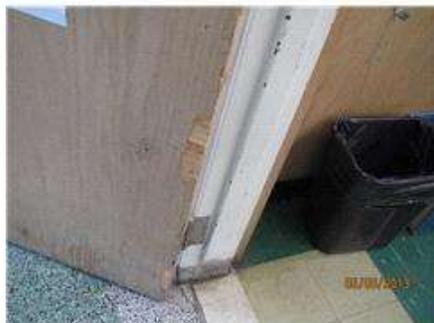
May 2013- Damaged interior door.

Recommendation 2013 - The interior doors have exceeded their useful life. Replacement of the interior doors is suggested.

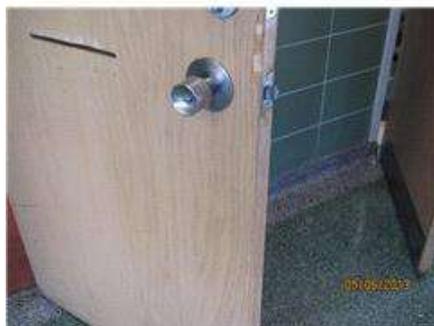
May 2013- Worn interior door.

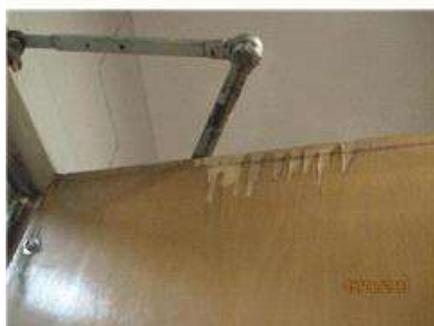
May 2013- Damaged interior door.

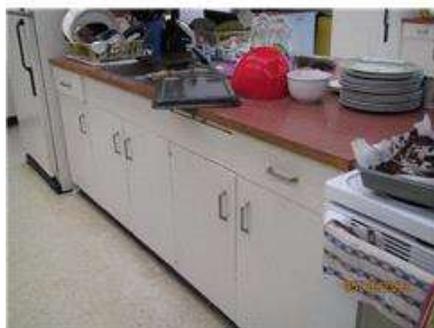
May 2013- Worn millwork fitting in the family classroom.

2013 - The millwork has exceeded its effective useful life expectancy. Replacement planning for the millwork is recommended.

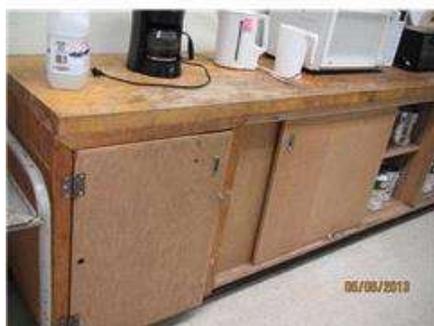
May 2013- Miss match millwork in the custodian room.

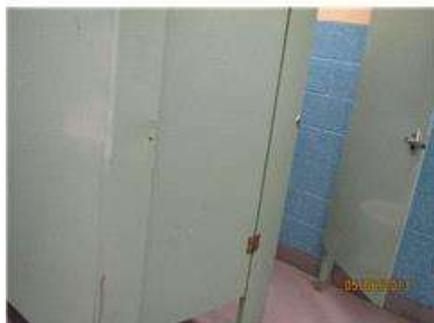
May 2013- Typical worn washroom partition in the building.

2013 - The washroom partitions were observed to be aged and worn beyond useful life. Replacement is suggested. OLD-Corroded washroom partitions were observed in the school. Replacement of all original washroom partitions is recommended.

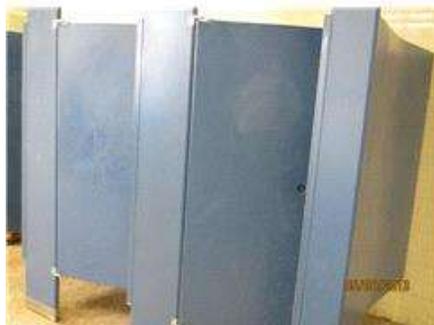
May 2013- Typical worn washroom partition in the building.

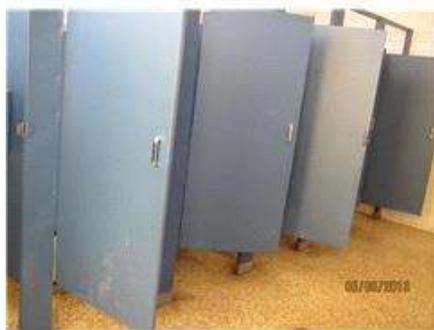
May 2013- Worn washroom partition in the building.

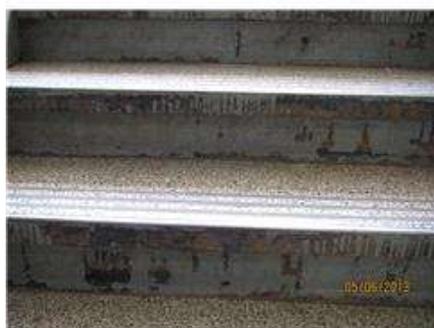
May 2013- Rusted interior stair frame and, finishes.

Recommendation 2013 - Replacement of initial flight of the interior stairs including the rubber covering is recommended

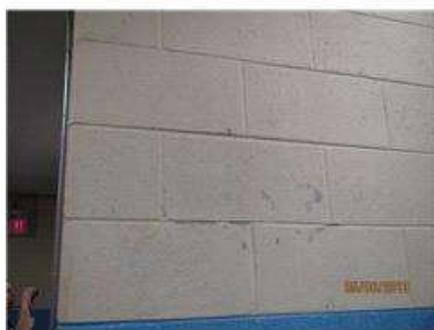
May 2013- Faded wall covering.

2013 - The aged and worn interior painted wall finishes are suggested to be replaced.

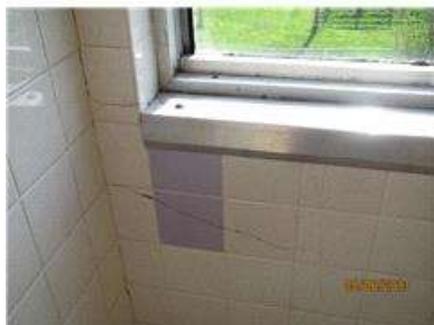
May 2013- Cracked ceramic tile wall covering in the washroom.

Recommendation 2013 - The ceramic wall tile wall finish are cracking and deteriorating. Full replacement is warranted.

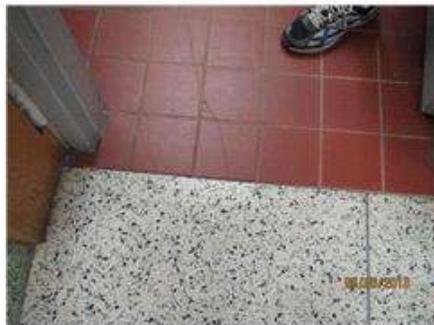
May 2013- Cracked ceramic tiles in the office area.

2013 - Replacement is recommended based on the observed condition

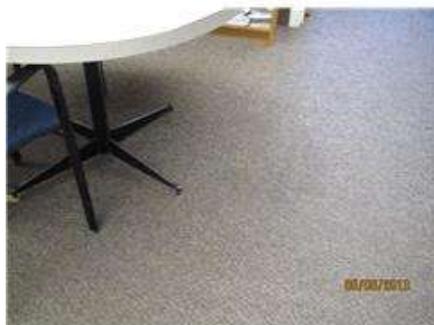
May 2013- Worn Carprt covering in the office.

2013 - Replacement is recommended based on the observed condition

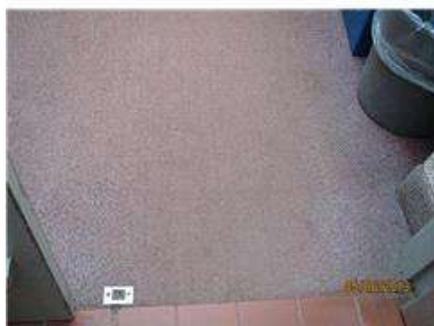
May 2013- Worn carpet flooring in the Library.

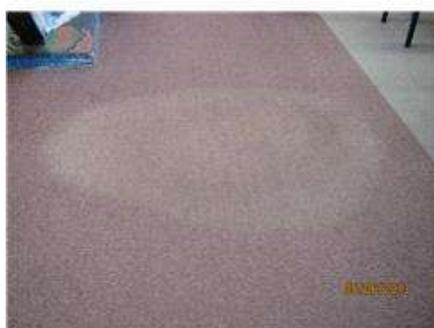
May 2013- Stained carpet flooring in the Library.

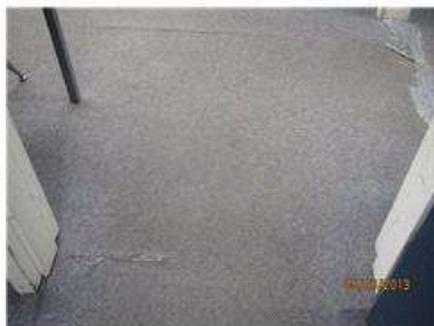
May 2013- Damaged and stained carpet in the tech wing classroom.

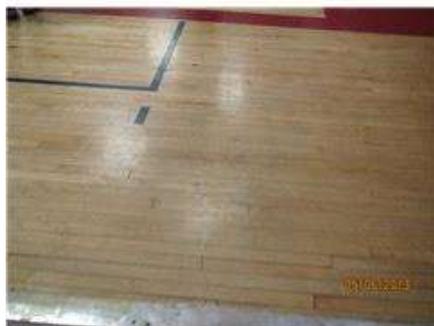
May 2013- Worn hardwood flooring in the GYM.

2013 - It is suggested that the hardwood flooring be refinished or replaced. OLD-Worn and deteriorated hardwood floors were observed in the school. Restoration of all hardwood floors is recommended.

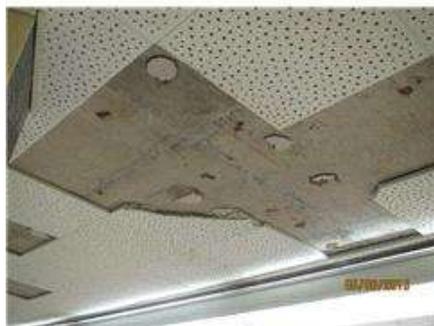
May 2013 - Loss/damaged Asbestos contains ceiling tiles in the boys washroom by the gym.

2013 - The 12" x 12" acoustic tile ceiling system has exceeded its useful life and is known to contain asbestos materials. Replacement planning is recommended as to update the appearance of the facility and remove any potential health concerns.

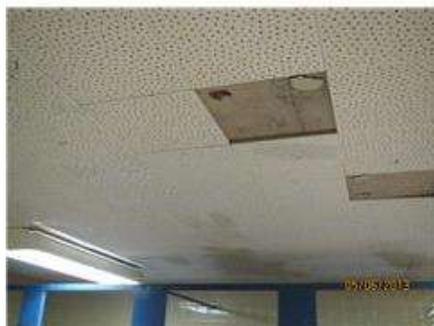
May 2013- Deteriorating ceiling tiles.

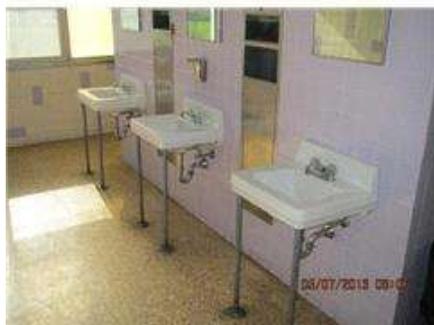
May 2013 - Typical Aged Lavatories

2013 - Replacement of the original and aged plumbing fixtures in the building (85%) is recommended based on the age, condition and rated useful life.

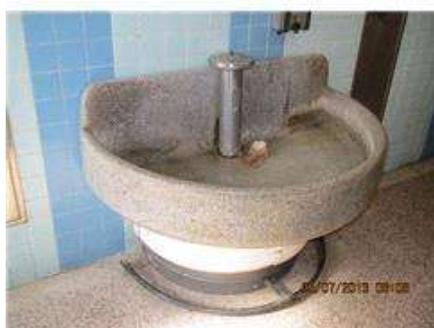
May 2013 - Typical Outdated Bradley Basins

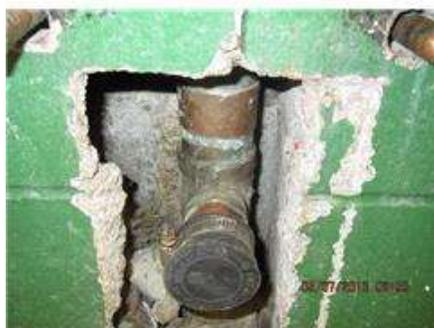
May 2013 - Minor Corrosion on Domestic Water Piping

2013 - Based on the age and theoretical useful life of the domestic water piping system replacement is recommended. A study is recommended to determine the current condition, remaining service life, current service requirements and the cost of replacement.

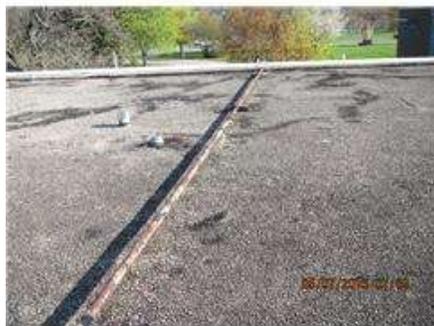
May 2013 - Gas Piping is Exposed to Elements and Corroded

Recommendation 2013 - Replacement of the exterior section of the natural gas distribution is recommended based on condition and age.

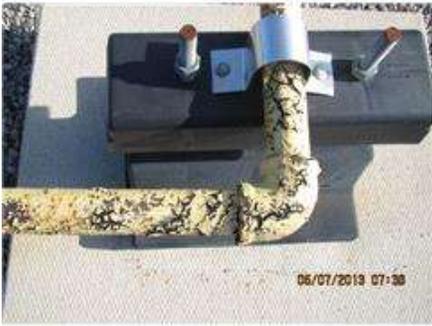
May 2013 - Gas Piping is Exposed to Elements and Corroded

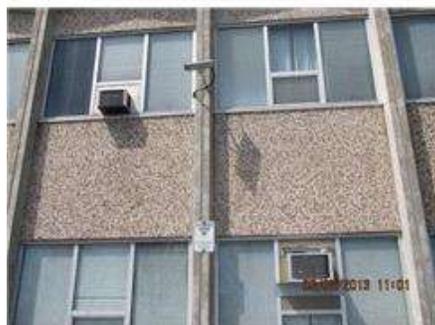
May 2013 - Aged and Undersized Window A/C Units

2013 - Replacement of the aged window A/C units is recommended with new window A/C's or split system cooling installed in the computer labs to prevent overheating of computer equipment.

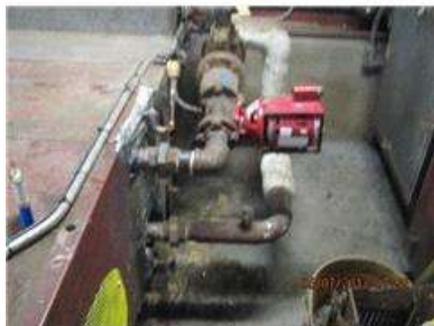
May 2013 - Aged Hot Water Heating Piping

2013 - Pending the outcome of the recommended study, replacement of the building's heating piping and distribution system may be required. In the current condition piping leaks may occur damaging the building interiors. The work associated with this project is expected to disturb material(s) suspected of containing, or known to contain asbestos, (ACMs). Testing of the suspected ACMs should be conducted prior to the initiation of any demolition and the costs should be adjusted based on the findings. The cost of hazardous materials abatement is not included in the replacement cost.

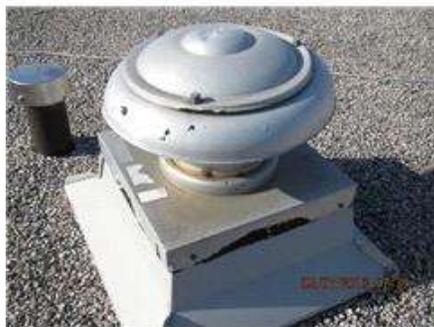
May 2013 - Aged Rooftop Exhaust Fan - Addition 1

2013 - The internal and rooftop exhaust fans are operating past their expected useful lives and will likely require replacement as most are in fair condition.

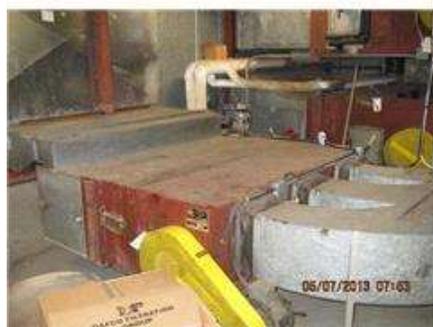
May 2013 - Original Air Handlers

2013 - Due to age and mechanical wear, the central air handlers should be replaced within the next 5 years for reliability.

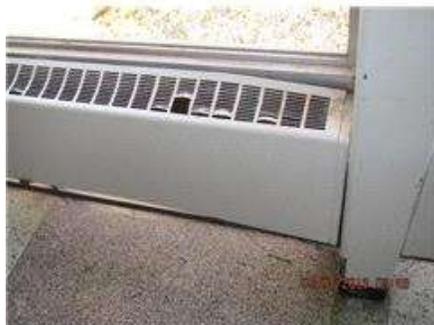
May 2013 - Damaged Fin Tube Radiator Covers - Foyer

2013 - Replacement of the aged fin tube radiation units and forced air units is recommended based on condition and theoretical life.

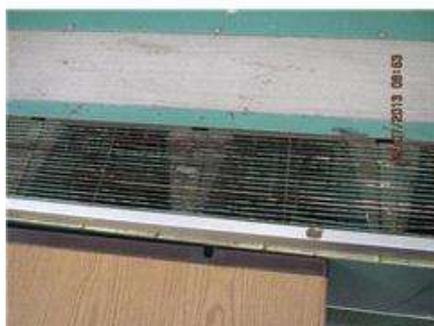
May 2013 - Aged and Worn Unit Ventilators

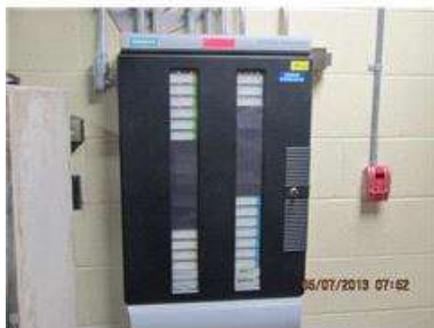
May 2013 - Aged Building Automation System in Boiler Room

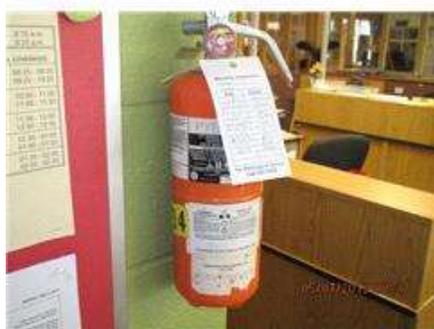
May 2013 - Aged Fire Extinguishers

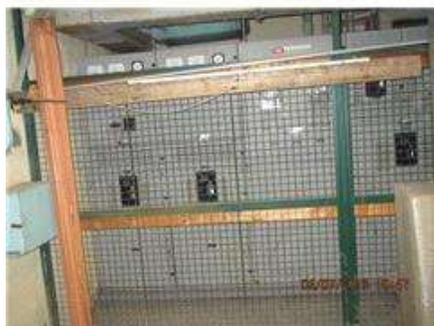
May 2013 - Original Main Switchboard

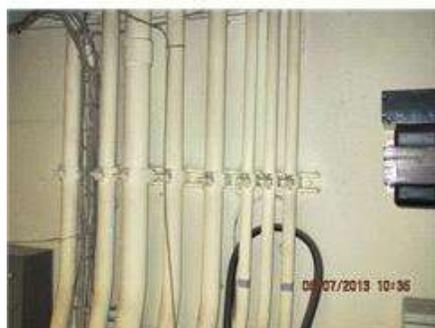
May 2013 - Aged Cabling in Mechanical Room

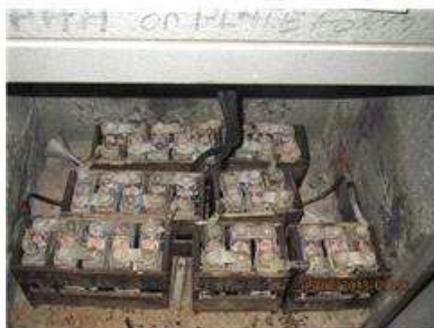
May 2013 - Aged and Corroded Emergency Lighting Batteries

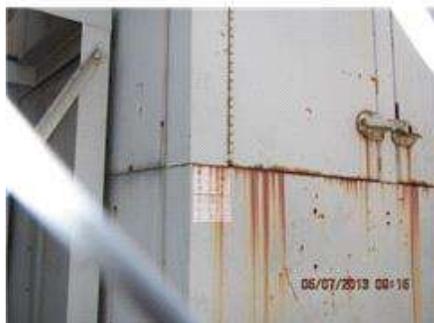
May 2013 - Minor Corrosion of Dust Collector

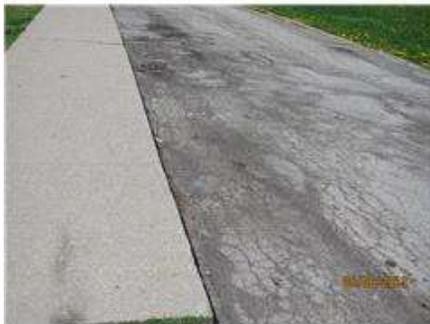
May 2013- Alligator cracking on the surface of the roadway.

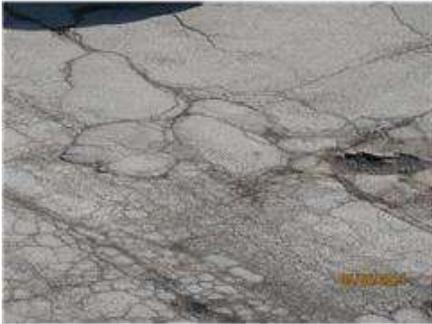
May 2013- Alligator cracking and potholes on the surface of parking lot.

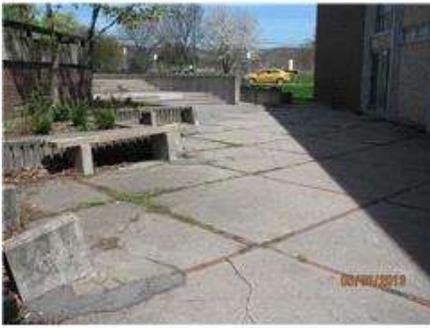
May 2013- Evidence of crack concrete surface of pedestrian.

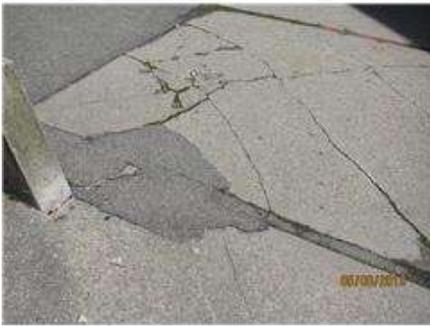
May 2013- cracked pedestrian.
