HAMILTON-WENTWORTH DISTRICT SCHOOL BOARD

FEASIBILITY STUDY and CONCEPT DESIGN

Orchard Park Secondary School
200 DeWitt Road, Hamilton, ON

November 2015

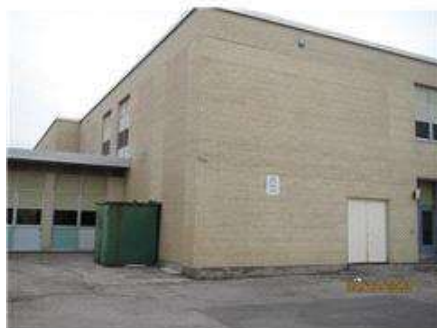
Apr 2013- Exterior brick veneer wall.

Recommendation 2013 - The exterior brick veneer walls are showing signs of deterioration on all facades of the building. Repointing and brick replacement is necessary as to maintain the integrity of the building envelope.

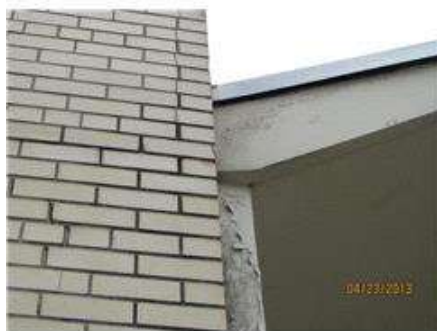
Apr 2013- Evidence of mortar joint deterioration and crack of exterior brick wall.

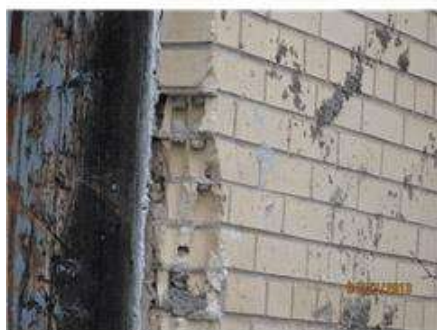
Apr 2013- Spalling brick on the east facade.

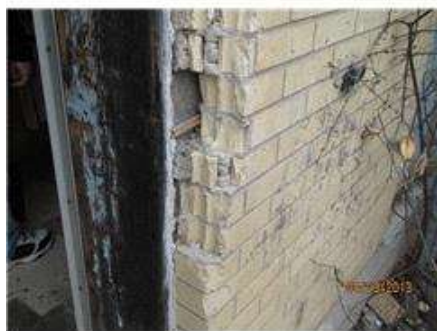
Apr 2013- Spalling brick on the east facade.

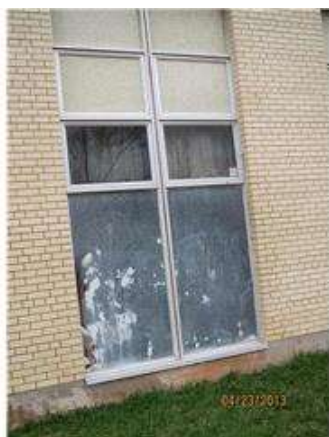
Apr 2013- Typical deteriorated windows on east, south and, north facade of the original building.

2013 - Due the condition of the exterior windows, replacement is recommended.

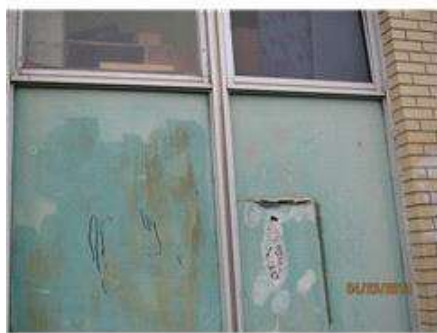
Apr 2013- Damaged exterior windows.

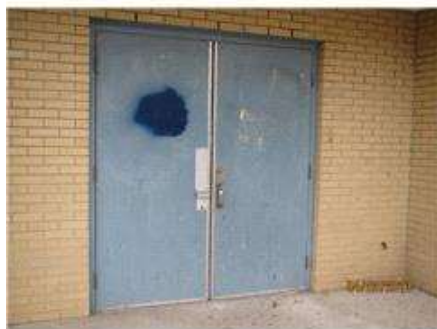
Apr 2013- Typical painted hollow metal around the original building.

Recommendation 2013 - The majority of the exterior door assemblies are original and have exceeded their effective design rated life. Replacement of the door assemblies is recommended.

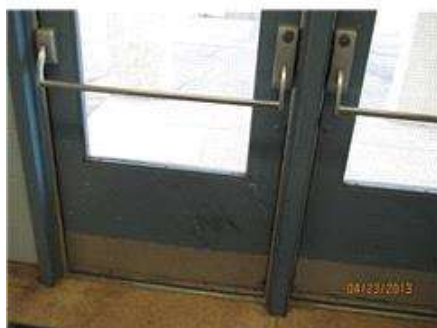
Apr 2013- Stained and scratched exterior door.

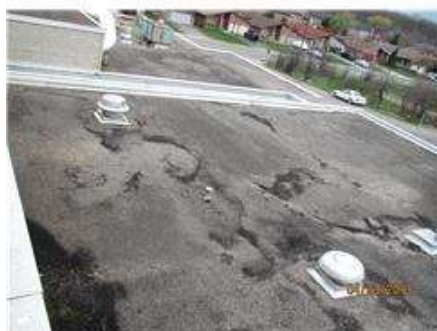
Apr 2013- Deteriorated roof assembly.

2013 - The roof assembly system of original building is beyond its expected service life and is no longer performing as intended. Replacement is recommended.

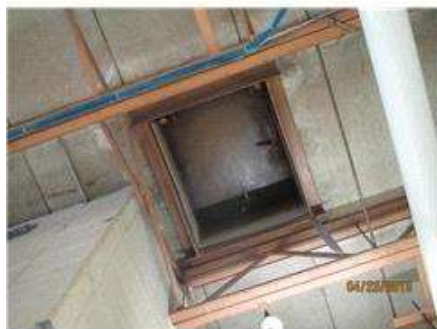
Apr 2013- Inside access hatch to the roof with no ladder.

Recommendation 2013 - It is recommended that the exterior access ladders on the roof to be replaced and access ladder to roof from inside building hatch to be provided.

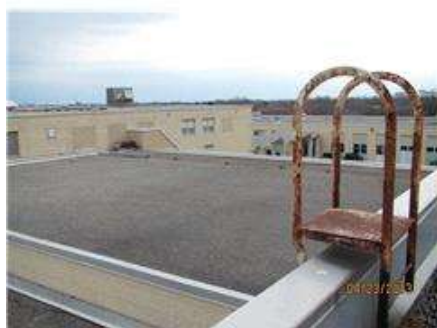
Apr 2013- Deteriorated access ladder from one roof to another.

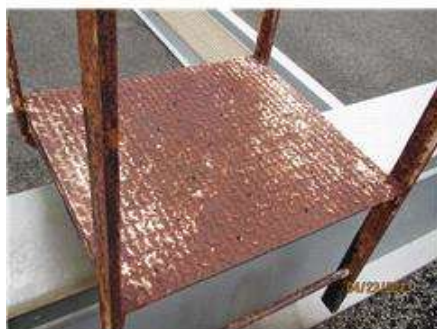
Apr 2013- Deteriorated access ladder on the roof.

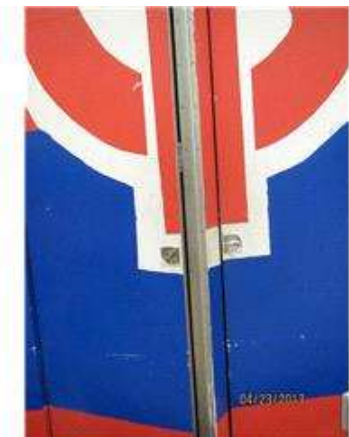
Apr 2013- Movable partition in the GYM.

Recommendation 2013 - The moveable partition in the gymnasium has surpassed its expected useful life. Replacement is recommended.

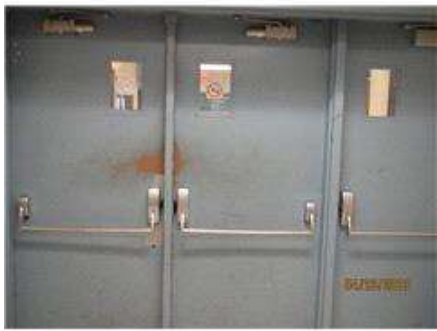
Apr 2013- Typical hollow metal interior doors in the original building.

2013 - The interior doors have exceeded their effective design rated life with the majority of the doors exhibiting damage. Replacement of the interior doors is recommended.

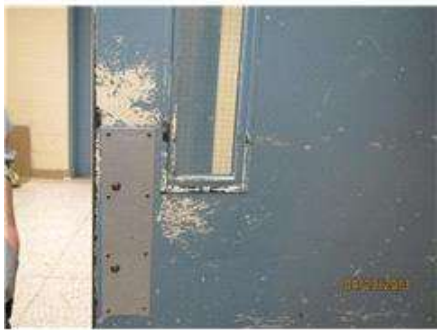
Apr 2013- Damaged interior door.

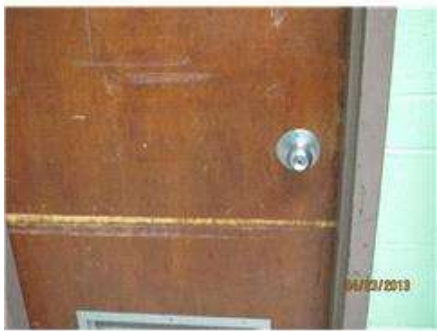
Apr 2013- Typical worn wood veneer interior door.

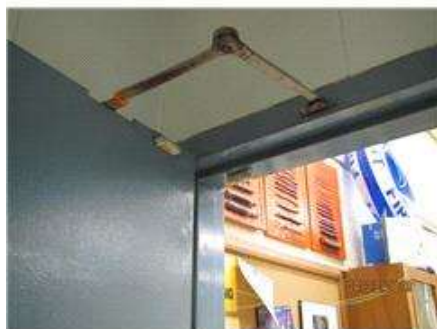
Apr 2013- Worn interior hardware.

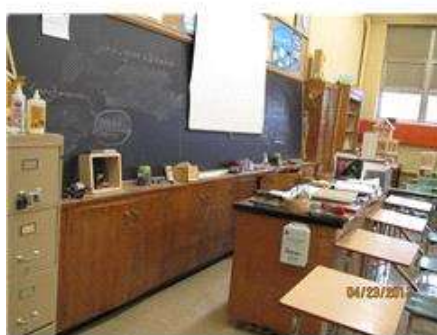
Apr 2013- Typical millwork in the classrooms.

2013 - As all the cabinetry, millwork items, counters and countertops have exceeded their expected useful life and are in fair condition the recommendation is to replace them.

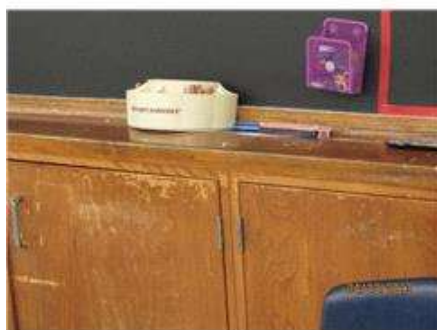
Apr 2013- Worn millwork.

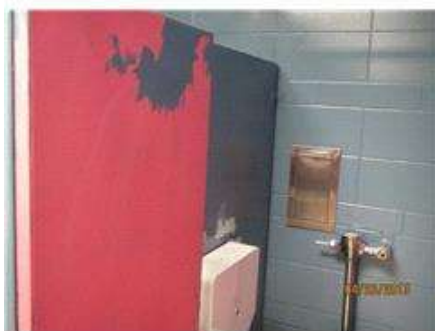
Apr 2013- Stained and Worn washroom partition.

2013 - The original floor mounted painted toilet partitions have exceeded their effective rated design life. Replacement is recommended.

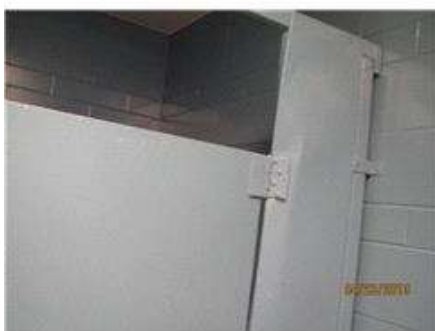
Apr 2013- Damaged washroom partition.

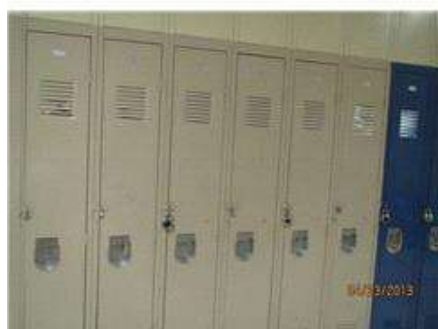
Apr 2013- Stained old lockers.

2013 - Recommend lockers to be replaced.

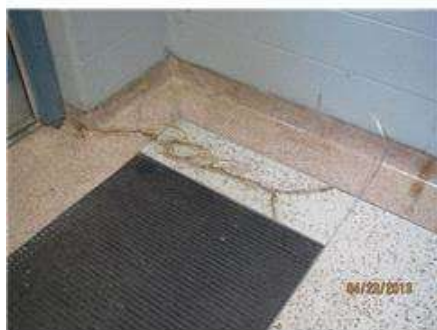
2013 - Settlement and expansion cracks are evident from the original construction. Repairs of the cracking is recommended for aesthetic reasons.

Apr 2013- Cracked terrazzo in the corridor

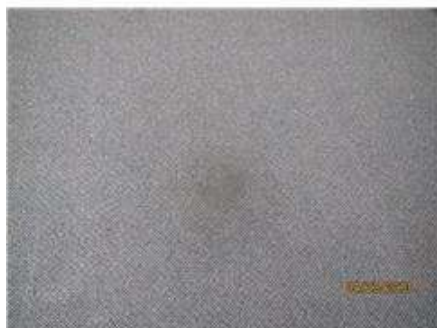
Apr 2013- Stained carpet in the music room.

2013 - The carpets located in the library, exercise room and, music room are subjected to frequent foot traffic. Wear was evident throughout these rooms. Replacement of carpet is recommended.

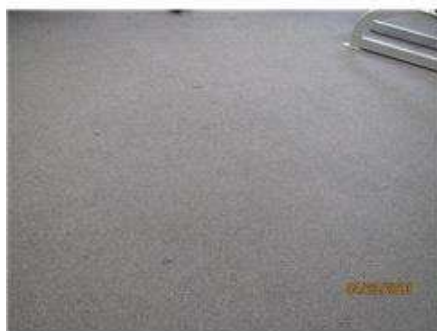
Apr 2013- Worn carpet in the exercise room.

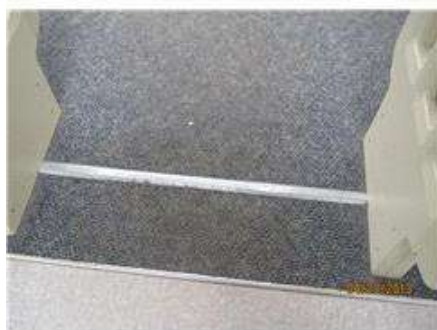
Apr 2013- Worn carpet in the Library.

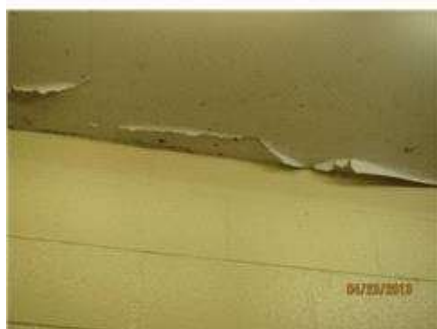
Apr 2013- Damaged gypsum board ceiling in the change room.

Recommendation 2013 - Gypsum board ceilings are original and have passed there EUL and should be refinished or replaced.

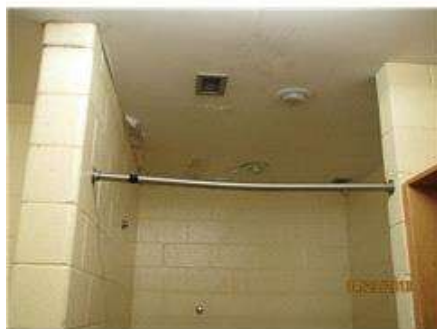
Apr 2013- Deteriorating Gypsum board ceiling in the shower of change room.

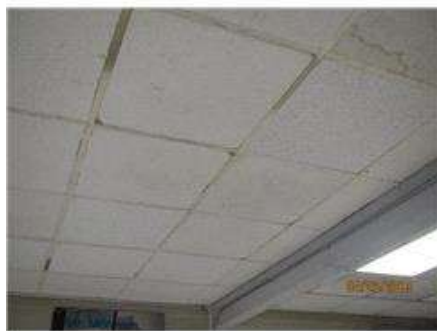
Apr 2013- Typical worn ceiling tiles in the corridors of the school.

Recommendation Mar 2013 - The acoustical suspended ceiling tile system is showing signs of wear. Replacement is recommended.

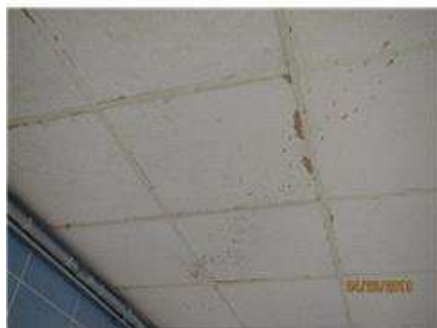
Apr 2013- Worn ceiling tiles.

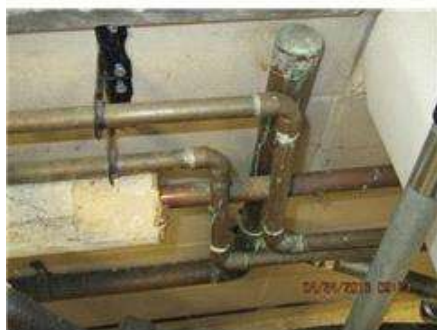
April 2013 - Original Domestic Water Piping

2013 - Based on the age and theoretical useful life of the domestic water piping system replacement is recommended. A study is recommended to determine the current condition, remaining service life, current service requirements and the cost of replacement.

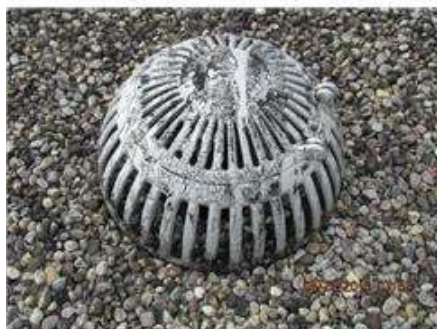
April 2013 - Aged Roof Rain Water Drainage

2013 - A study is recommended to determine the condition of the rainwater drainage distribution system, the required recommended scope of work and the cost for system renewal.

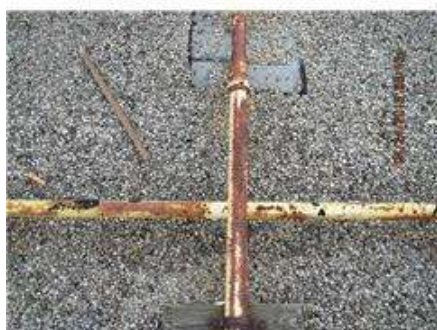
April 2013 - Exterior Section of Gas Piping is Aged and Weathered

2013 - Planned replacement of the exterior section of the gas piping is recommended based on age and condition.

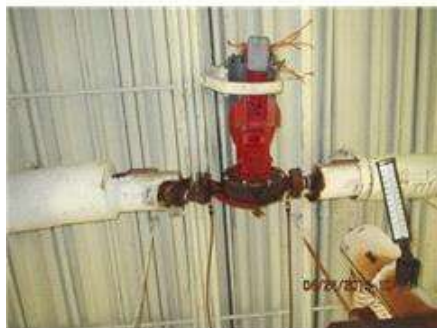
April 2013 - Leaking Pump Directly Above Chiller

2013 - Replacement of the cooling systems pumps in the chiller room is recommended to prevent damage to the chiller and associated equipment in the room and prevent disruption of service due to repairs caused by leaks.

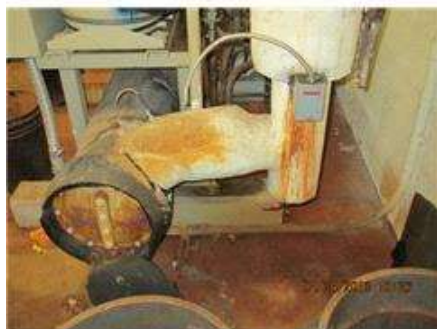
April 2013 - Corrosion of Chiller Caused by Leaking Pumps

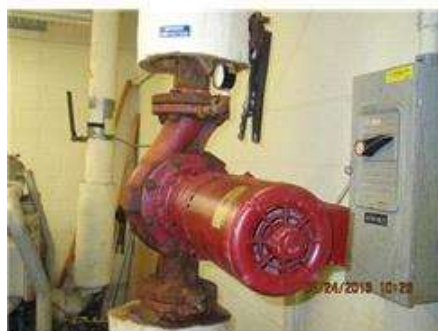
April 2013 - Leaking Pump Directly Above Chiller

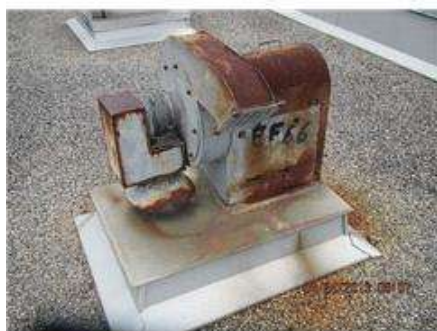
April 2013 - Original Rooftop Exhaust Fan - Aged and Weathered

2013 - The exhaust fans are operating past their expected useful lives and will likely require replacement as most are in fair condition.

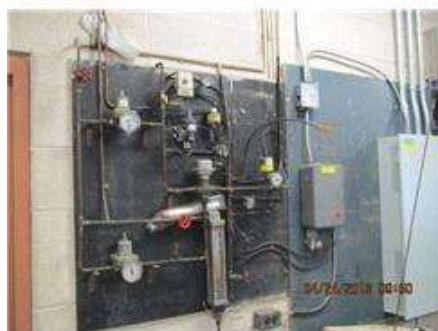
April 2013 - Aged Pneumatic Controls

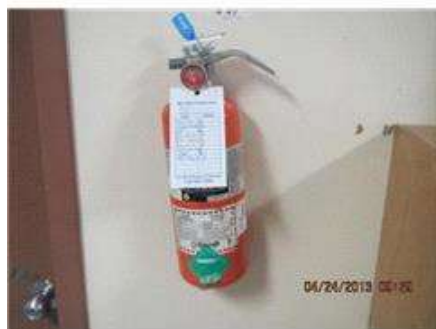
April 2013 - Aged Fire Extinguisher

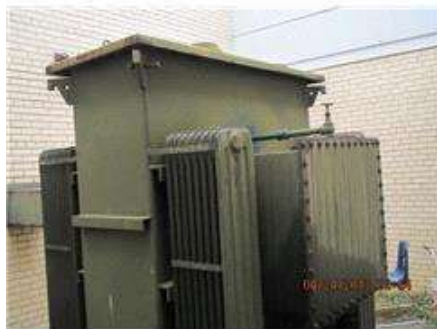
April 2013 - Original Main Transformer

Recommendation 2013 - Based on the age and theoretical useful life of the main transformer, replacement is recommended.

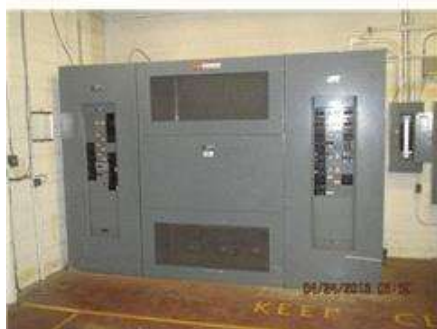
April 2013 - Original Secondary Switchgear

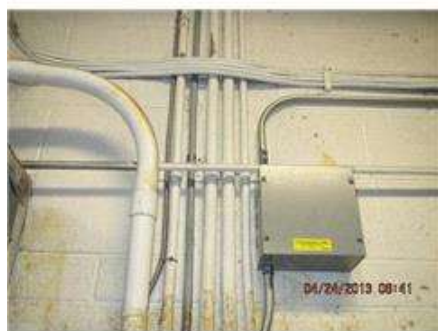
April 2013 - Original Branch Wiring - Original Building

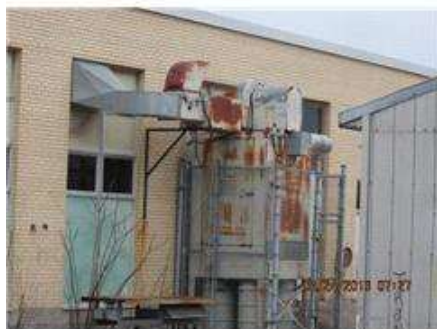
April 2013 - Aged Dust Collector

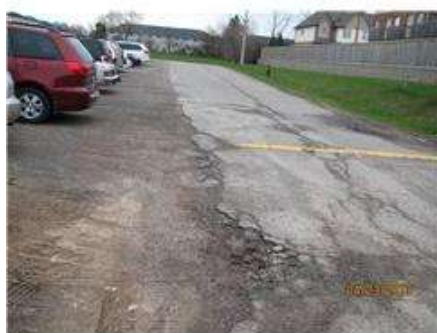
Apr 2013- Extensive Sign of Deterioration of the road.

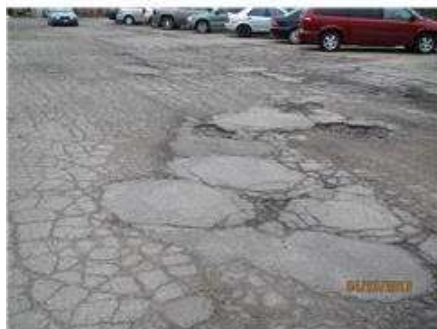
Apr 2013- Evidence of alligator cracking and pot holes in the parking lots.

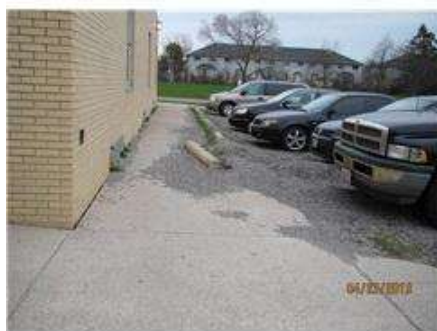
Apr 2013- Typical deteriorated concrete sidewalk round the building

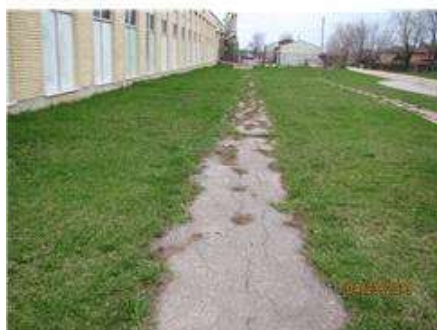
Apr 2013- Deteriorated asphalt sidewalk on the east side of the building.

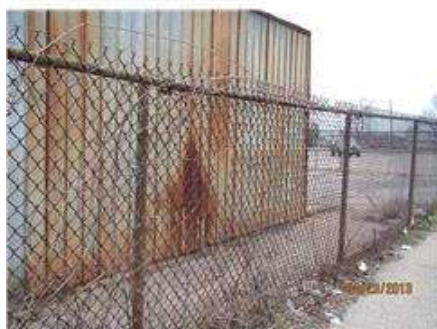
Apr 2013- Corroded fence on the east side of the building.

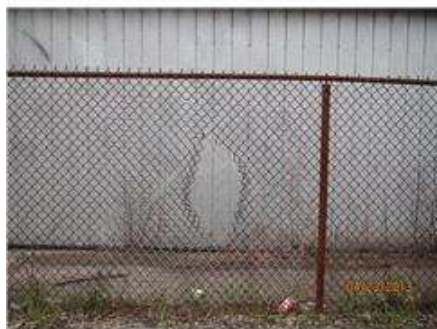
Apr 2013- Damaged fence.
