HAMILTON WENTWORTH DISTRICT SCHOOL BOARD
FEASIBILITY STUDY AND CONCEPT DESIGN

SHERWOOD SECONDARY SCHOOL
25 High Street, Hamilton, ON

Condition Assessment

Sherwood SS, Building ID 9143-1

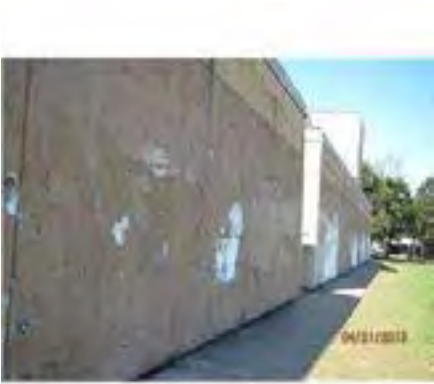
Apr 2013- Deteriorating exterior EFS wall system.

Recommendation2013 - The exterior EFS walls are showing signs of deterioration on all facades of the building. Replacement is necessary as to maintain the integrity of the building envelope.

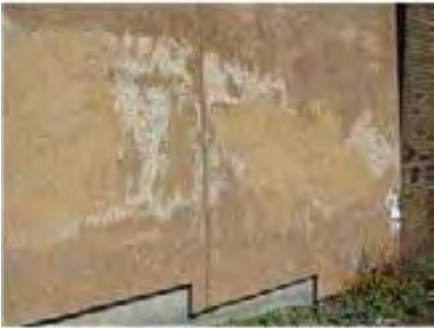
Apr 2013- Deteriorating EFS system.

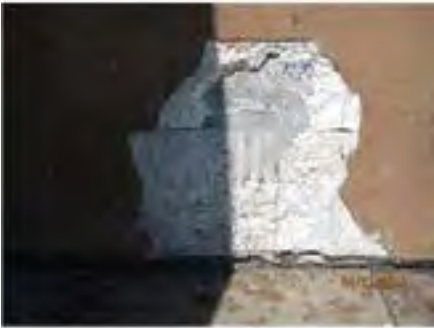
Apr 2013- Damaged exterior EFS wall system.

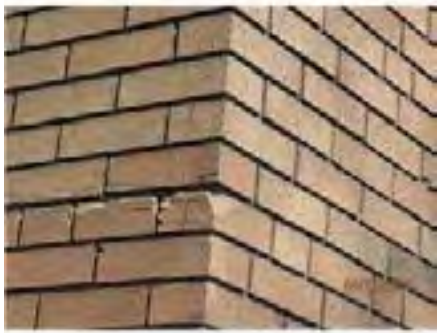
Apr 2013- Broken brick and spalling mortar joint.

2013 - The exterior brick veneer walls are showing signs of deterioration on all facades of the building. Repointing and brick replacement is necessary as to maintain the integrity of the building envelope.

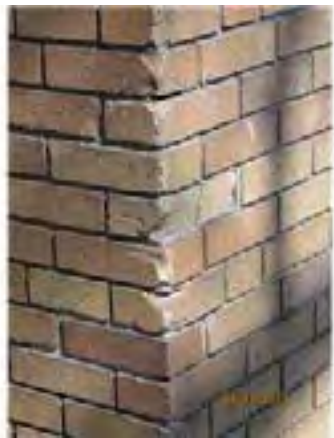
Apr 2013- Spalling bricks.

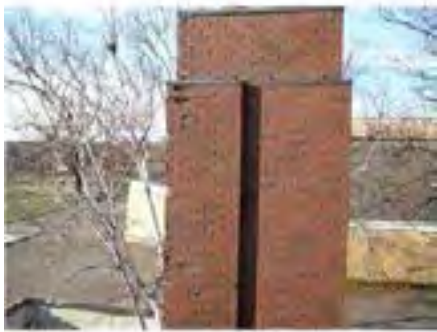
Apr 2013- Spalling brick veneer on chimney on the roof.

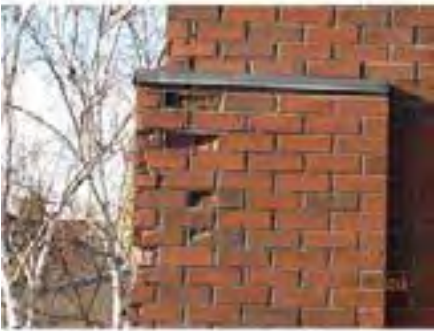
Apr 2013- Spalling brick veneer.

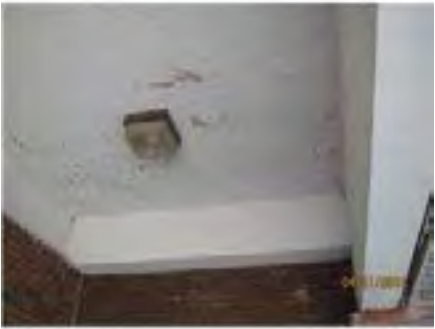
Apr 2013- Peeling Paint covering of soffit.

Recommendation 2013 - It is recommended that the gypsum Board soffits be repainted as soon as possible.

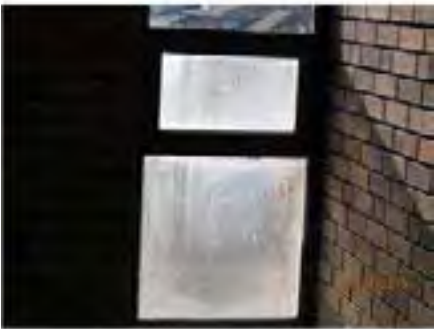
Mar 2013- Deteriorating exterior window.

Recommendation 2013 - The windows of the building are beyond their expected service life. Based on the windows performance and observed condition, age, design and thermal properties, replacement of the building windows is recommended.

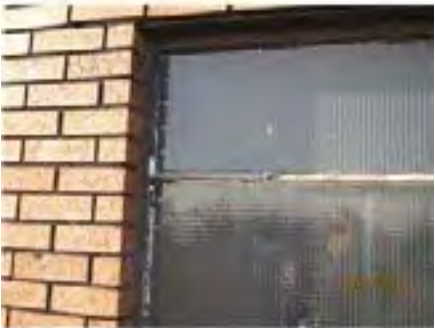
Mar 2013- Damaged and, broken seal of the exterior window.

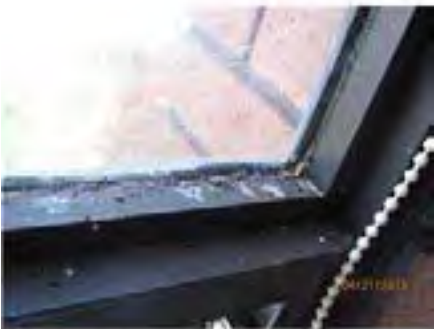
Mar 2013- Deteriorating exterior window from inside of the facility.

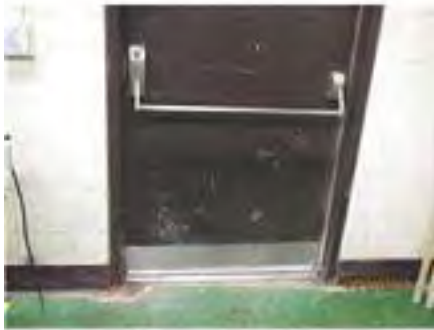
Apr 2013- Worn exterior hollow metal door.

2013 - The majority of the exterior door assemblies are original and have exceeded their effective design rated life. Replacement of the door assemblies is recommended.

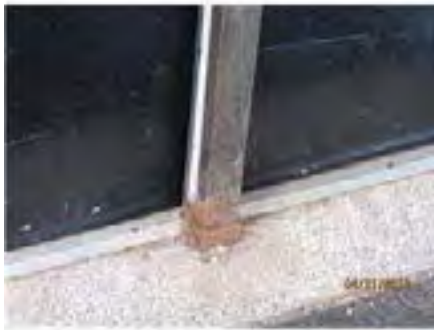
Apr 2013- Rusted Exterior door frame.

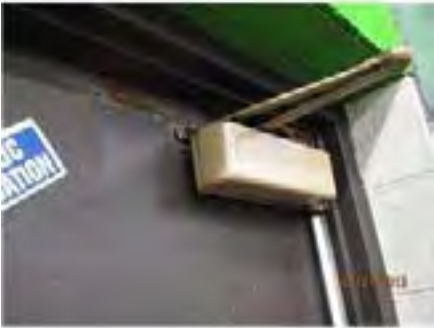
Apr 2013- Worn exterior door hardware.

Recommendation	2013 - It is recommended that the exterior door hardware should be replaced at the time the exterior doors are replaced.
-----------------------	--

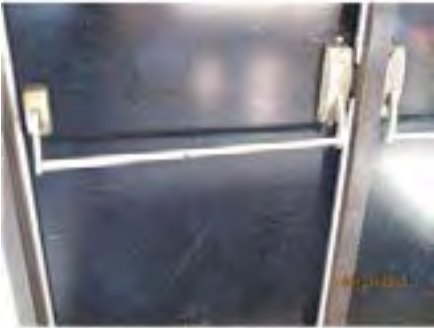
Apr 2013- Worn exterior door hardware.

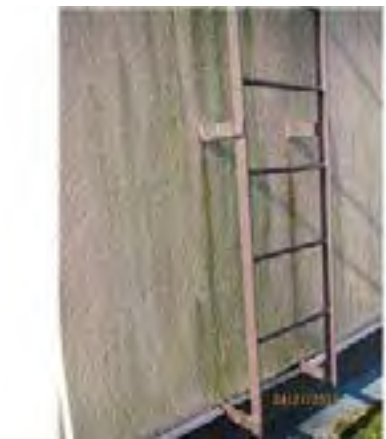
Apr 2013- Worn roof access ladder.

Recommendation 2013 - Replacement are recommended based on condition of metal access ladders.

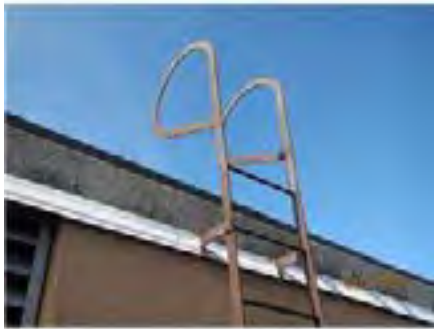
Apr 2013- Worn roof access ladder.

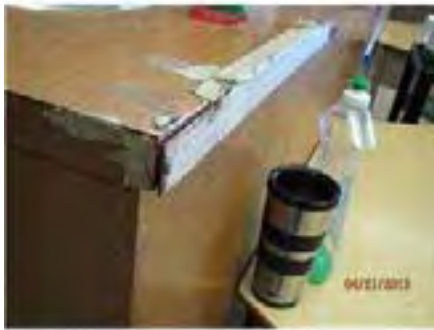
Apr 2013- Damaged millwork.

Recommendation	2013 - As all the cabinetry, millwork items, counters and countertops have exceeded their expected useful life and are in fair condition the recommendation is to replace them
----------------	--

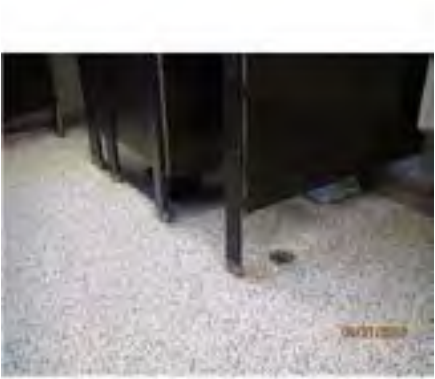
Apr 2013- Worn washroom floor mounted partition.

Recommendation	2013 - The original floor mounted painted toilet partitions have exceeded their effective rated design life. Replacement is recommended.
-----------------------	--

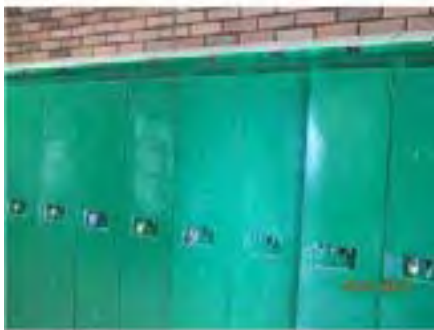
Apr 2013- Typical old worn lockers in the school.

Recommendation The lockers are from original construction and have exceeded their theoretical useful life. Damage to door panels and sidings, and corrosion of the hardware and shelving was evident. Full replacement is required based on age and condition.

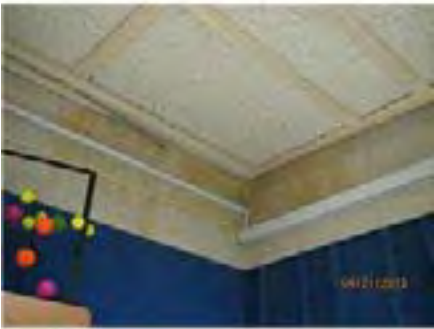
Apr 2013- Stained wall covering.

Recommendation 2013 - Recommend all interior wall finishes be repainted as the finishes are fading and showing signs of age

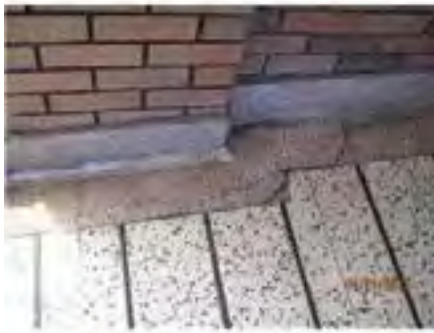
Apr 2013- Crack on terrazzo flooring of the corridor

Recommendation2013 - Settlement and expansion cracks are evident from the original construction. Repairs of the cracking is recommended for aesthetic reasons.

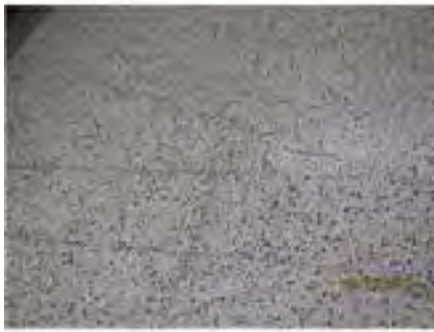
Apr 2013- Cracked terrazzo flooring.

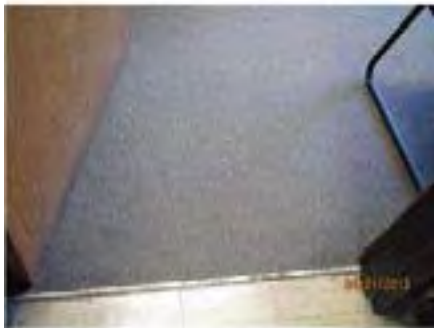
Apr 2013- Typical stained carpet in the building.

Recommendation 2013 - The carpet located in the Resource Center is subjected to frequent foot traffic. Excessive wear was evident throughout the Resource Center. Replacement of carpet is recommended.

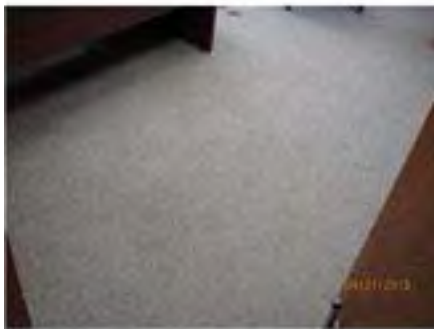
Apr 2013-Worn carpet covering.

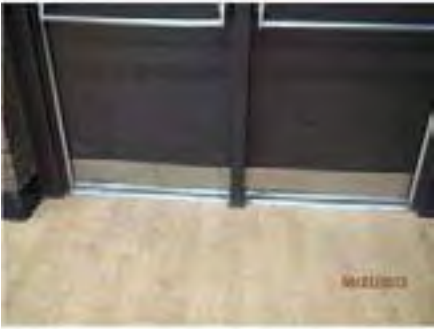
Apr 2013-Worn vinyl sheet flooring in the GYM>

Recommendation2013 - The vinyl sheet goods and vinyl base is worn and aged beyond its effective design rated life. Replacement is recommended.

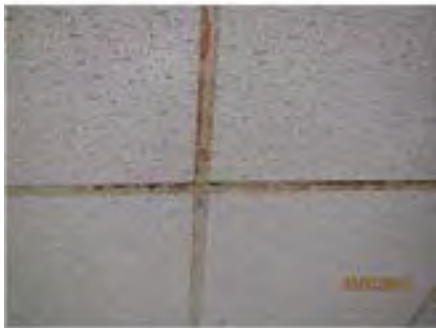
Apr 2013- Discolored and deteriorated grid ceiling in the GYM change room.

2013 - The 2'x4' acoustic tile ceiling system has exceeded its useful life and is known to contain asbestos materials. Replacement planning is recommended as to update the appearance of the facility and remove any Chrysotile asbestos spray fireproofing present which presents potential health concerns. especially an third floor ceiling space, refer to asbestos report that has been done in Nov 2012..

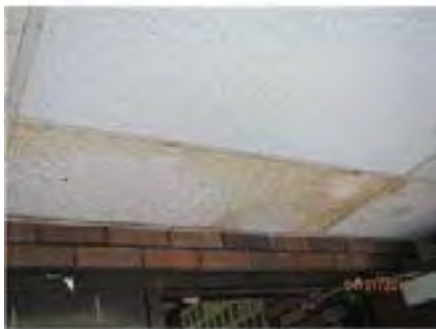
Apr 2013- Stained ceiling tile.

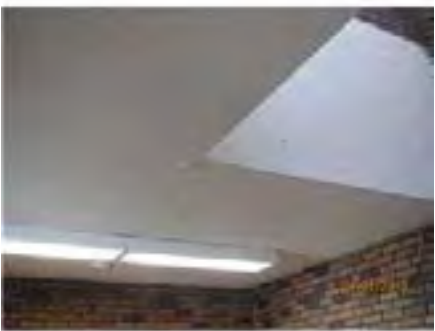
Apr 2013- Peeling paint gypsum board ceiling.

Description		2013 - Gypsum board ceilings	
Condition Assessment		2013 - At the time of the assessment the gypsum board ceilings were in fair condition	
Last Replacement Year		1967	
Theoretical Life		15	
Ceiling Finishes Type		Unspecified	
Technical Condition		Fair	
Replacement [C3030 Ceiling Finishes - Original Building]			
Event Type:	Replacement	Priority:	Medium
Brief Description		Replacement [C3030 Ceiling Finishes - Original Building]	
Estimated Cost		\$24,798	
Fiscal Event Year		2015	
2011-2015 Cost		\$24,798	
2011-2015 Priority		Medium	
2011-2015 Year		2015	
Recommendation		2013 - Gypsum board ceilings are original and have passed there EUL and should be replaced.

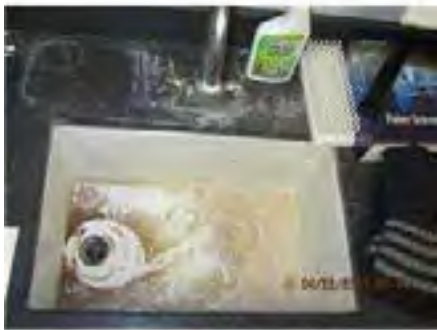
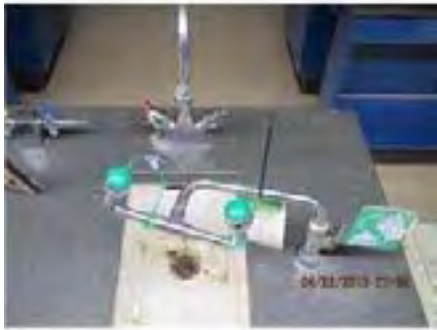
April 2013 - Aged Science Lab Sinks

2013 - The science lab sinks are original, stained and in fair condition. Replacement is recommended.

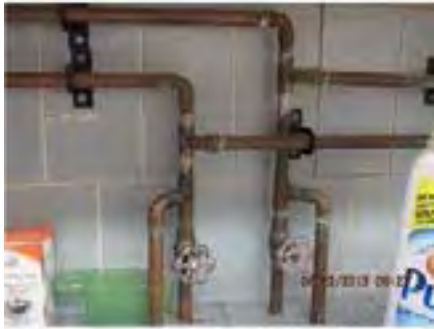
April 2013 - Original Domestic Water Piping

Recommendation 2013 - Based on the age and theoretical useful life of the domestic water piping system replacement is recommended. A study is recommended to determine the current condition, remaining service life, current service requirements and the cost of replacement.

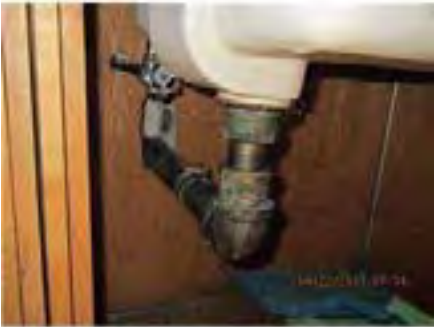
April 2013 - Original Sanitary Waste Piping

Recommendation	2013 - Planned replacement of the waste water distribution system is recommended based on age and condition.
-----------------------	--

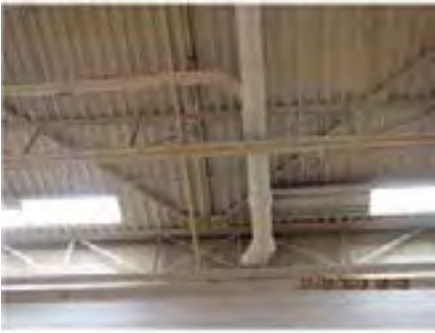
April 2013 - Original Rain Water Drainage Piping

Recommendation	2013 - Planned replacement of the rain water drainage system is recommended based on age and condition.
-----------------------	---

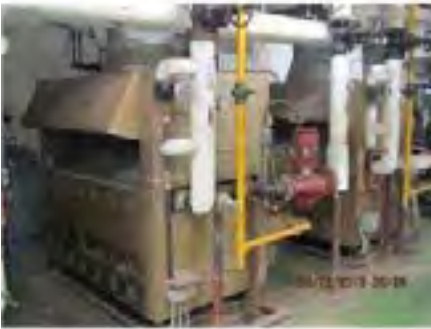
April 2013 - Aged Atmospheric Boilers

Recommendation 2013 - Replacement of the aged atmospheric boilers is recommended with more efficient condensing boilers..

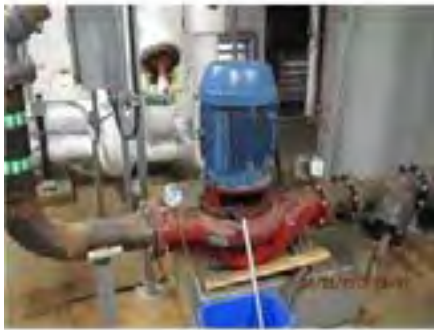
April 2013 - Aged HVAC Pumps

Recommendation 2013 - Replacement of the aged HVAC pumps is recommended to ensure functionality of the heating and cooling systems.

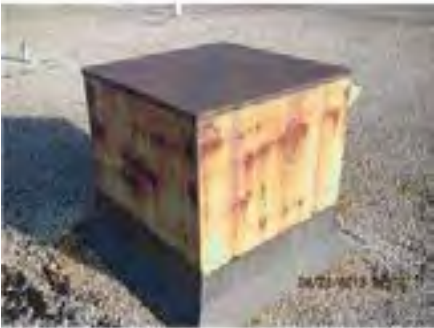
April 2013 - Original Weathered Rooftop Exhaust Fan

2013 - The exhaust fans are operating past their expected useful lives and will likely require replacement as most are in fair condition.

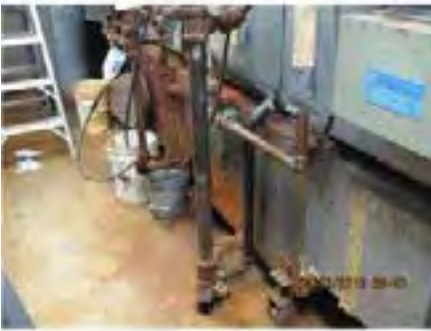
April 2013 - Original Air Handlers

Recommendation 2013 - While it is impossible to predict with certainty when any air handler will fail, air handling units typically last (35) years according to their theoretical life. Due to age and some mechanical wear, the units should be replaced within the next 5 years for reliability.

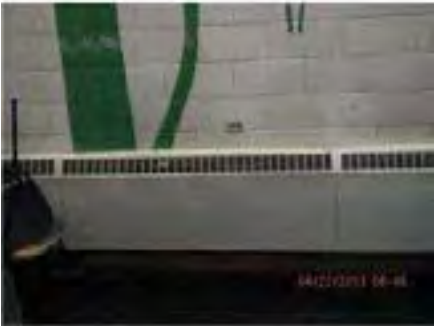
April 2013 - Original Fin Tube Radiators

2013 - Replacement of the aged fin tube radiation units and forced air units is recommended based on condition and theoretical life.

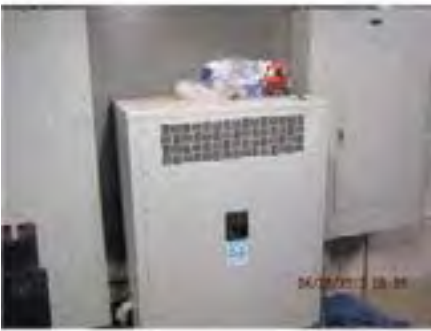
April 2013 - Original Secondary Transformer 225 kVA

Recommendation2013 - Replacement of the aged secondary transformer is recommended based on age and condition.

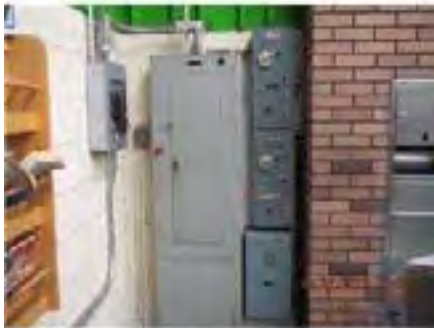
April 2013 - Aged Branch Wiring, Panels and Switches

Recommendation 2013 - Based on the age of the branch wiring, replacement is recommended. An in depth study should be conducted to determine the current condition, remaining useful life cost of replacement.

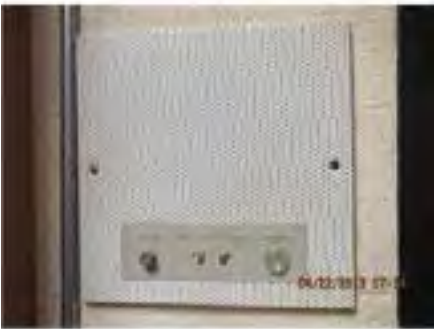
April 2013 - Original PA Speakers

Recommendation 2013 - The public address system speakers and wiring are aged beyond their rated life and are recommended for replacement.

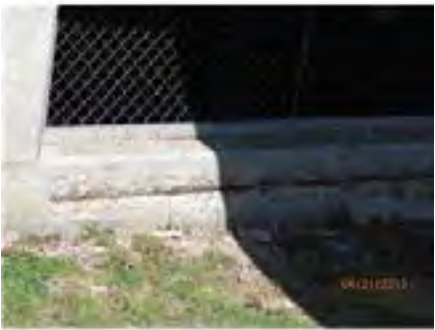
Apr 2013- Corroded concrete retaining wall.

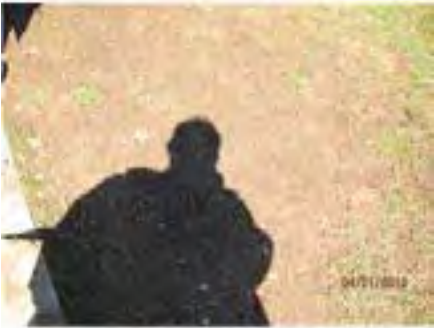
Apr 2013- Damaged landscaping due to weather element.
