**HAMILTON-WENTWORTH DISTRICT SCHOOL BOARD**  
FEASIBILITY STUDY and CONCEPT DESIGN

**Sir Winston Churchill Secondary School**  
1715 Main Street E, Hamilton, ON

November 2015

Sir Winston Churchill SS, Building ID 9149-1

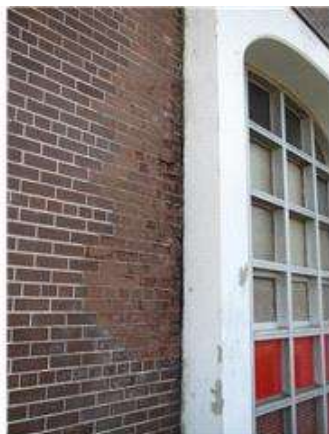
**Recommendation** 2013 - The exterior brick veneer walls are showing signs of deterioration on all facades of the building. Repointing and brick replacement is necessary as to maintain the integrity of the building envelope.

Apr 2013- Deteriorating Exterior wall brick veneer.

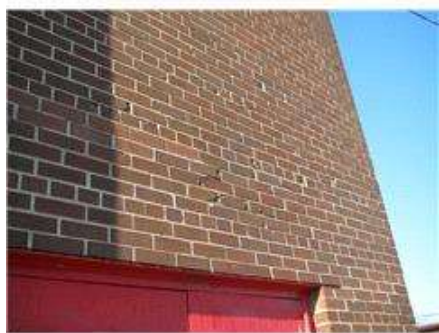
Apr 2013- Sign of deteriorating of exterior wall brick.

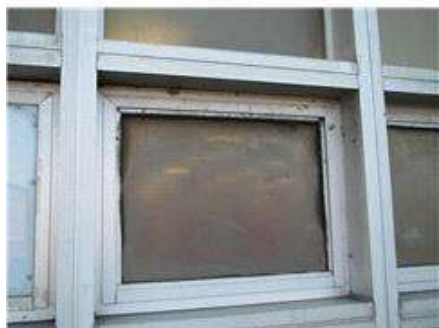
**Recommendation** 2013 - The windows of the building are beyond their expected service life. Based on the windows performance and observed condition, age, design and thermal properties, replacement of the building windows is recommended.

Apr 2013- Deteriorated exterior window.

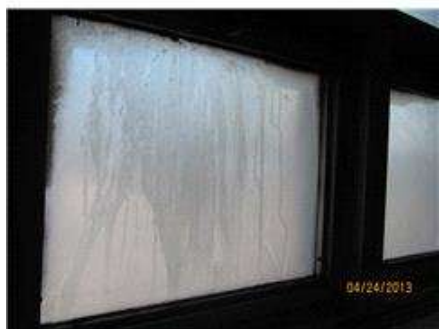
Apr 2013-Worn exterior window.

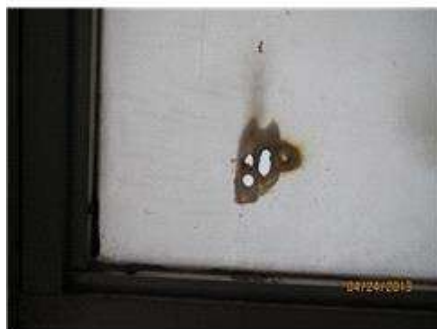
Apr 2013- Damaged exterior window.

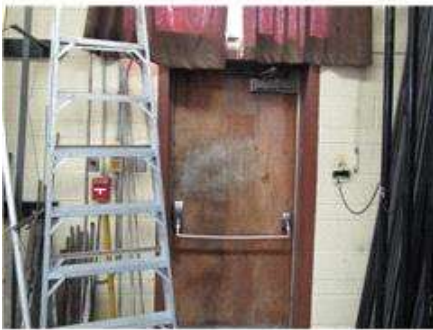
Apr 2013- Worn-out Exterior door.

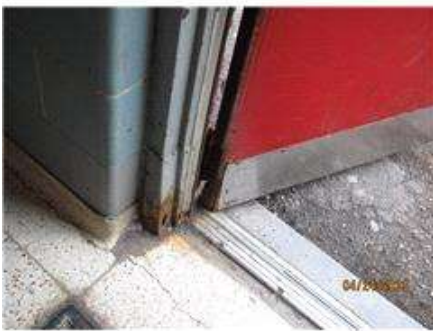
Apr 2013- Rusted and deteriorated exterior door frame.

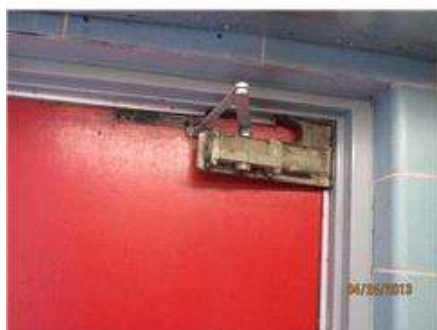
2013 - It is recommended that the exterior door hardware should be replaced at the time the exterior doors are replaced.

Apr 2013- Typical worn and aged exterior door hardware.

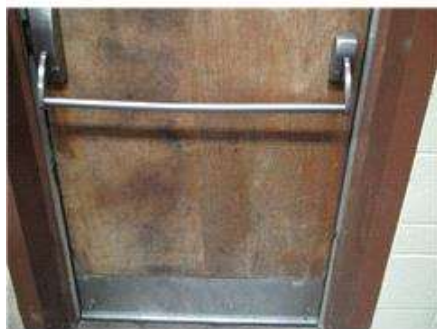
Apr 2013- Worn exterior door hardware.

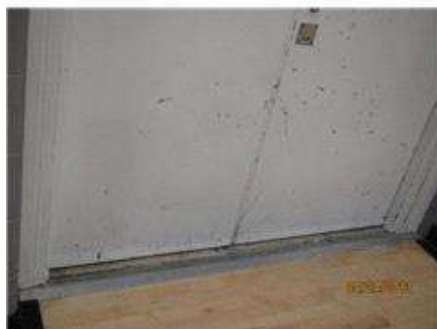
2013 - The moveable partition has surpassed its EUL. Planning for renewal is recommended for the latter portion of 5 year planning window.

Apr 2103- Aged movable partition.

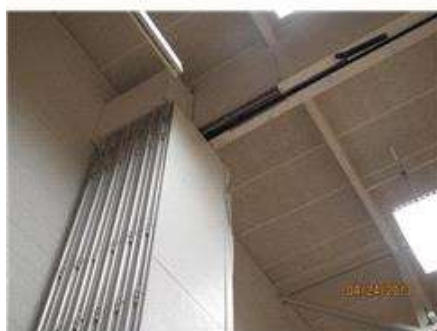
Apr 2013- Worn retractable partition.

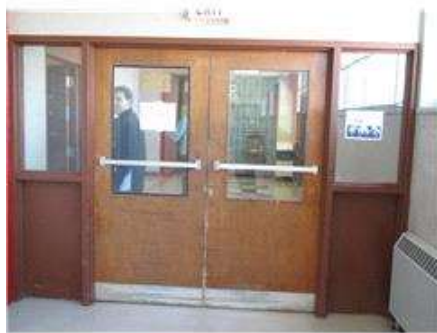
2013 - The interior doors have exceeded their effective design rated life with the majority of the doors exhibiting damage. Replacement of the interior doors is recommended.

Apr 2013- Typical worn-out interior wood door.

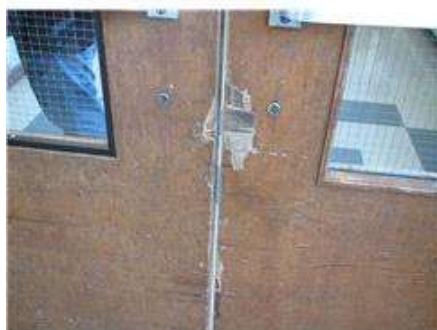
Apr 2013- Damaged interior wood door.

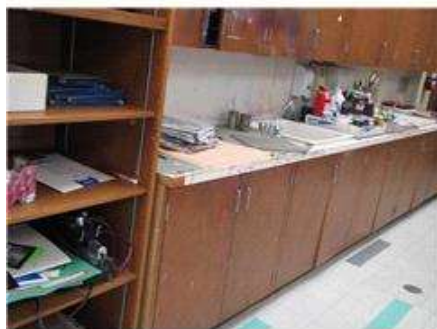
**Recommendation** 2013 - As all the cabinetry, millwork items, counters and countertops have exceeded their expected useful life and are in fair condition the recommendation is to replace them

Apr 2013- Typical worn classroom millwork fitting.

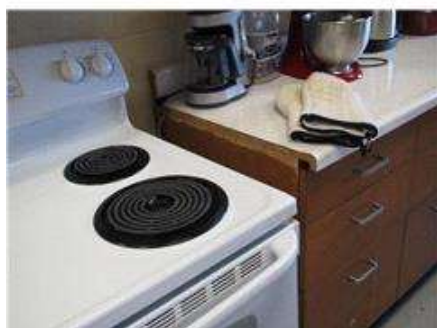
Apr 2013- Damaged Millwork fitting.

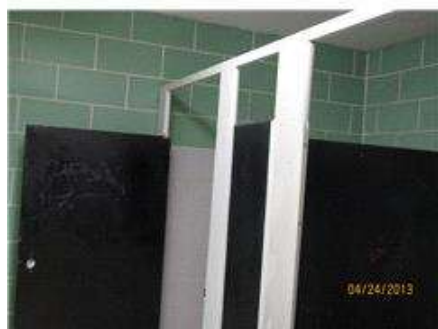
2013 - The original floor mounted painted toilet partitions have exceeded their effective rated design life. Replacement is recommended. OLD-Damages were noted on the metal washroom partitions. The washroom panels have exceeded their useful life based on the age and observed condition. Replacement is recommended.

Apr 2013- Stained washroom partition in the school.

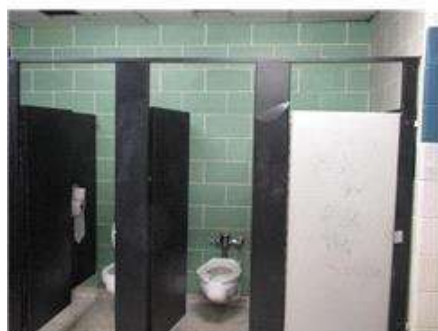
Apr 2013- Stained and worn washroom partition in the school.

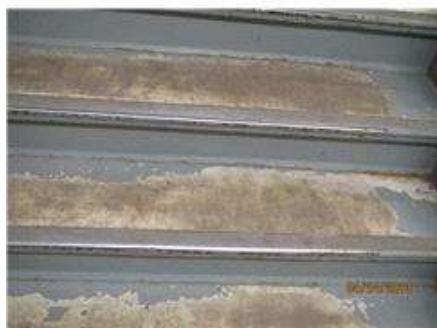
**Recommendation** 2013 - Replacement of initial flight of the interior stairs including the rubber covering is recommended

Apr 2013- Deteriorated stairs finish.

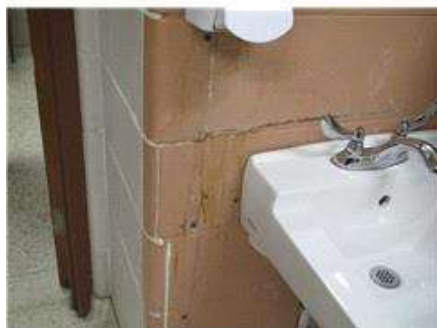
**Recommendation** 2013 - Recommend all interior wall finishes be repainted as the finishes are fading and showing signs of age

Apr 2013- Stained wall covering in the Special education room

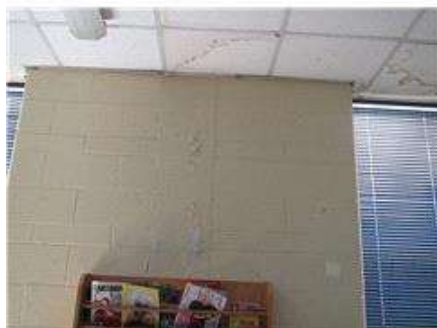
Apr 2013- Peeling paint wall covering.

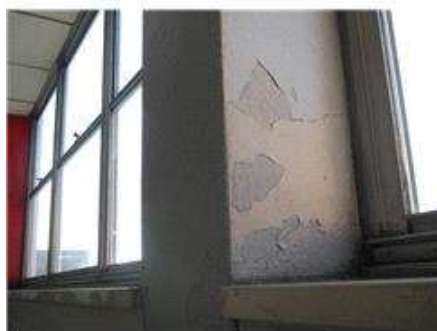
Apr 2013- Damaged paint wall covering.

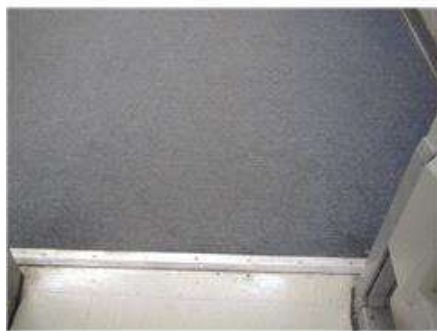
**Recommendation** Wear, tear, wrinkles and degradation at the seams was noted on the aged carpet in library and auditorium. Replacement is recommended. 2007: Auditorium carpet replaced.

Apr 2013- Worn carpet floor covering in the Library.

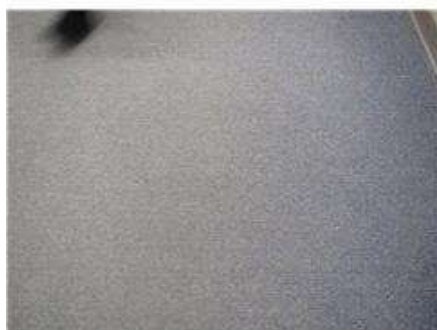
Apr 2013- Worn carpet floor covering.

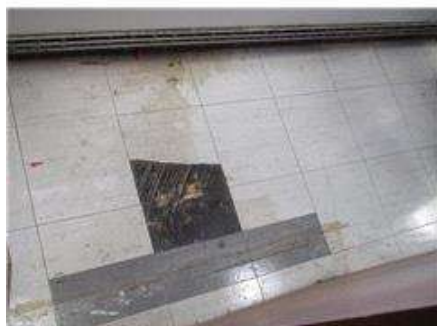
2013 - The vinyl composite floor tile and vinyl base is exhibiting signs of wear and has exceeded its effective rated design life. Replacement planning is recommended.

Apr 2013- Damanged VCT floor covering.

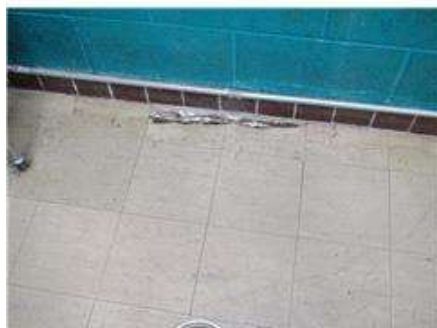
Apr 2013- Damanged VCT floor covering.

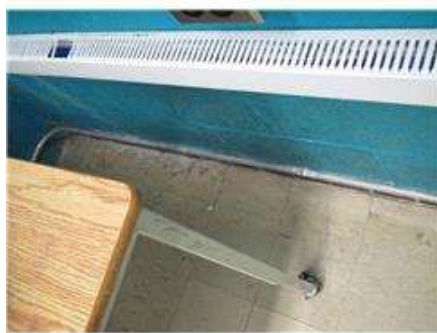
Apr 2013- Stained and worn VCT floor covering.

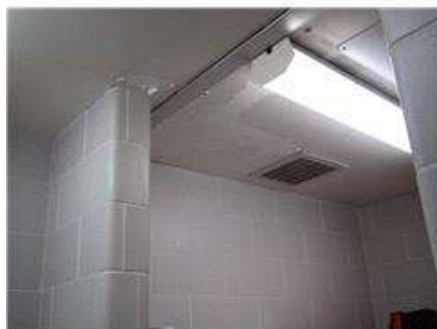
**Recommendation** 2013 - Gypsum board ceilings are original and have passed there EUL and should be replaced

Apr 2013- Worn Gypsum board ceiling in the change room.

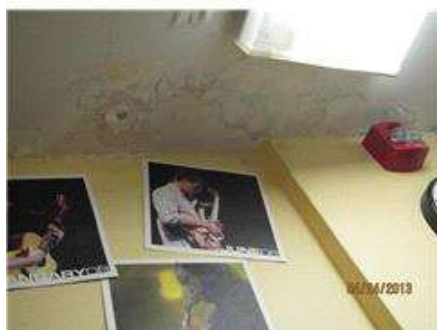
Apr 2013- Damaged gypsum board ceiling.

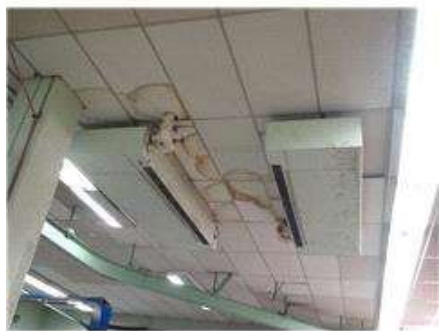
Apr 2013- Stained and worn ceiling tile.

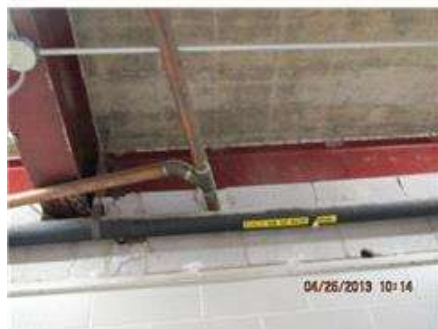
2013 - Based on the age and theoretical useful life of the domestic water piping system replacement is recommended. A study is recommended to determine the current condition, remaining service life, current service requirements and the cost of replacement.

April 2013 - Domestic Water Distribution Piping

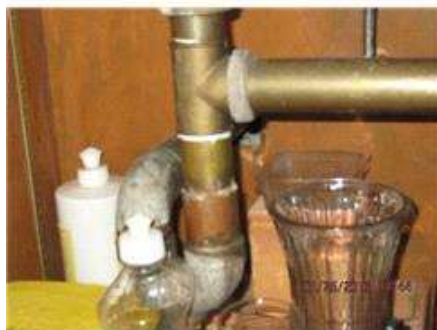
**Recommendation** 2013 - Planned replacement of the waste water distribution system is recommended based on age and condition.

April 2013 - Aged Sanitary Water Piping

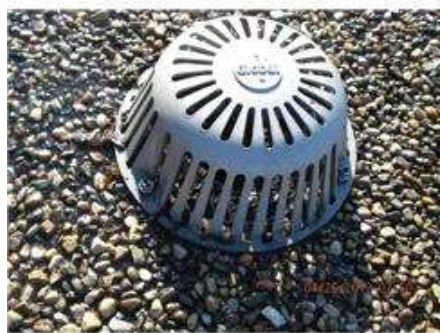
**Recommendation** 2013 - Planned replacement of the rain water drainage system is recommended based on age and condition.

April 2013 - Roof Drain - Rain Water Drainage System

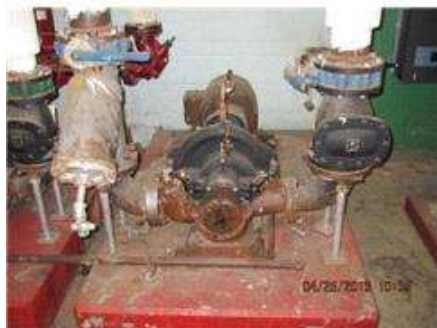
2013 - Based on age, the HVAC pumps have past their expected useful life, which is generally 25 years. Replacement of the HVAC pumps is recommended to minimize the potential impact on the heating system.

April 2013 - Typical Original HVAC Pump

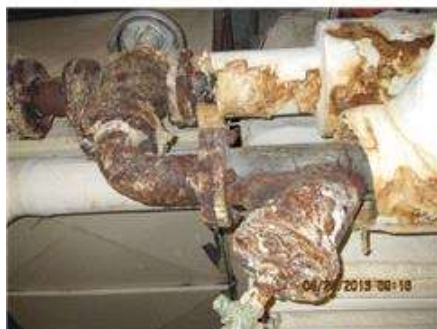
April 2013 - Aged and Corroding Heating Piping

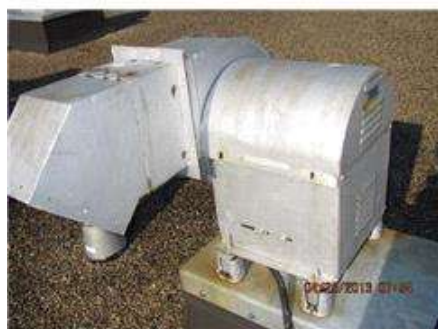
2013 - The exhaust fans are operating past their expected useful lives and will likely require replacement as most are in fair condition.

April 2013 - Original Rooftop Exhaust Fan

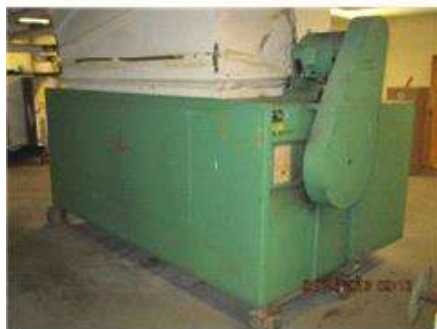
2013 - Due to age and mechanical wear, the central air handlers should be replaced within the next 5 years for reliability.

April 2013 - Original Central Air Handler

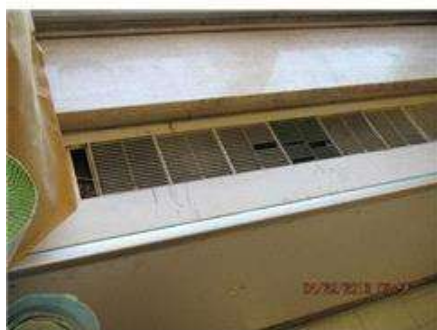
April 2013 - Unit Ventilator Wear and Tear

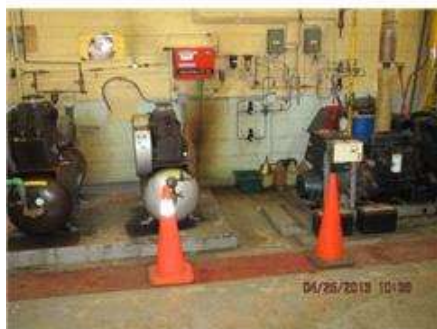
April 2013 - Pneumatic Controls Air Compressor and Drier

2013 - Remove the existing controls and replace with a new DDC HVAC control system. Work to include removal of the existing components and installation of new controls, including energy monitoring and electronic actuators. Coordinate with other HVAC deficiency correction projects.

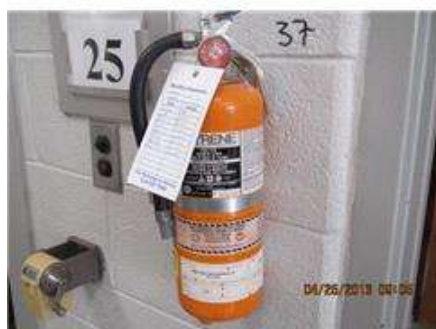
April 2013 - Aged Fire Extinguishers

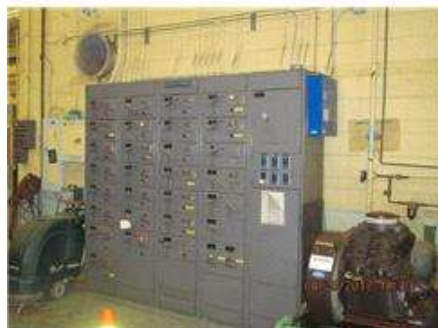
2013 - The MCC is part its useful life and should be replaced within the next 3 years.

April 2013 - Original Motor Control Centre

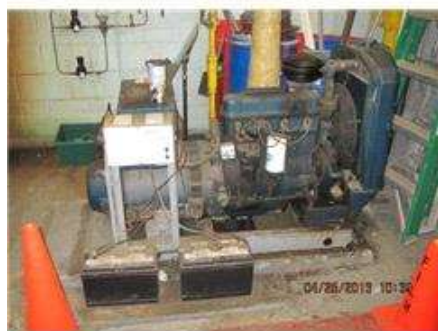
April 2013 - Aged Emergency Power Generator

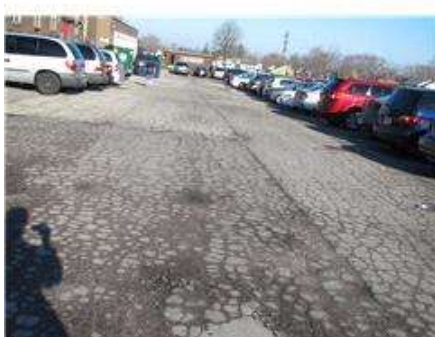
Apr 2013- Parking surface on the south side of the site with evidence of alligator cracking.

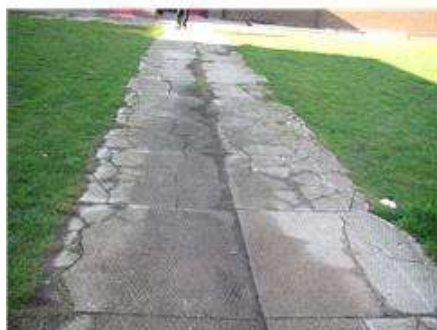
Apr 2013- Evidence of deterioration and settlement.

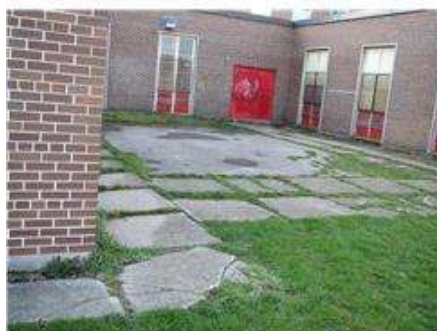
Apr 2013- Deteriorated pedestrsin on the west side.

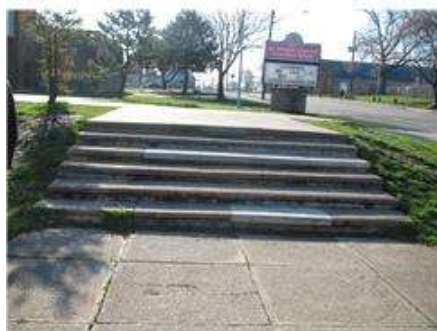
Apr 2013- Deteriorating Concrete stairs.
