HAMILTON-WENTWORTH DISTRICT SCHOOL BOARD
FEASIBILITY STUDY and CONCEPT DESIGN

Westmount Secondary School
39 Montcalm Drive, Hamilton, ON

November 2015

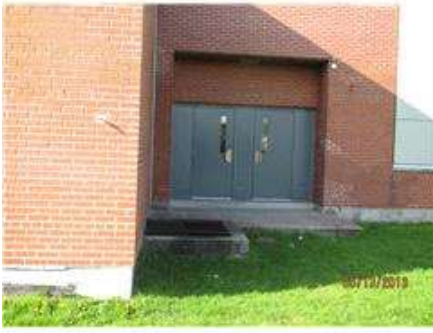
May 2013- Evidence of efflorescence on the surface of exterior brick wall.

Recommendation 2013 - Repairs to the deteriorated mortar joints should be done as soon as possible to avoid any further damage to the building envelope.

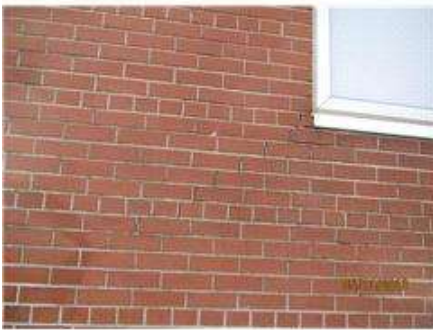
May 2013- Sign of cracks on the surface of the exterior brick wall.

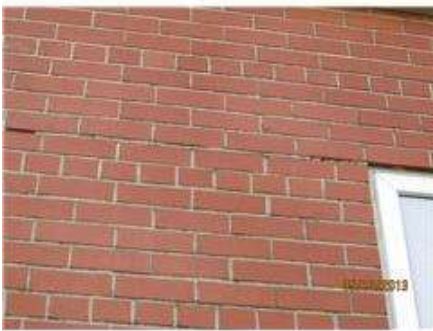
May 2013- Deteriorating Mortar on the surface of the brick wall.

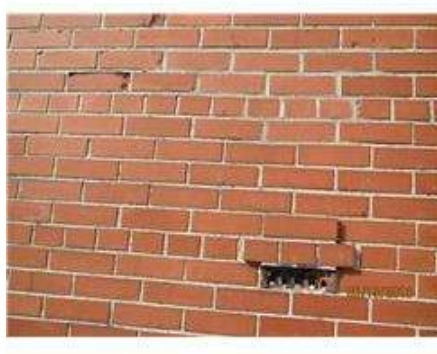
May 2013- Spalling exterior bricks.

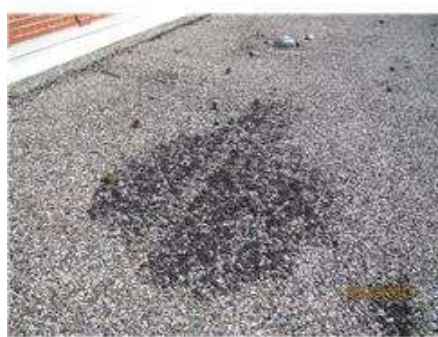
2013 - The built up roof covering of section 503 is showing signs of displaced ballast and blueberries. Replacement planning of the roof is recommended.

May 2013- Blueberries on roof covering of section 503.

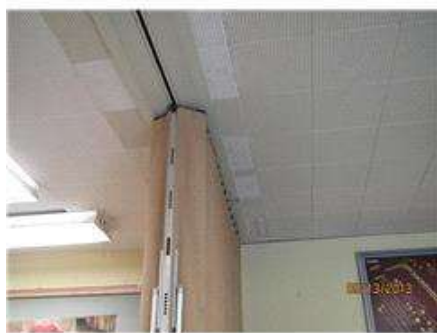
May 2013- Movable partition in music room 1141.

Recommendation 2013 - The moveable partition in the music room 1141 has surpassed its expected useful life. Replacement recommended.

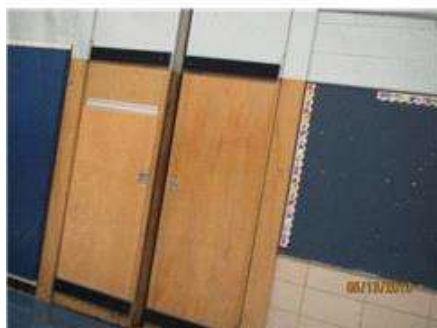
2013 - The moveable partition in the gymnasium has surpassed its expected useful life. Replacement is recommended.

May 2103- Movable partition in the Gymnasium.

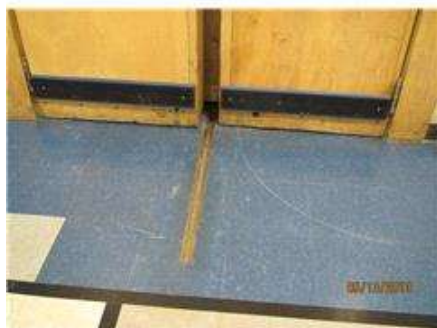
May 2103- Worn movable partition in the Gymnasium.

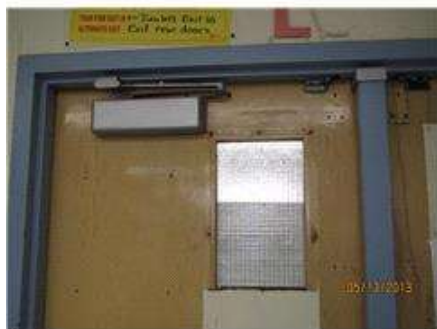
2013 - The interior doors have exceeded their effective design rated life with the majority of the doors exhibiting damage. Replacement of the interior doors is recommended.

May 2013- Damaged interior wood door.

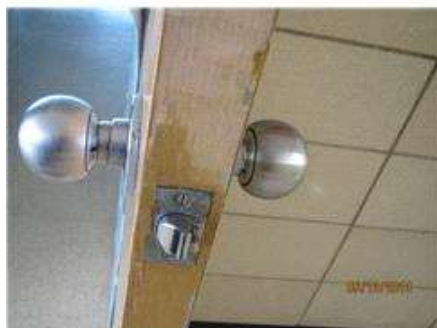
May 2103- Typical interior door hardware.

2013 - Recommend replacing all interior door hardware at the same time the doors are replaced.

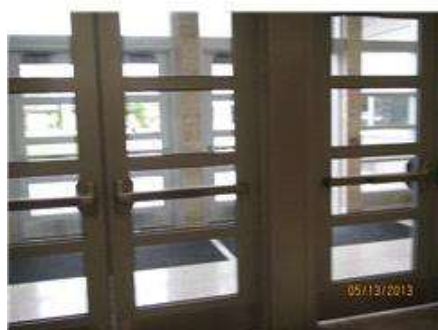
The original interior wood doors jam and do not close poorly. The doors have reached their theoretical service life. Replacement is recommended.

May 2103- Typical interior doors.

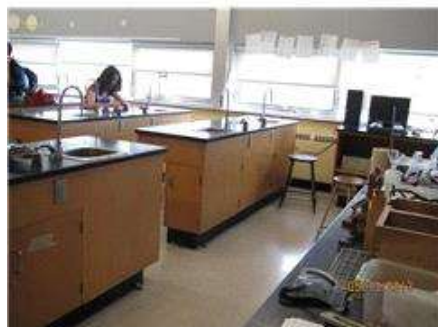
May 2013- Typical millwork fitting in the science classrooms.

2013 - As all the cabinetry, millwork items, counters and countertops have exceeded their expected useful life and are in fair condition the recommendation is to replace them

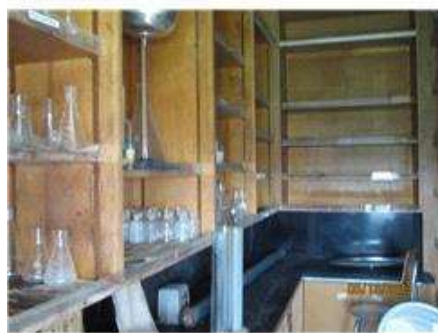
May 2013- Worn millwork fitting in the science classroom.

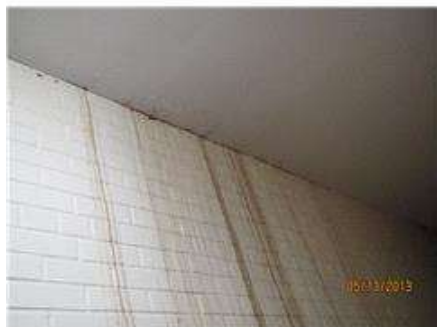
2013 - The painted wall finishes throughout the school are starting to look worn from normal day to day use with some faded and peeling areas and, in isolated area specially in the basement there is signs of water stain. Refinishing of the school is recommended.

May 2013- Stained paint wall covering in the basement.

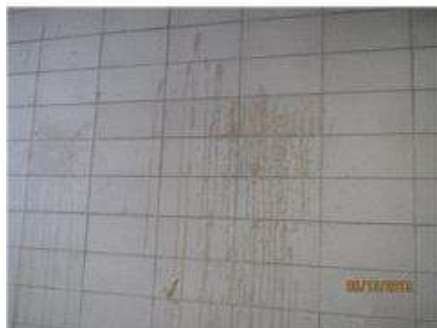
Recommendation 2013 - The glazed wall tiles are stained. Full replacement is warranted.

May 2013- Stained glazed wall covering in the stair case 1150.

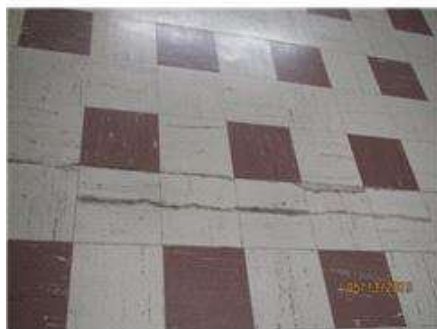
May 2013- Worn and damaged VAT in the science classrooms.

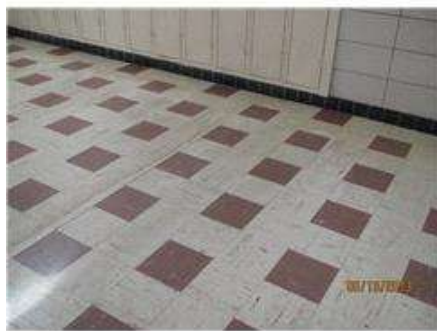
May 2013- Worn VAT floor covering in the corridor of the second floor.

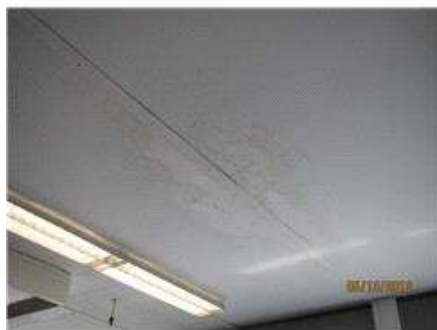
May 2013- Worn gypsum board ceiling.

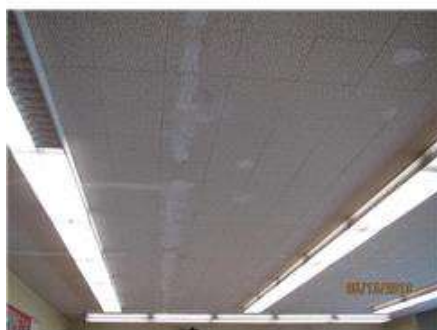
May2013- Won and stained 12"x12" acoustic ceiling tile in the second floor classroom.

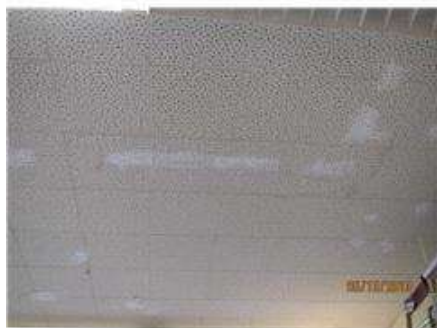
May 2013- Stained 12x12 ceiling tiles.

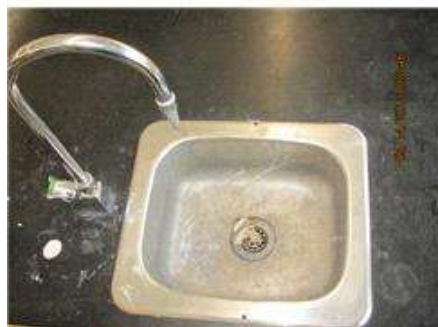
2013 - The science room lab sinks are aged and many are stained and due for replacement.

May 2013 - Science Lab Sinks

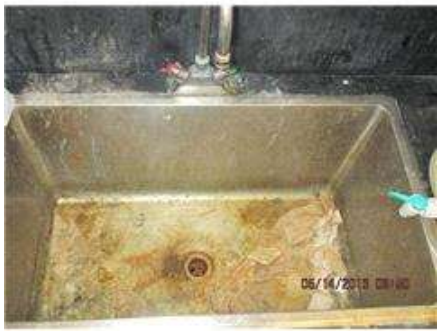
May 2013 - Science Lab Sinks

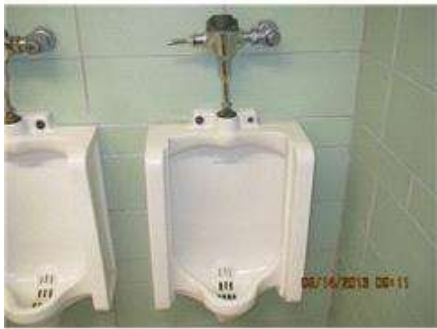
May 2013 - Aged Urinals

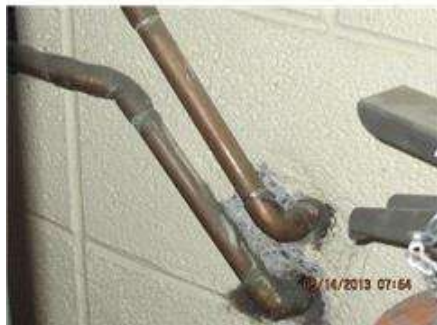
May 2013 - Aged Domestic Water Distribution Piping

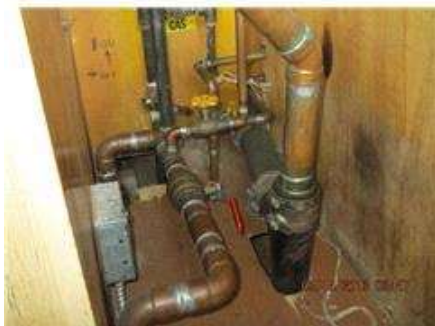
May 2013 - Aged Sanitary Waste Piping

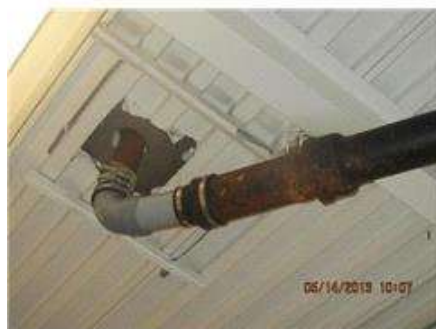
May 2013 - Original Rain Water Drainage Piping

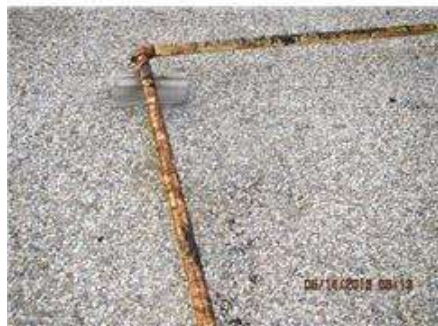
May 2013 - Aged Gas Piping - Roof

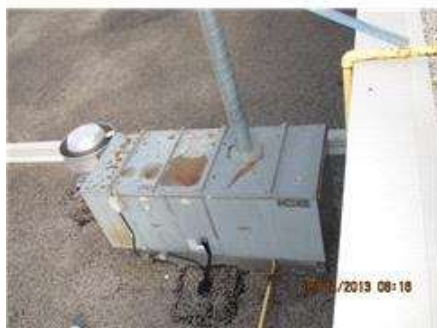
May 2013 - Aged Rooftop Make-Up Air Handler - Minor Corrosion

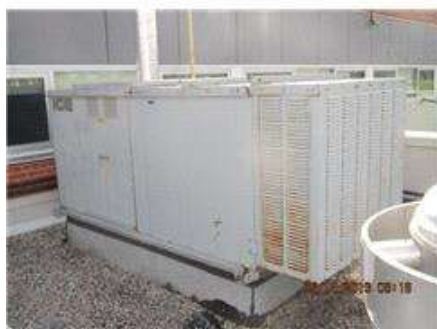
May 2013 - Aged Rooftop Make-Up Air Handler - Minor Corrosion

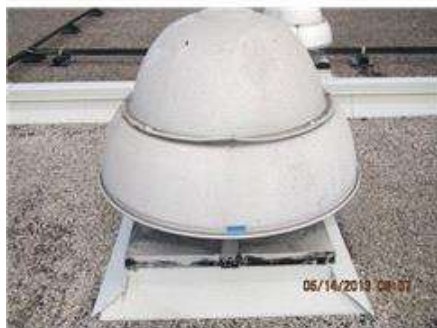
May 2013 - Typical Aged Rooftop Exhaust Fan

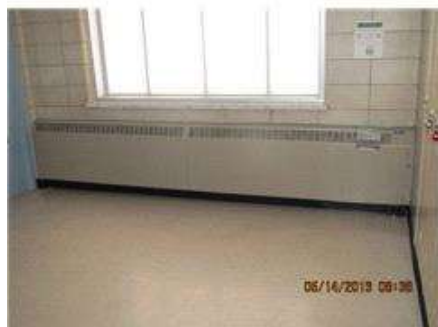
May 2013 - Original Fin Tube Radiators

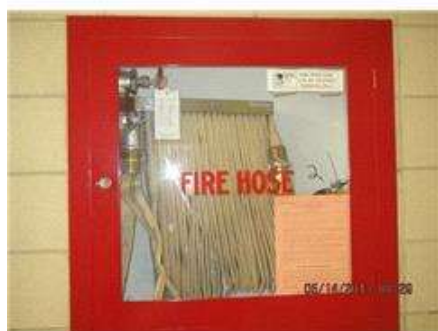
May 2013 - Original Standpipe System

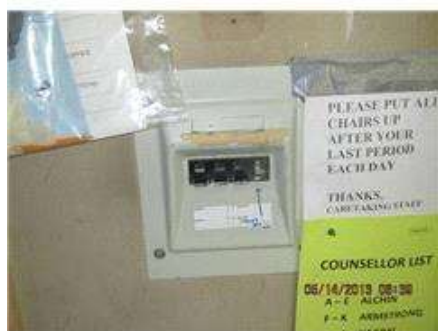
May 2013 - Typical Classroom Breaker Panel

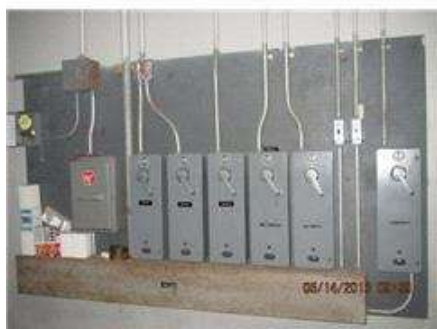
May 2013 - Original Branch Wiring

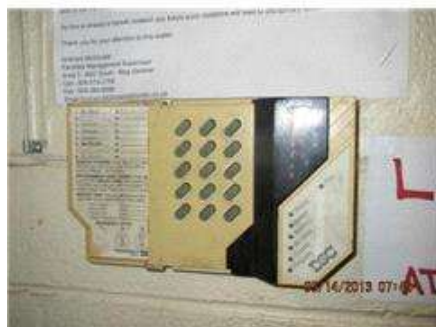
May 2013 - Aged Security System - Keypad

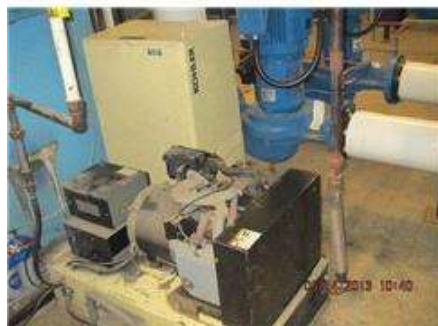
May 2013 - Emergency Lighting & Power - Emergency Generator

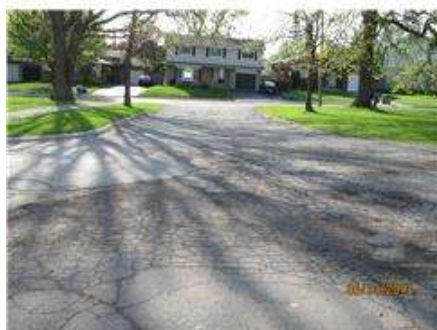
May 2013- Evidence of alligator cracking on surface of the roadway.

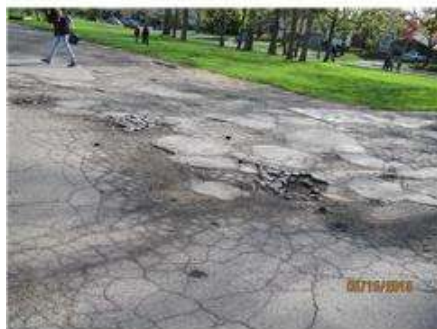
May 2013- Cracked and damaged roadway.

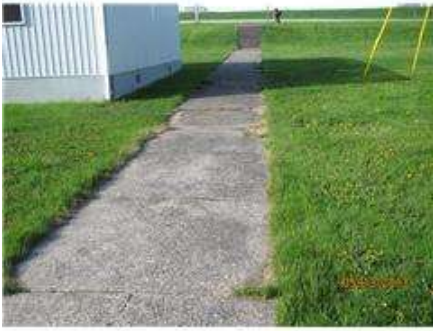
May 2013- Asphalt paved pedestrian on north side of the building.

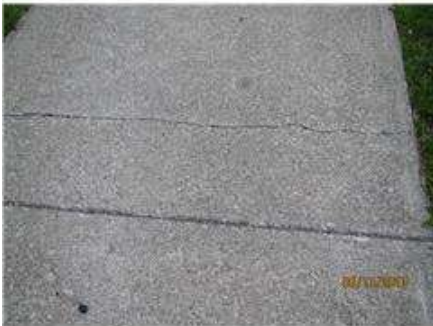
May 2013- Cracked concrete paved pedestrian.
