Mary Hopkins Elementary School HVAC and Ceiling Replacement

Designated Substance Audit Report

March 17, 2023

MTE File No.: 53042-100

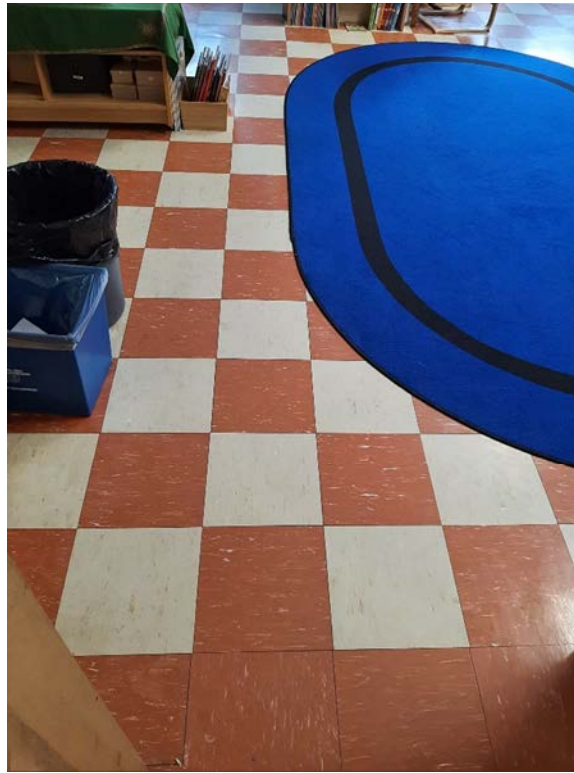
Photograph No. 1 – The Vinyl Floor tile in classrooms 218 and 215 is asbestos-containing. The associated mastic is non-asbestos.

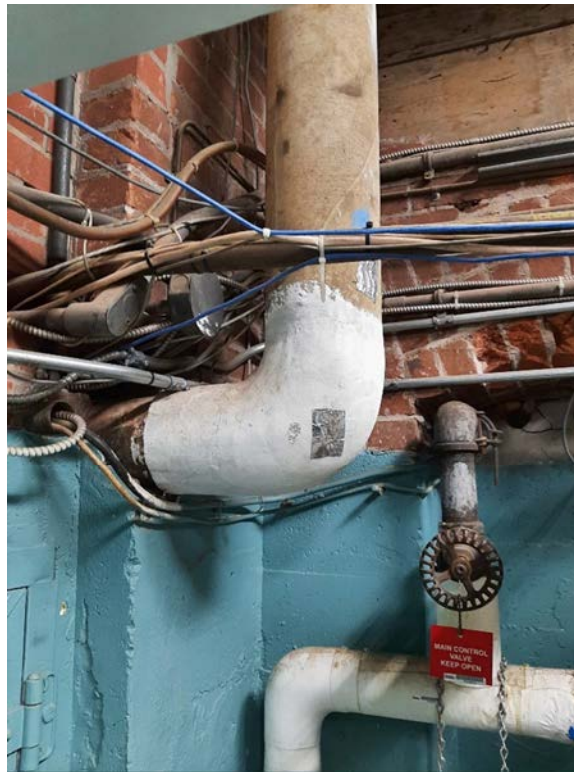
Photograph No. 2 – Aircell pipe insulation on pipe straights throughout the boiler room and adjacent mechanical rooms is asbestos-containing. The parging on pipe fittings is also asbestos-containing.

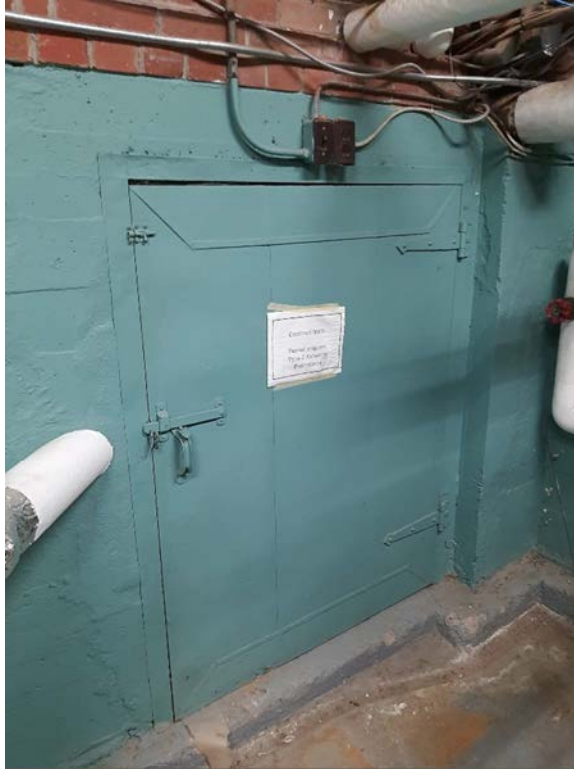
Photograph No. 3 – Fire doors were observed in the boiler room and are suspected to contain asbestos insulation.

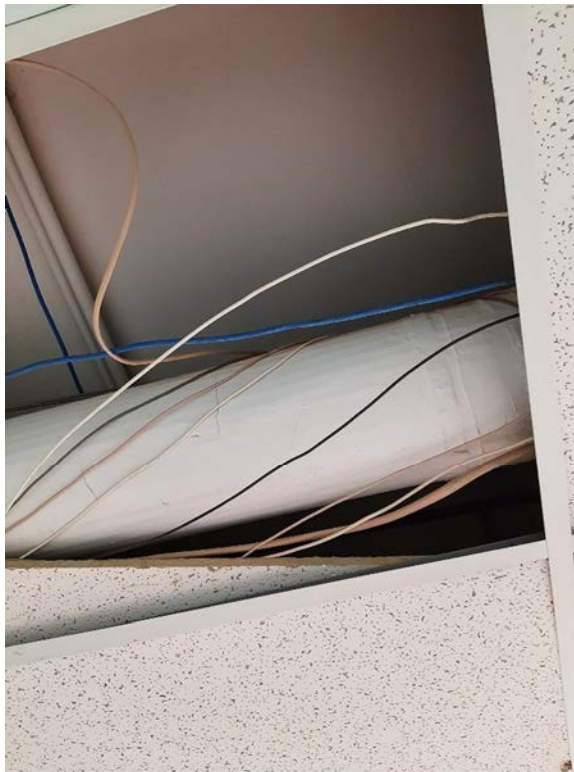
Photograph No. 4 – Asbestos-containing aircell pipe insulation was observed on pipe straights in the basement above ceilings throughout. Associated parging on pipe fittings also contains asbestos.

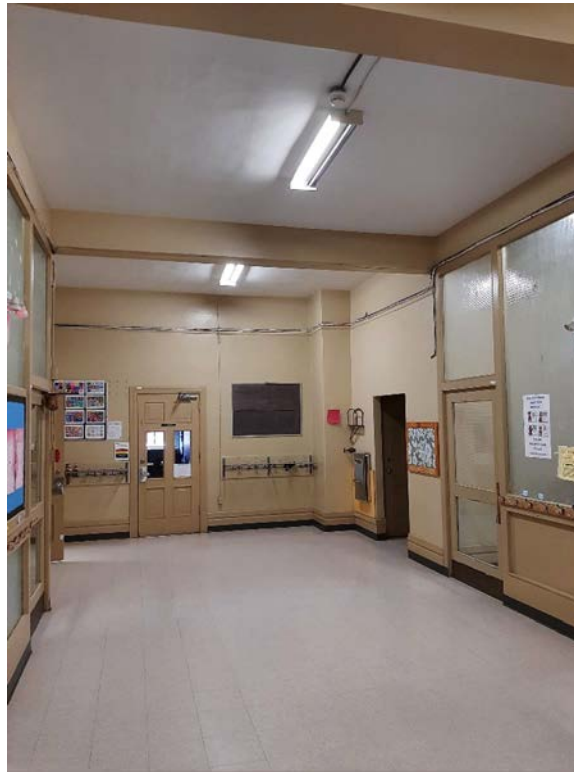
Photograph No. 5 – The beige paint on interior walls is lead-containing.

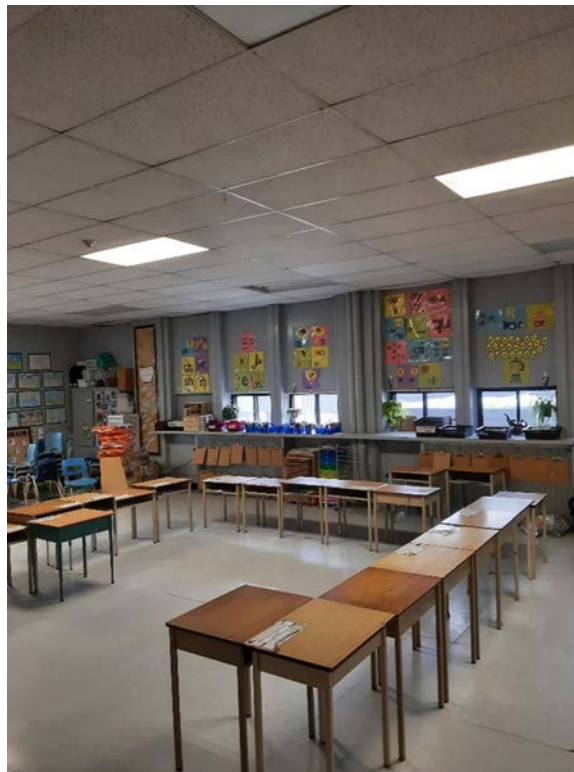
Photograph No. 6 – The grey paint on walls in classrooms is lead-containing.

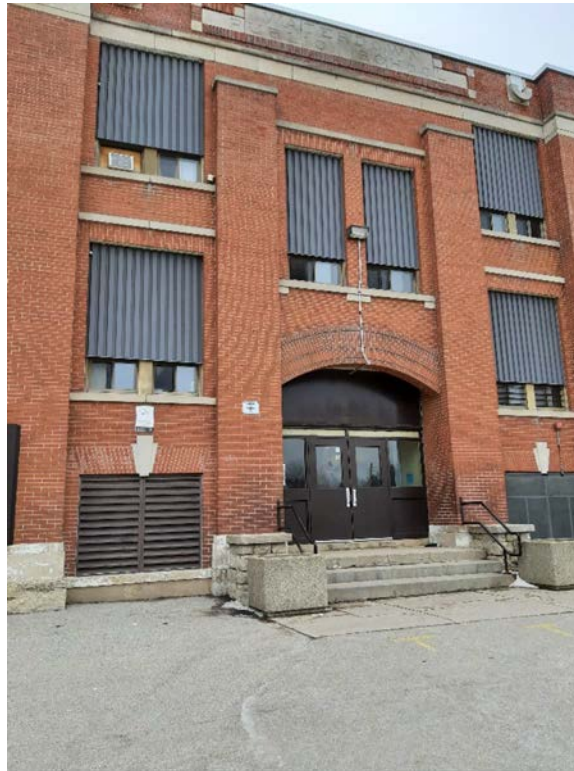
Photograph No. 7– The white paint on the foundation is lead-based. The brown paint on exterior doors and windows is Lead-based. The exterior brick mortar was sampled and does not contain asbestos.

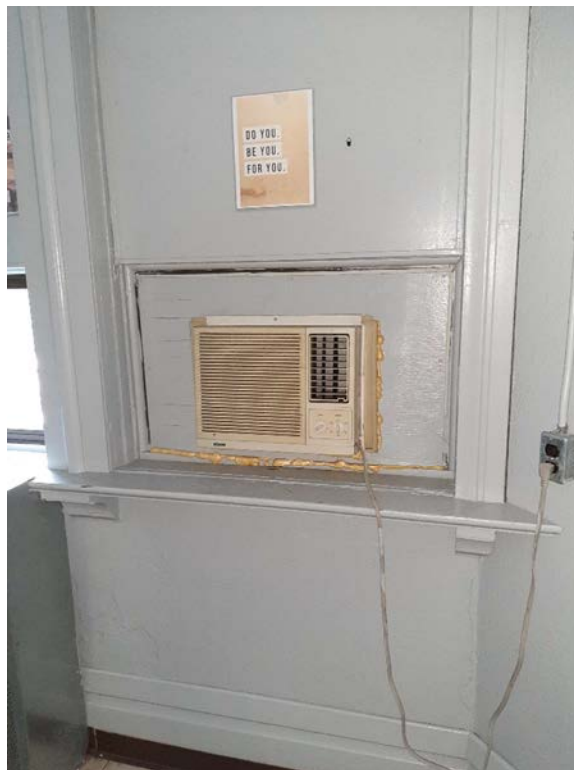
Photograph No. 8 – Window mounted air conditioning units were found throughout the building in classrooms and are suspected to contain ozone depleting substances.

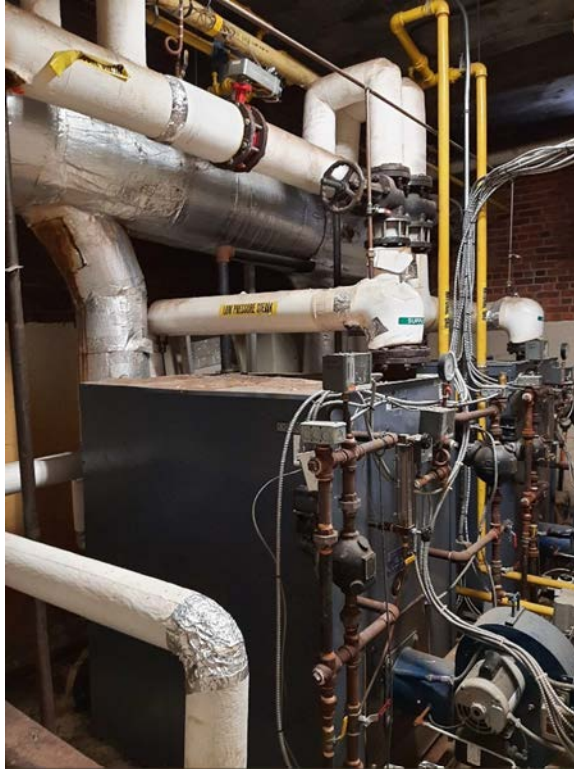
Photograph No. 9– The boiler is suspected to contain asbestos components such as gaskets.

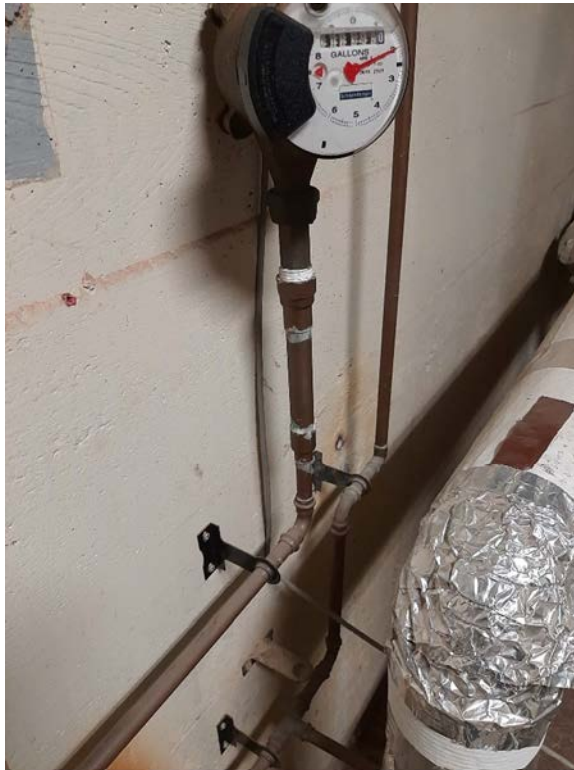
Photograph No. 10– Suspect lead solder on copper piping was observed in the boiler room.

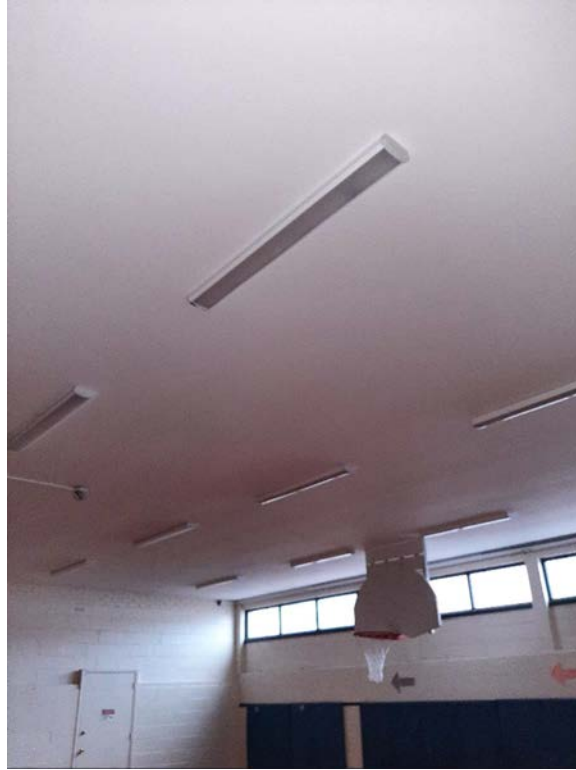
Photograph No. 10– The drywall ceiling in the Gymnasium does not contain asbestos.

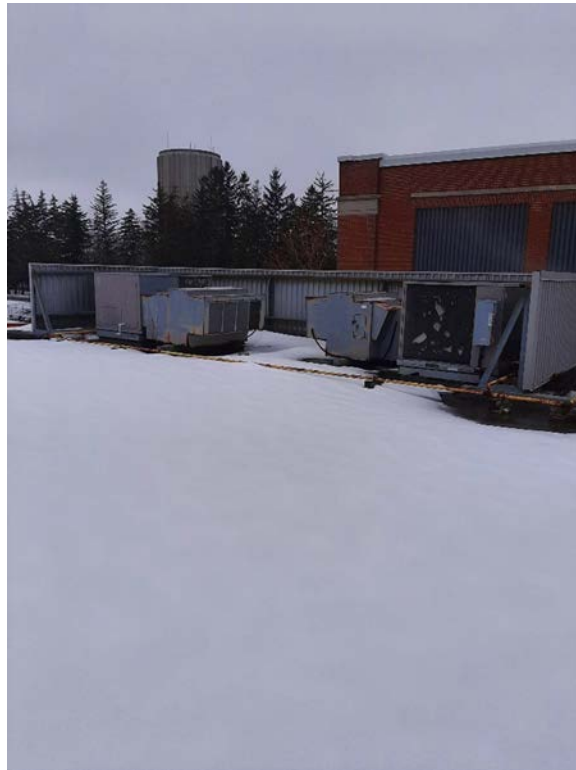
Photograph No. 11– Roof mounted air handling units were observed and are suspected to contain ozone depleting substances.

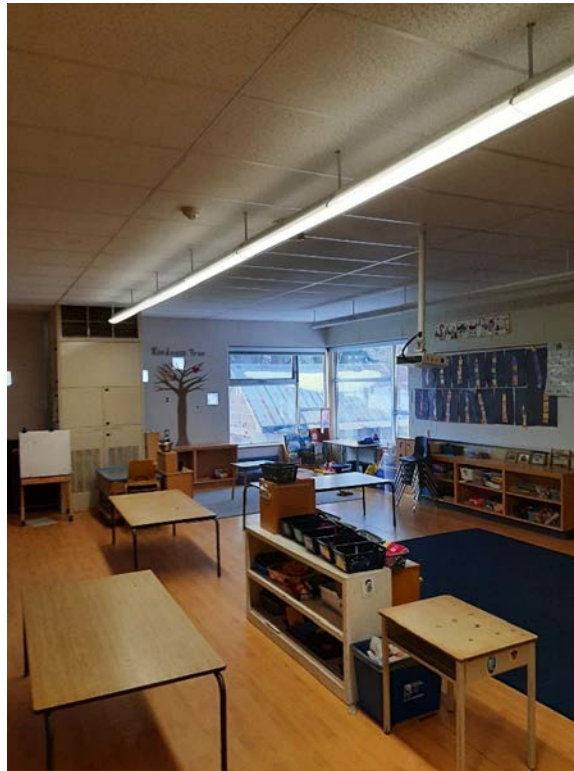
Photograph No. 12– Mercury contain fluorescent light tubes were observed throughout the interior. Associated light ballasts could not be de-energized and accessed; therefore, they are suspected to contain PCBs.

Mercury-containing materials were identified. All mercury containing materials or sources should be removed, intact, prior to any work which may disturb or damage them and cause worker exposure to mercury liquid and/or vapour.

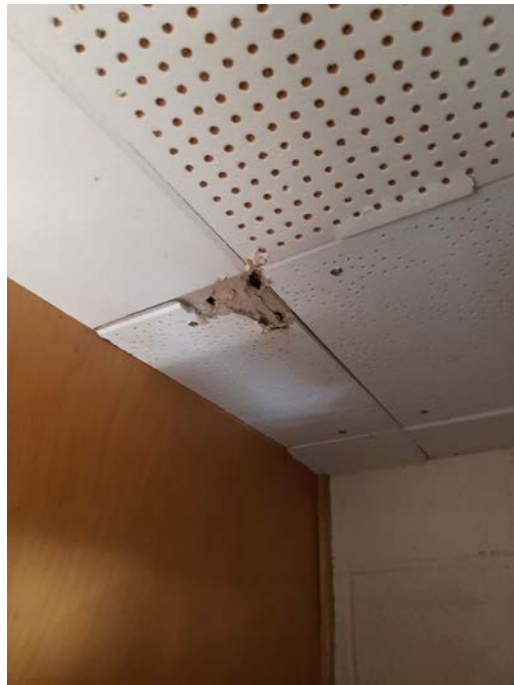
Photograph No. 14– 1'x1' small pinhole and large pinole ceiling tiles above the drop ceiling in Room 205 were sampled and do not contain asbestos. These same tiles are present at various locations throughout the ground floor.

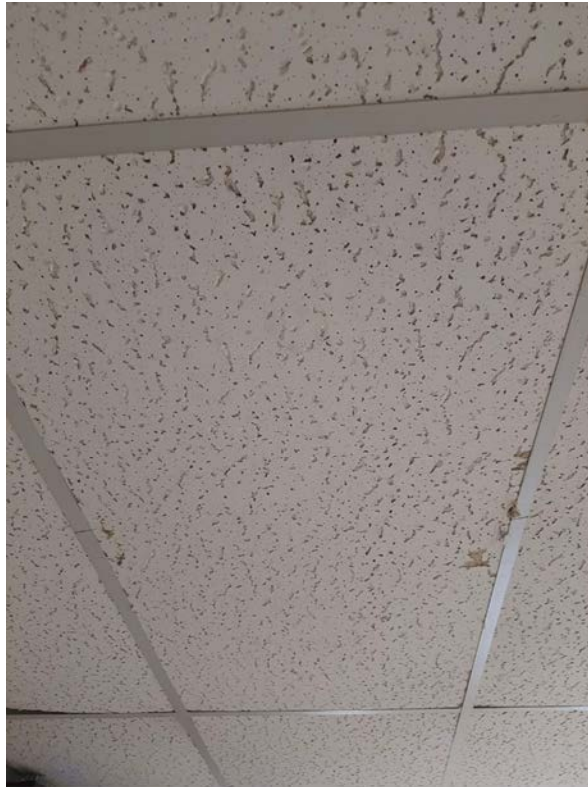
Photograph No. 13– 2'x4' medium fissure random pinhole ceiling tile was sampled in room 205 and does not contain asbestos.

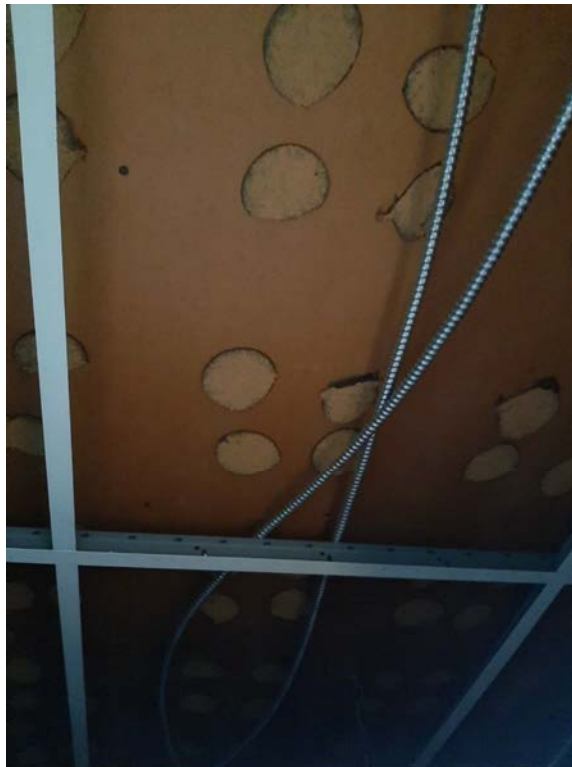
Photograph No. 15– Mastic was sampled above the drop ceiling in room 215 and does not contain asbestos.

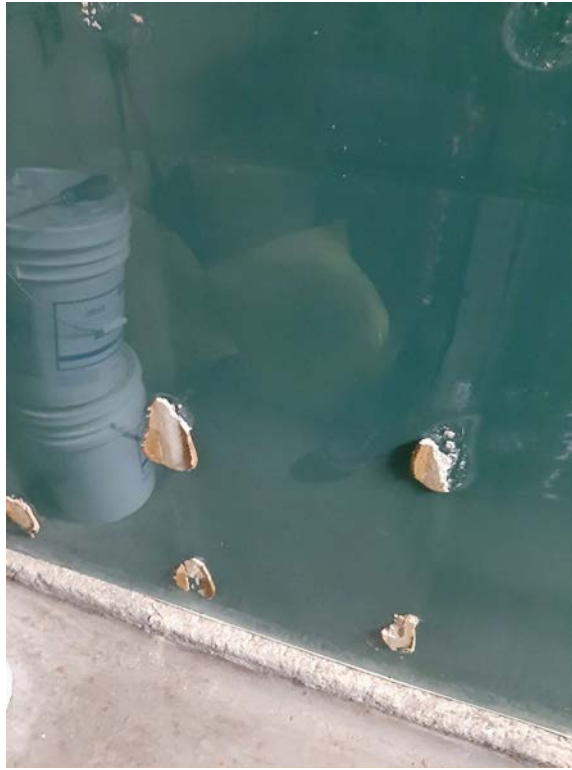
Photograph No. 16– The mastic behind the classroom chalkboards was sampled and is asbestos-containing.
