HAMILTON-WENTWORTH DISTRICT SCHOOL BOARD
FEASIBILITY STUDY and CONCEPT DESIGN

Westdale Secondary School
700 Main St. W, Hamilton, ON

November 2015

Westdale, Building ID 9158-1

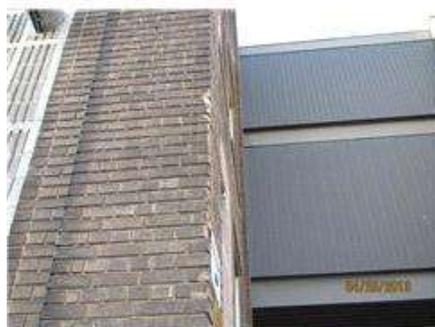
Apr 2013- Spalling brick on the north facade on the building.

Recommendation 2013 - The exterior brick veneer walls are showing signs of deterioration on all facades of the building. Repointing and brick replacement is necessary as to maintain the integrity of the building envelope.

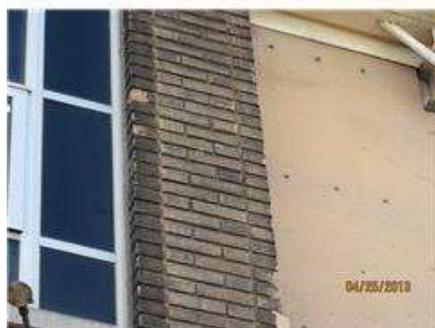
Apr 2013- Spalling bricks on the facade.

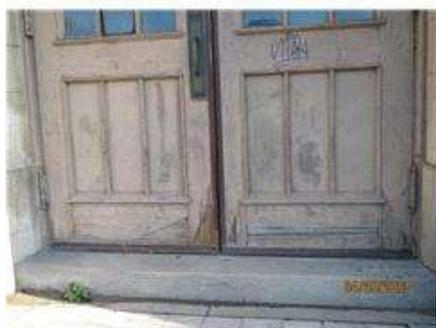
Apr 2013-Damaged exterior door.

Recommendation 2013 - The majority of the exterior door assemblies are original and have exceeded their effective design rated life. Replacement of the door assemblies is recommended.

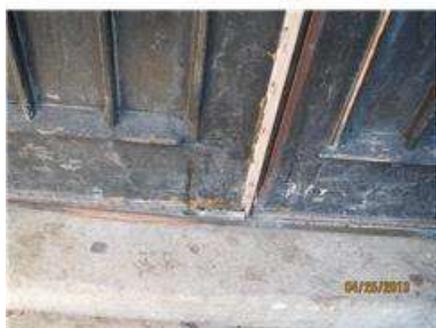
Apr 2013- Deteriorated exterior door.

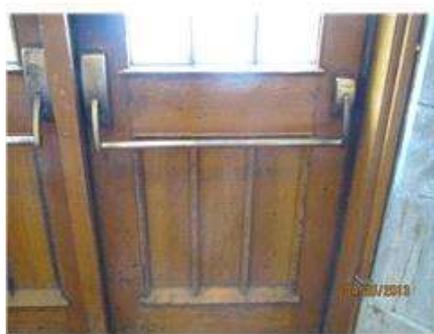
Apr 2013- Worn exterior door push bar.

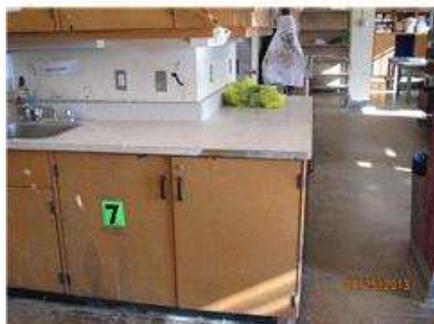
Apr 2013- Damaged/stained millwork fitting.

Recommendation 2013 - Recommend that the original millwork and cabinetry be replaced as soon as possible

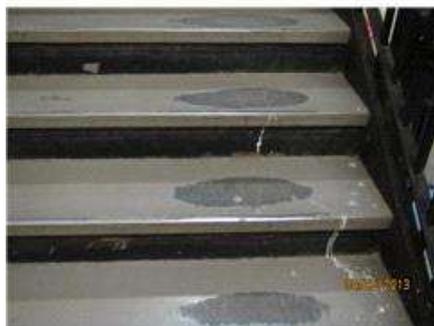
Apr 2013- Worn interior stairs finishes.

Recommendation 2013 - Replacement of initial flight of the interior stairs including the rubber covering is recommended

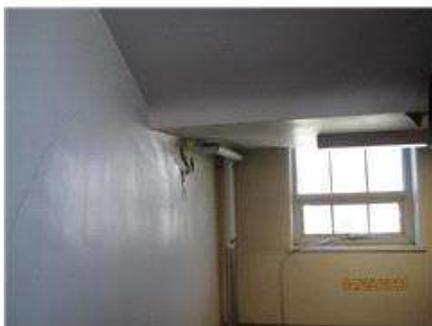
Apr 2013- Damaged wall covering.

Recommendation 2013 - The painted wall finishes throughout the school are starting to look worn from normal day to day use with some faded and peeling areas. Refinishing of the school is recommended.

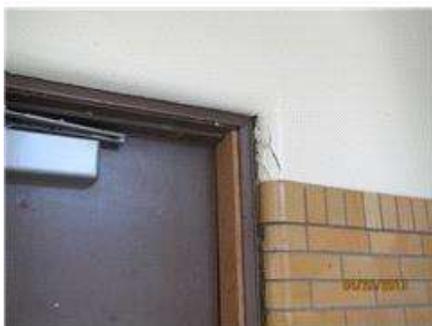
Apr 2013- Peeling paint wall covering.

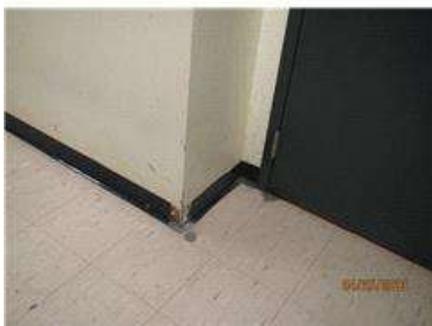
Apr 2013- Worn/stained wall covering.

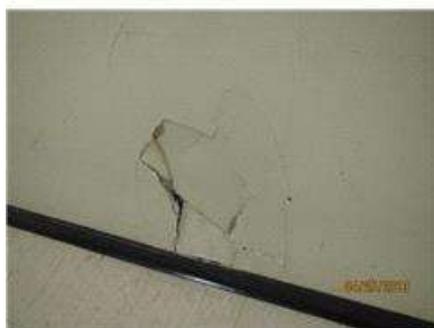
Apr 2013- Damaged wall covering.

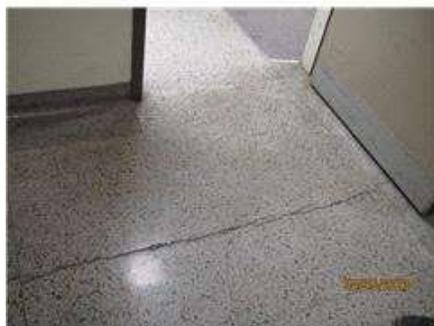
Apr 2013- Cracked Terrazzo flooring in the corridor.

Recommendation 2013 - Settlement and expansion cracks are evident from the original construction. Repairs of the cracking is recommended for aesthetic reasons.

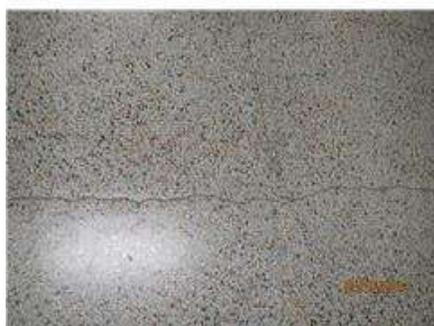
Apr 2013- Cracked Terrazzo flooring.

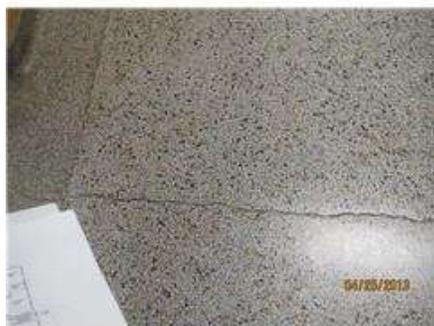
Apr 2013- Cracked Terrazzo flooring.

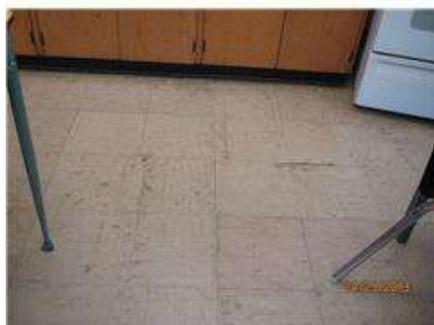
Apr 2013- Worn VCT in the Family Classroom.

2013 - The Vinyl Composite floor finish has exceeded its effective design rated life. Replacement of the Vinyl Composite floor finish is recommended as to update the appearance and mitigate any potential health concerns.

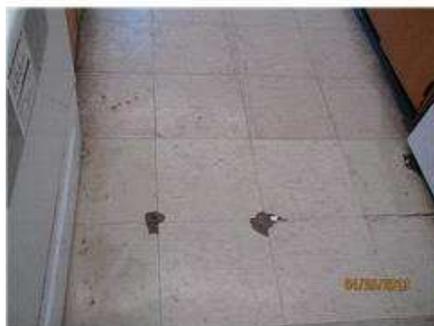
Apr 2013- Damaged VCT.

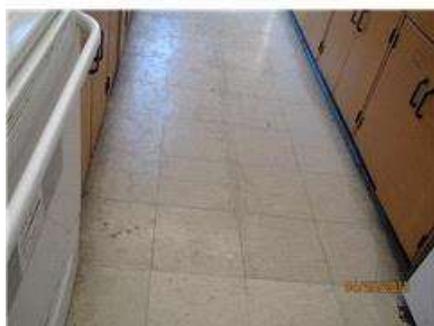
Apr 2013- Worn VCT floor covering.

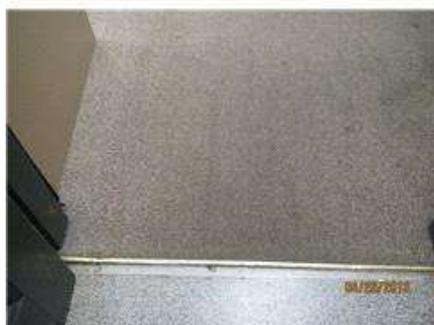
Apr 2013- Worn carpet floor covering in the Library.

2013 - Replacement is recommended based on the observed condition.

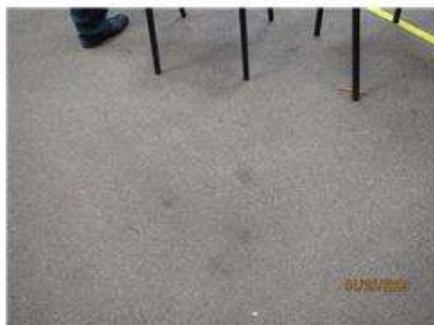
Apr 2013- Stained Carpet in the Library.

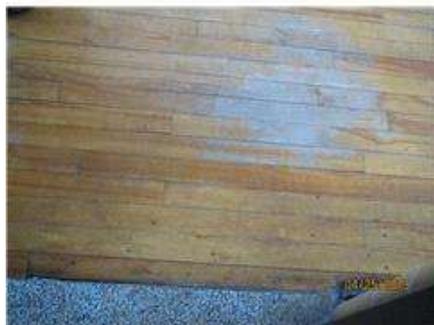
Apr 2013- Worn Hard wood floor covering in the GYM.

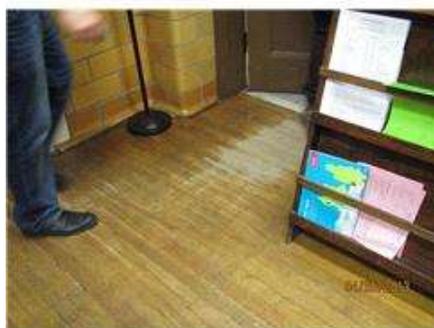
Apr 2013- Worn Hard wood floor covering in the office area.

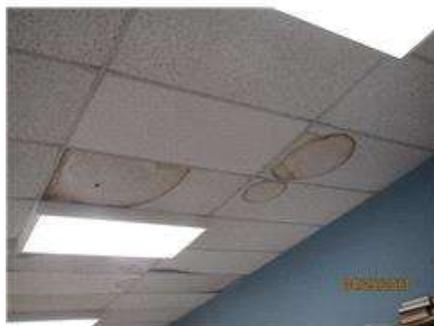
Apr 2013- Stained ACT.

Recommendation 2013 - The acoustical suspended ceiling tile system is showing signs of wear. Replacement is recommended.

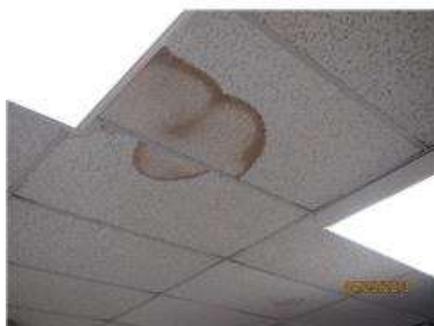
Apr 2013- Stained ACT.

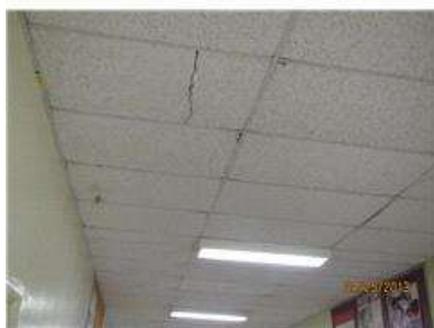
Apr 2013- Broken ACT.

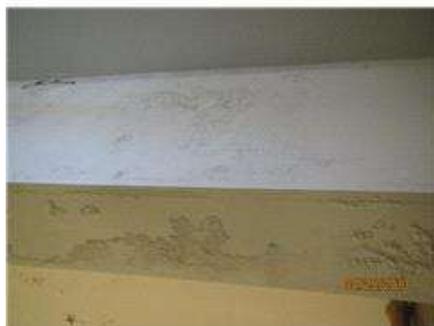
Apr 2013- Water damaged Exposed ceiling in the Gym.

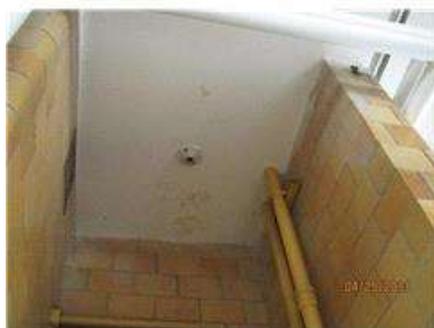
Apr 2013- Peeling paint Gypsum board ceiling.

Recommendation 2013 - Gypsum board ceilings are original and have passed there EUL and should be replaced

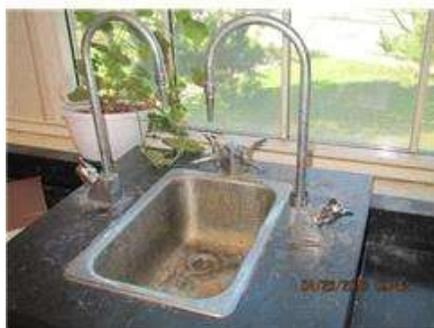
April 2013 - Aged and Worn Science Lab Sinks

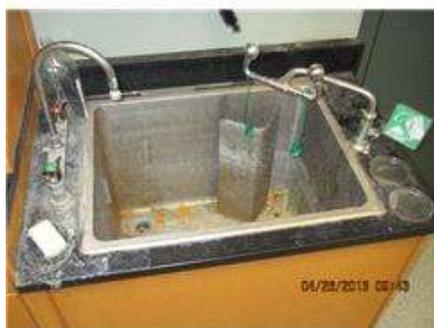
April 2013 - Aged and Worn Science Lab Sinks

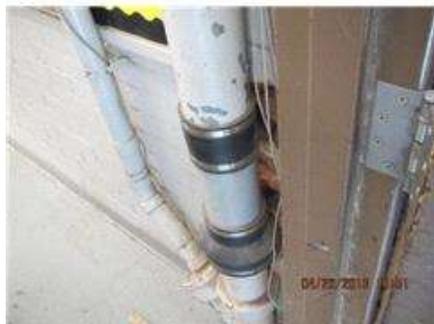
April 2013 - Aged Rain Drainage Piping

Recommendation 2013 - Planned replacement of the rain water drainage system is recommended based on age and condition.

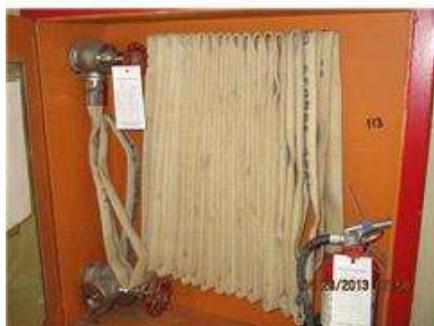
April 2013 - Aged Standpipe

Recommendation 2013 - Replacement of the standpipe system is recommended based on the age and theoretical useful life of the system. Planning for renewal is recommended to maintain functionality during and emergency.

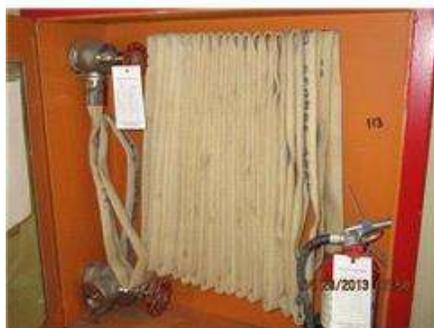
April 2013 - Aged Standpipe Fire Hose

2013 - Replacement of the aged and worn standpipe fire hoses is recommended to ensure reliability.

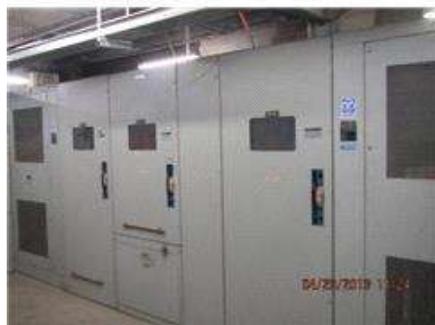
April 2013 - Aged Main Switchboards

2013 - Replacement of the aged switchboards and other assemblies including aged distribution panels, breaker, fuses and meters of the building is recommended.

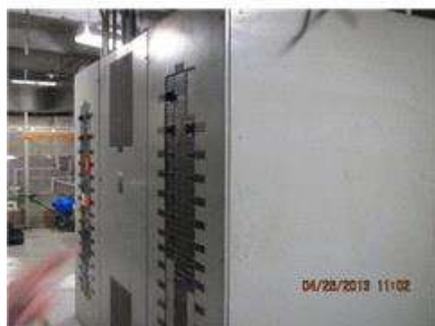
April 2013 - Aged Secondary Switchgear

2013 - Planned replacement of the secondary switchgear is recommended within the next 5 years.

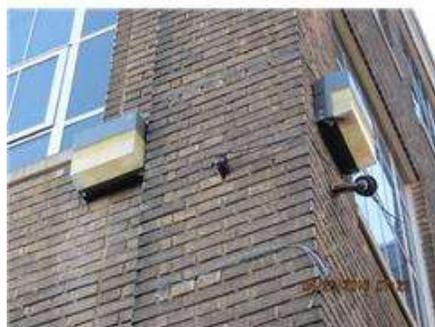
April 2013 - Typical Aged and Stained Wall Mounted Lighting Fixtures

2013 - The exterior lighting fixtures are original and appear to be functional at this time, but have surpassed their anticipated service life. Replacement of existing aged lamps and fixtures with higher efficiency lamps and fixtures is recommended.

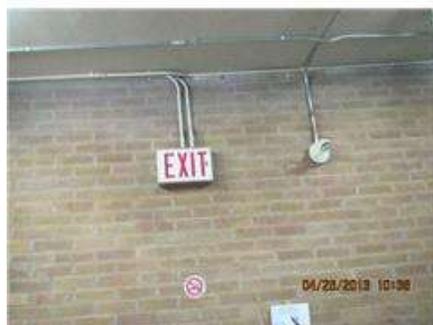
April 2013 - Aged Emergency Lighting Fixture

2013 - Replacement of existing aged emergency lighting lamps and fixtures with higher efficiency lamps and batteries is recommended.

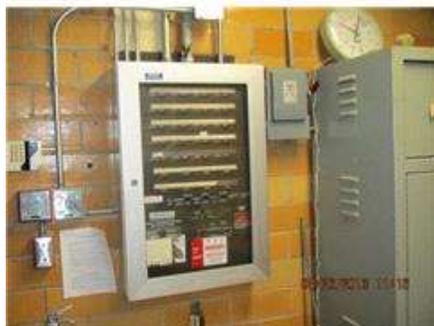
April 2013 - Aged Fire Alarm Control Panel

Recommendation 2013 - Replacement of the existing system with a new addressable fire alarm system, provided with control panel, smoke detectors, pull stations, horn/strobes and associated equipment should be planned within the next 3 years.

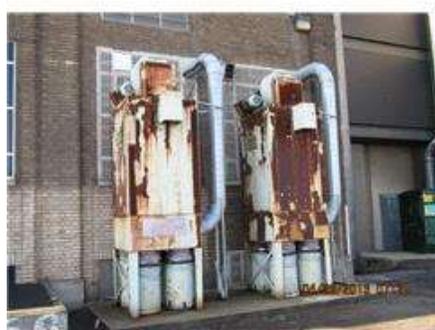
April 2013 - Aged and Extremely Rusted Dust Collectors

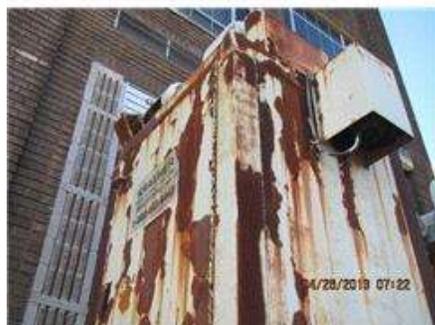
April 2013 - Aged and Extremely Rusted Dust Collectors

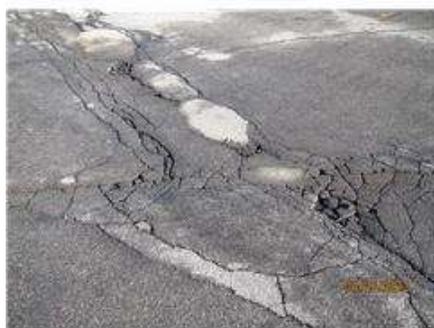
Apr 2013- Evidenc of pothole and, alligator cracking.

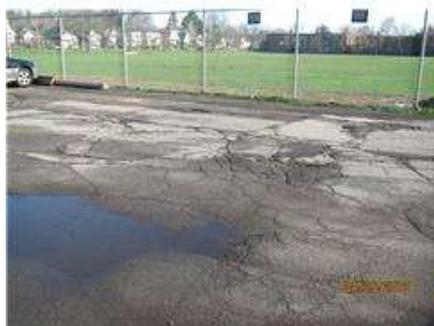
Apr 2013- Evidence of water ponding and, alligator cracking.

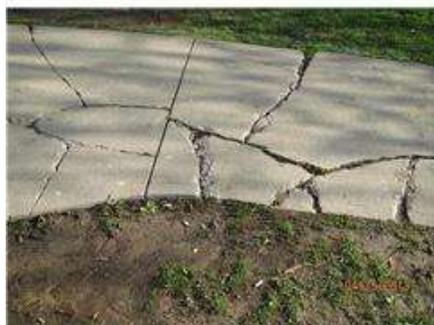
Apr 2013- Cracked Concrete pedestrian

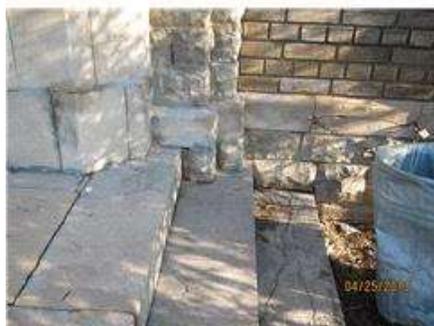
Apr 2013- Deteriorating cast in place concrete stairs.

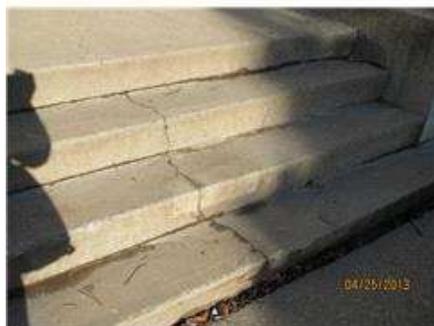
Apr 2013- Cracked Concrete stairs.

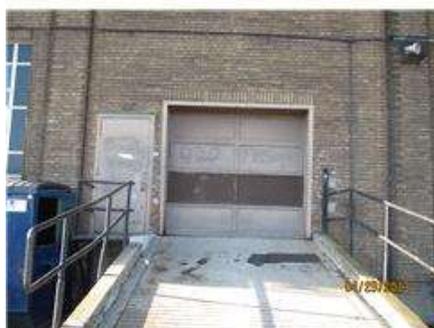
Apr 2013- Deteriorating Concrete Ramp on the north side of the building.

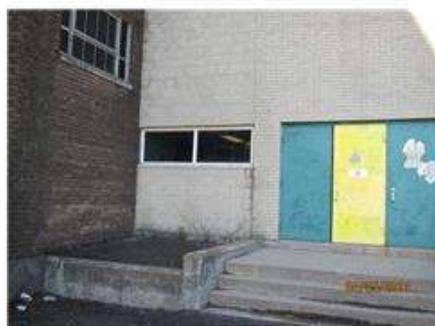
Apr 2013- deteriorating Concrete retaining wall.

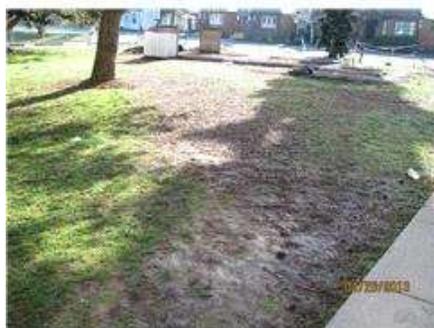
Apr 2013- Water damaged landscaping on the south side.
