HAMILTON WENTWORTH DISTRICT SCHOOL BOARD
FEASIBILITY STUDY AND CONCEPT DESIGN

SALTFLEET DISTRICT HIGH SCHOOL
108 Highland Rd. West, Stoney Creek, ON

MAY 10, 2016

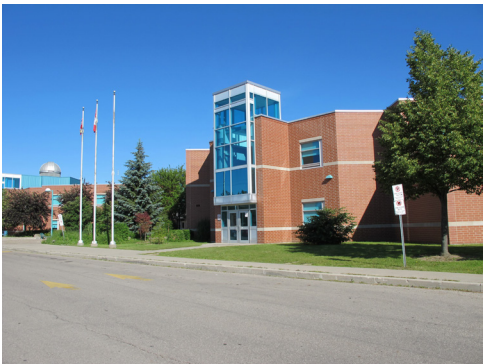
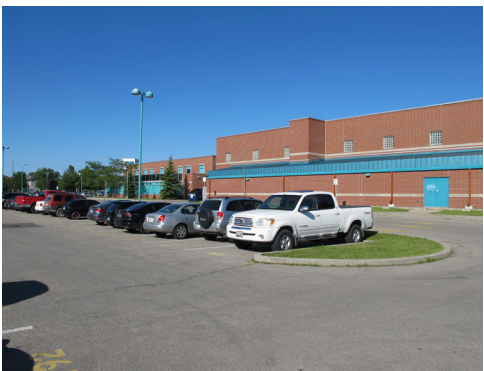
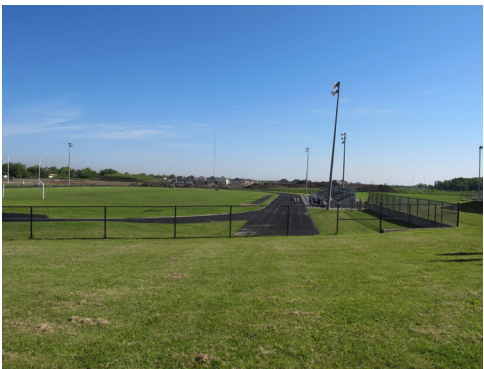
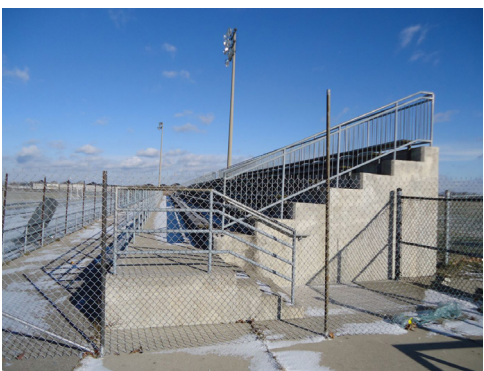
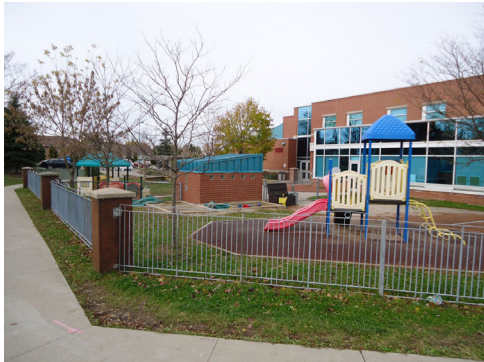
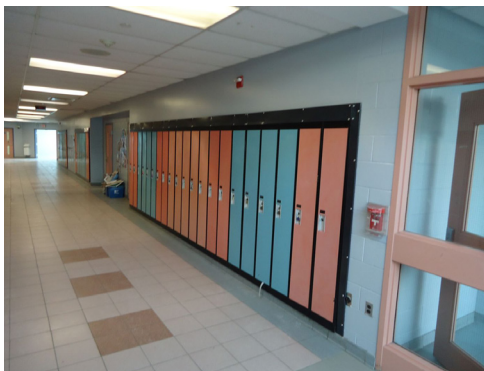
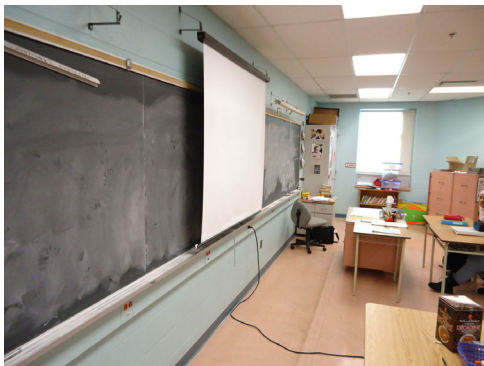
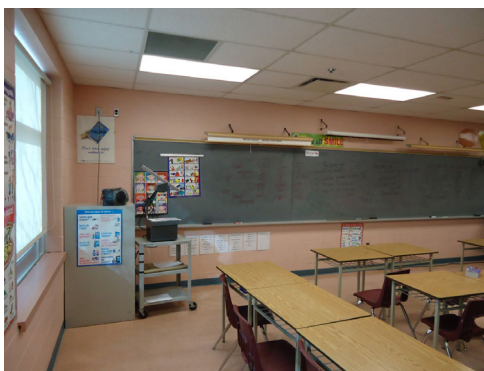
- exterior walls: brick veneer finished assembly
- roof: EPDM roof covering assembly - aged and in fair condition
- interior finishes:
 - floors: terrazzo, mainly ceramic tiles and, vinyl composite tiles, hard wood flooring and carpet – carpet, hardwood and VCT are aged and in fair condition

- walls: painted masonry, plaster and gypsum are aged and are in fair condition. The moveable folding partition and the gypsum walls – aged and in fair condition

- ceilings: acoustic ceiling tiles and gypsum board ceilings– aged and in fair condition
 - millwork: wood cabinetry with plastic laminate countertops – aged and in fair condition

- washroom partitions:
 - lockers:
 - interior doors / hardware: HM with paint finish, wood natural, painted or with plastic laminate finish, often with partial vision panel are aged and in fair condition

- interior stairs: steel with rubber treads – replace first flight of stairs and all tread coverings
