HAMILTON - WENTWORTH DISTRICT SCHOOL BOARD  
CONCEPT DESIGN AND FEASIBILITY STUDY

**GLENDALE SECONDARY SCHOOL**

145 RAINBOW DRIVE, HAMILTON

Grguric Architects Incorporated  
Glendale SS Facility Conditions Assessment Report  
June 26, 2015

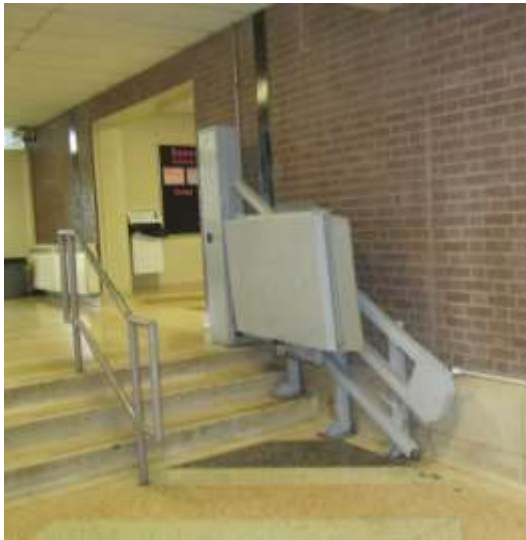
Photo 1.0.A – Corridor 1047

On the ground floor level the east wing Corridor 1047 and Vestibule 1046 each have stair transitions of four and three risers, respectively. Accessibility is provided at these stairs by means of a wall mounted stair lift system (Photo 1.0.A). The south access doors from Vestibule 1046 has an asphalt ramp to the doors providing some means of accessibility at this location (Photo 1.0.B). This building has one barrier free accessible entrance at the main entrance, complete with concrete ramp and automatic door operators (Photo 1.0.C). This building has an existing elevator providing accessibility to the entire second floor area (Photo 1.0.D). A single unisex washroom located each on the ground and second levels are the only available barrier free washroom facilities. There are no barrier free provisions in the existing change rooms or showers.

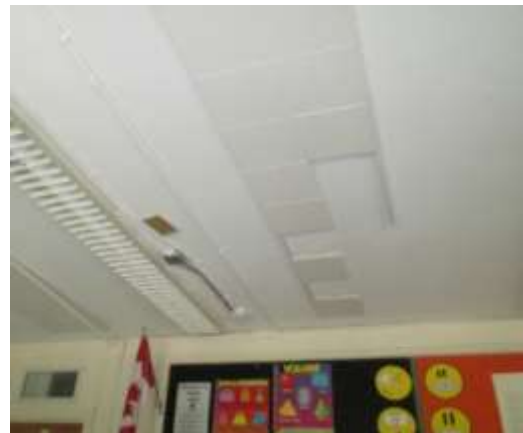
Photo 2.2.B – Classroom 2078 (Room 201)

The corridors throughout the facility have acoustic ceiling tiles and they were generally found to be in good and serviceable condition. There are examples of water damage and broken or chipped edges (Photo 2.2.A). The T-bar grids in the facility are original and exhibit signs of surface discoloration. Other than the ground floor shop classrooms, the classrooms in the facility are typically finished with a metal lathe and plaster ceiling finish and surface mounted 12x12 perforated acoustic tile arranged in linear panels. In most cases, classrooms were found to have several missing 12x12 tiles (Photo 2.2.B). For the most part these ceiling types remain in good condition requiring paint refinish and some repairs. There are several classrooms along with the stairwell ceilings that are continuously finished in the 12x12 perforated tile surface mounted to the plaster ceiling. Before completing renovation to this ceiling finish the 12x12 tiles should be tested for ACM. Photo 2.2.C below, illustrates a segment of missing expansion joint trim found in the ceiling finish of the Music Classroom 1039. Generally the plaster ceiling finish in the washrooms remain in good condition, however in the Girls Washroom 1019, the plaster ceiling has some areas where the paint finish has sustained moisture related damage and exhibits signs of surface bubbling and finish peeling (Photo 2.2.D).

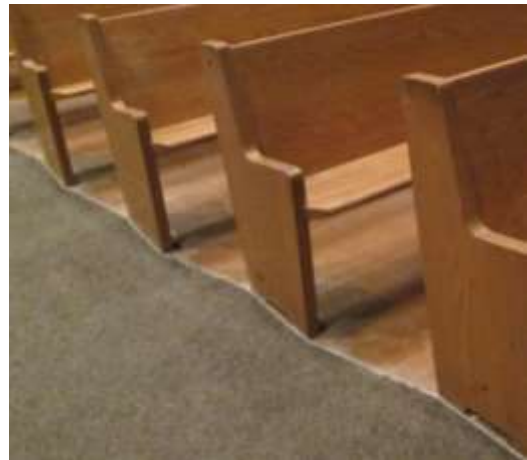
Photo 2.3.B - Auditorium

The existing flooring finishes consist of carpeting along the aisles and resilient sheet flooring over the extent of the bench seating. The existing resilient sheet flooring shows extensive surface wear and staining and the carpeting is in need of replacement (Photos 2.3.B and 2.3.C). The existing stage wood flooring and subbase have been removed and stripped down to the existing concrete slab surface. The installation of a new flooring system would require the concrete surface to be skim coated and levelled to cover over the existing bumpy surface (Photo 2.3.D).

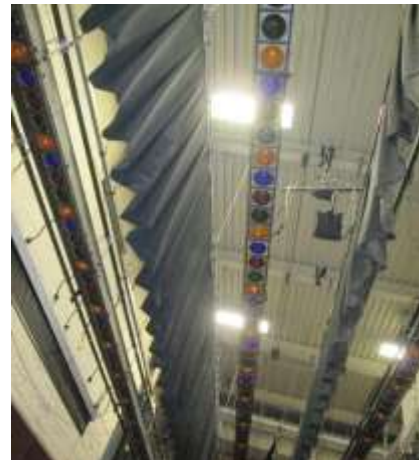
Photo 2.3.F – Auditorium Stage

- Orchestra pit sump pump: the adjacent carpet flooring is still damp from a recent surface flooding. This points to an operational problem with the pump that will need to be addressed (Photo 2.3.E).
- Stage Back Room wood flooring requires refinishing or replacement.
- The existing A/V System should be reviewed for upgrades: example – the older type of stage lighting could be replaced with current and more efficient LED Systems (Photo 2.3.F).
- The 2-piece washroom does not conform to current codes and would need be revised (Photo 2.3.G).
- Oversized doors: the existing steel plate exterior doors are difficult to operate and latch close and offer no insulation value (Photo 2.3.H).

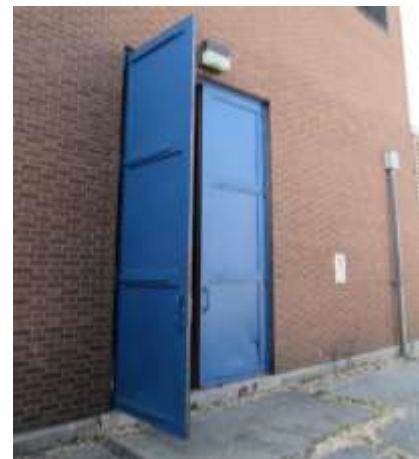
Photo 2.3.H – Auditorium Exterior Doors

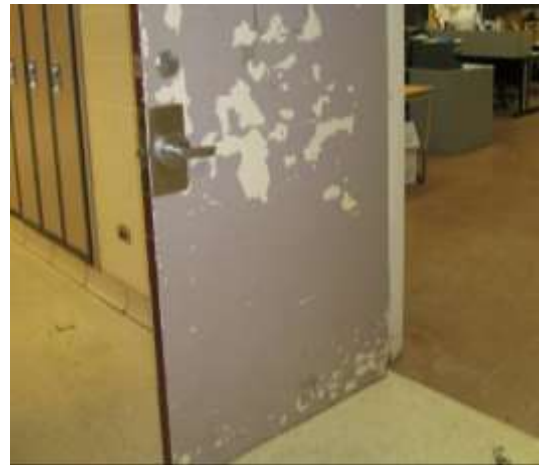
The existing hollow metal doors and frames in the facility are exhibiting signs of surface finish wear and deterioration (Photo 2.4.D). As in this example, some existing hollow metal door frames show signs of extensive moisture related deterioration that will need to be replaced (Photo 2.4.E). The metal doors at this location have a painted wood slat finish on the exterior side (Photo 2.4.F).

Photo 2.4.D – Classroom CO-OP 2039

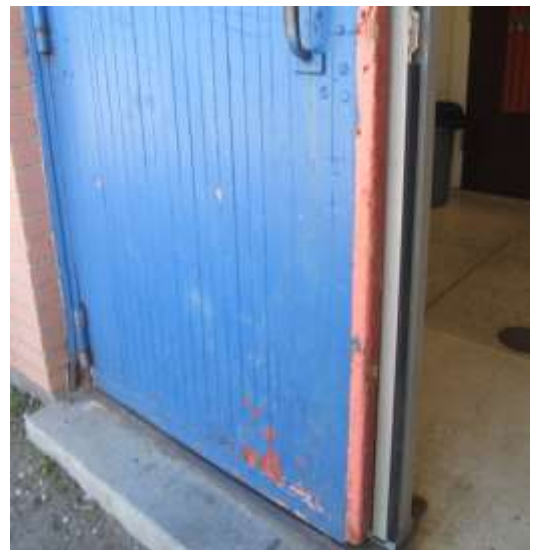
Photo 2.4.F – Vestibule 1046

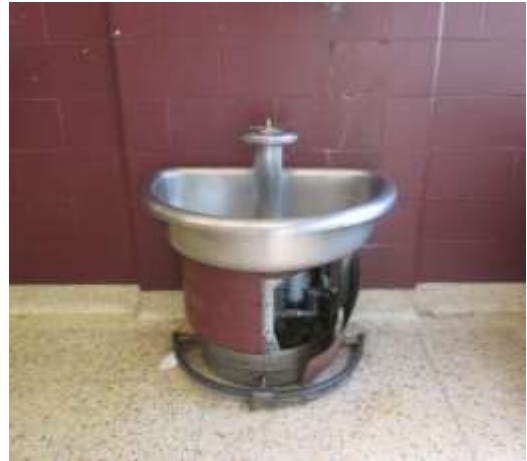
Photo 2.4.H – Boys Washroom 1010

The existing Boys and Girls washroom facilities generally remain in fair to good condition, however, they are equipped with inefficient fixtures and other aging equipment such as the toilet partition and accessories. The tall style urinals in the Boys washrooms sit on a raised curb (Photo 2.4.G). The older style Bradley wash fountains exhibit signs of wear (Photo 2.4.H). These facilities will eventually be in need of upgrading to replace the aging Bradley wash fountains, toilet partitions and plumbing equipment with newer efficient fixtures (Photos 2.4.I and 2.4.J) and given that there are no barrier free access provisions in these existing Boys and Girls washroom groups, these upgrade works can be combined.

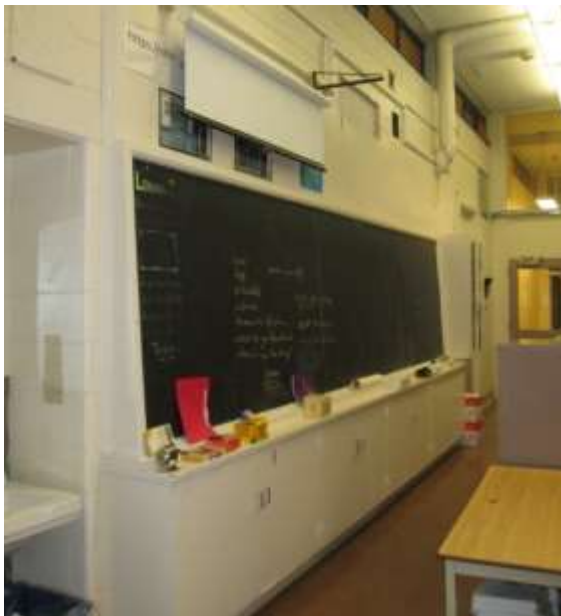
Photo 2.4.K Classroom CO-OP 2039

Millwork: The millwork in the facility remains in fair and ongoing serviceable condition. The typical chalkboard millwork unit located at the front of class, consists of angled chalkboard slabs encased in a wood frame around the perimeter and with integrated cabinets below (Photo 2.4.K). The following are some examples of existing millwork items in advanced state of wear requiring repair or replacement.

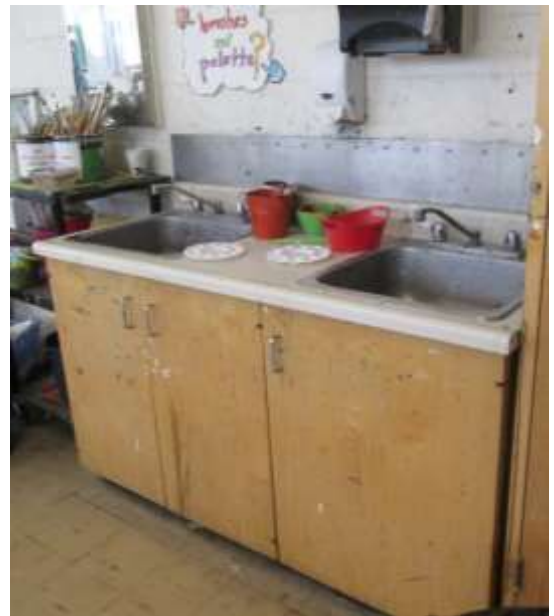
Photo 2.4.L – Art Room 1042 (Room 130)

- Sink counter unit in the Art Room (Photo 2.4.L)
- Boys Change Room wood box construction benches with damaged painted surface finish (Photo 2.4.M).
- Science Lab benches with worn surface finishes and damaged gable ends (Photo 2.4.N)

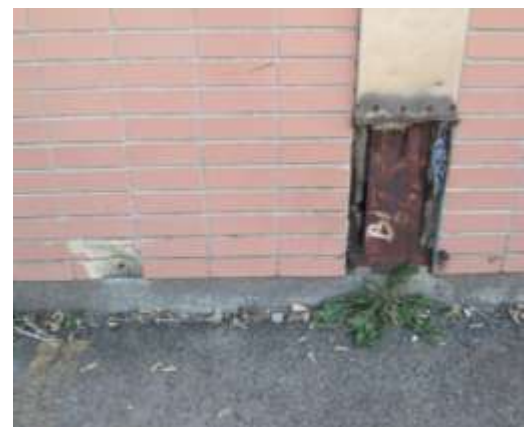
Photo 3.1.B

- Existing glazed tile with extensive surface damage sustained from previous impact. Missing segment of stainless steel cover plate at base of wall exposing steel column to the elements. (Note that column is uninsulated per original design detail (Photo 3.1.B).

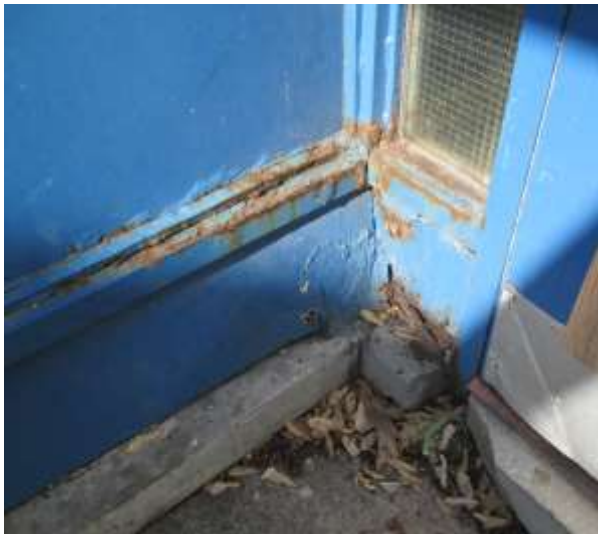
Photo 3.1.C

- The south facing exterior wall along Vestibule (and corridor) 1046 is comprised of a metal pipe frame construction with painted metal spandrel panels and glazed panels. This segment of exterior wall construction is showing signs of rusting along the lower mullion frame and the lower spandrel which is in contact with top of concrete foundation wall and missing a proper base flashing (Photo 3.1.C)

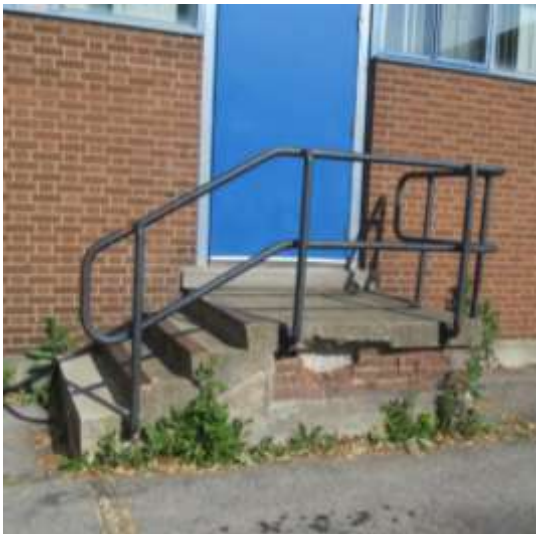
Photo 3.1.D

- There are two noted examples of deteriorated brick facing along the exterior stair landing base wall. This moisture based damage was caused by the absence of a proper drip edge along the bottom of the landing slab and led the moisture accumulation on the brick cladding below. In the illustrated example, the landing slab has spalled exposing the rebar within (Photo 3.1.D).

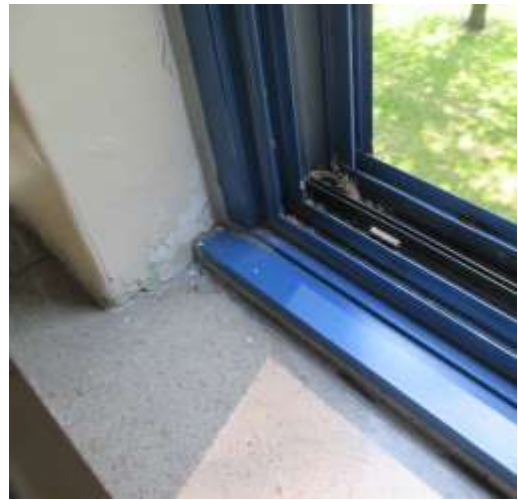
Photo 3.2.F – Classroom 2078 (Room 201)

- The interior gypsum board finish around the column has sustained moisture related damage at the sill level. The source of this moisture originated from an improperly closed slider window during precipitation events. There may have also been some impact type damage at this location (Photo 3.2.E).
- This example may partly explain image “E”. The slider tracks have accumulated debris and moisture leading to difficult slider operation and in some cases, blockage. As in image “E”, the adjacent gypsum board finish is exposed to external moisture and starting to sustain some damage. In this same image the interior caulking between sill and window frame has broken away exposing some gaps (Photo 3.2.F).

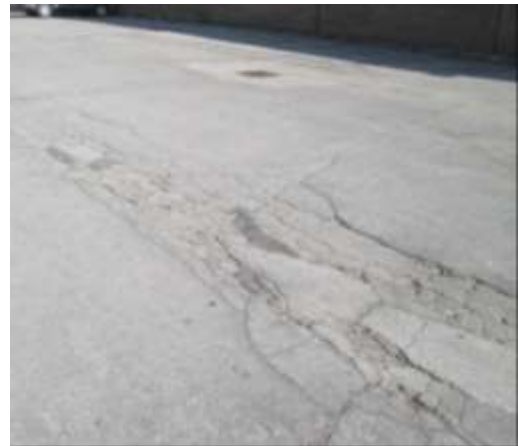
Photo 4.0.B - Site

- The asphalt parking area to the north driveway along the north and east side of the school are exhibiting signs of aging and wear and there are some areas along the driveway where the surface is cracking and spalling. This area has had some previous asphalt infill patching (Photo 4.0.B).
- Concrete curbs along the entrance loop near the main entrance have sustained some impact related damage and deteriorated over time (Photo 4.0.C).
- In the same drop-off loop the catch basin elevation is located above the adjacent asphalt paved surface and, as a result, the ponding water around the catch basin is causing damage to the surrounding asphalt paving (Photo 4.0.D).

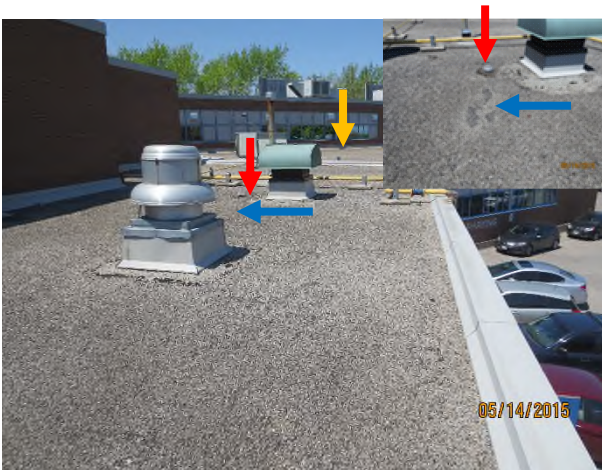
**Photograph 3** – N/W view of Area 303  
**Red arrow** – debris/vegetation on roof surface  
**Blue arrow** – membrane blister  
**Yellow arrow** – Area 302

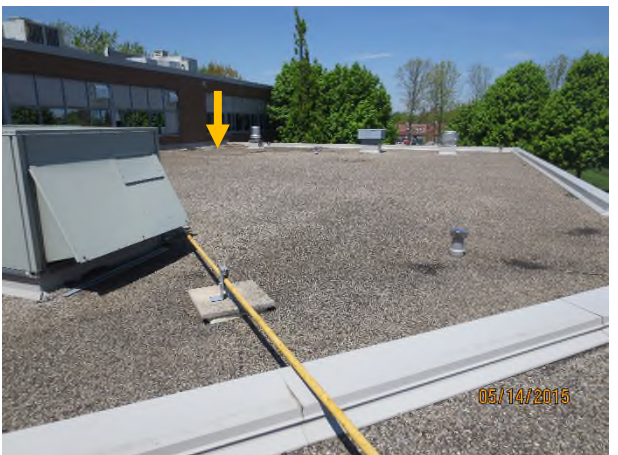
**Photograph 6** – N/W view of Area 302  
**Yellow arrow** – debris/vegetation on roof surface and around drains

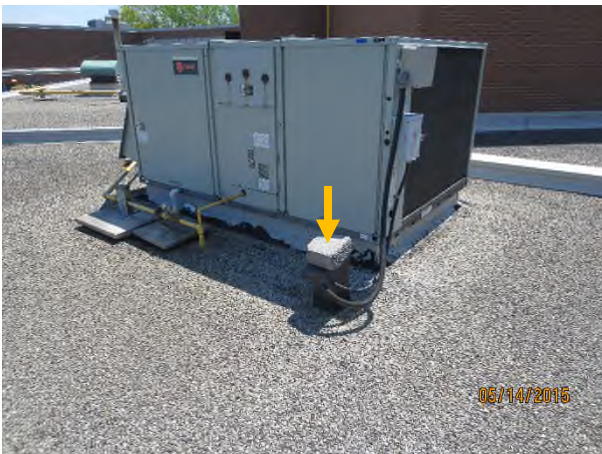
**Photograph 7** – Close-up view of HVAC unit on Area 302 from Photo#6  
**Yellow arrow** – conduit cap not secured

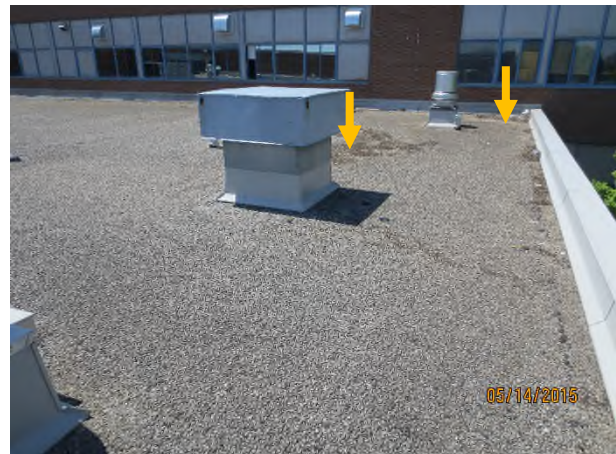
**Photograph 8** – West view of Area 302  
**Yellow arrows** – debris/vegetation

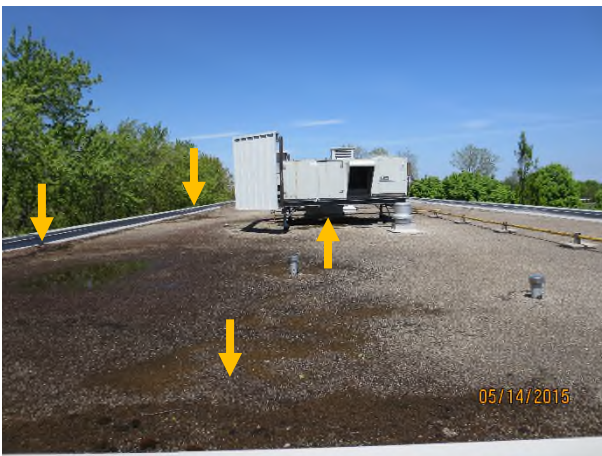
**Photograph 9** – North view of Area 501  
**Yellow arrows** – excessive vegetation growth along west wall (tree line) on roof area  
**Orange arrow** – water ponding

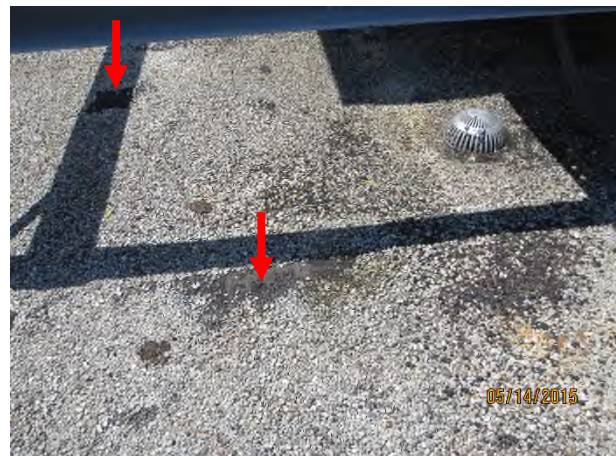
**Photograph 10** – East view of Unit on Area 501 in Photo#9  
**Red arrows** – exposed bitumen and felt

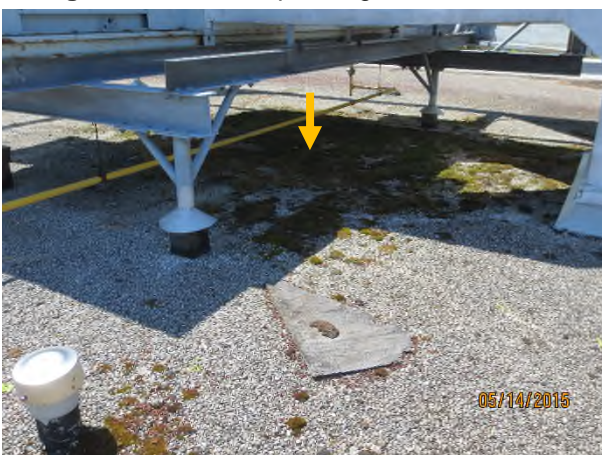
**Photograph 11** – View of typical mechanical platform in Photo#9  
**Yellow arrow** – vegetation/moss growth under platform

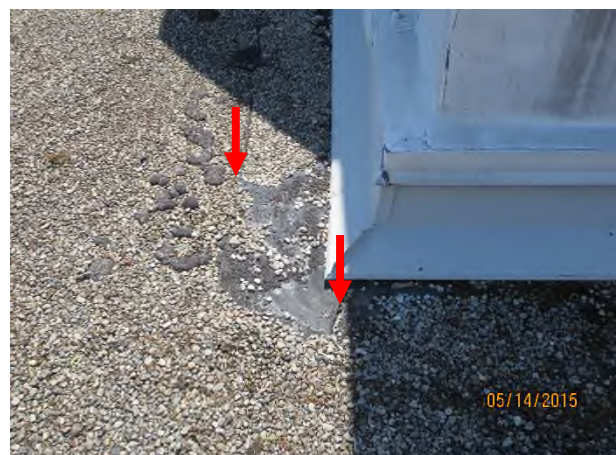
**Photograph 12** – North side of Unit on Area 501 in Photo#9  
**Red arrow** – open FR40 flashing laps

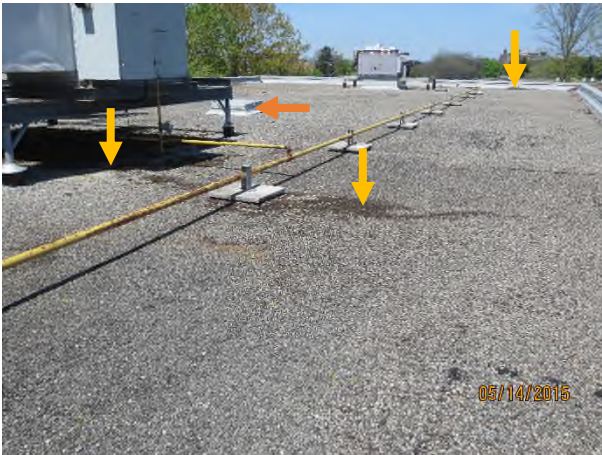
**Photograph 13** – N/W view of Area 501  
**Yellow arrows** – vegetation  
**Orange arrow** – abandoned curb

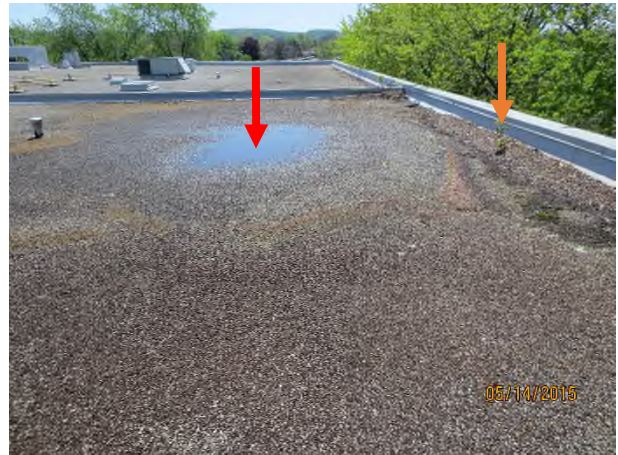
**Photograph 14** – South-west corner on Area 501  
**Red arrow** – ponding water on roof surface. Consider new drain at this location when re-roofing  
**Orange arrow** – excessive vegetation and 'tree growth'

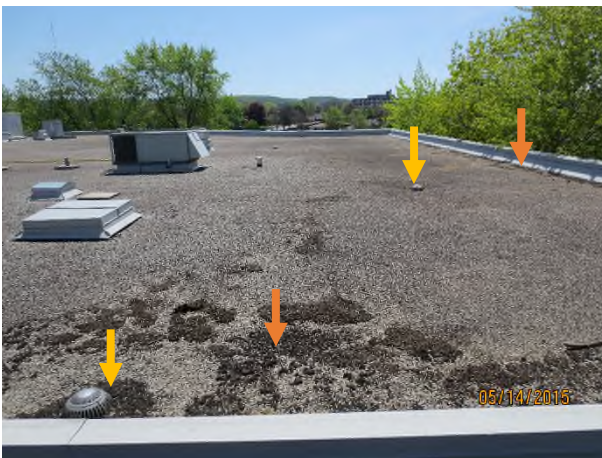
**Photograph 15** – South view of Area 502  
**Yellow arrows** – vegetation clogging drains  
**Orange arrow** – dry vegetation

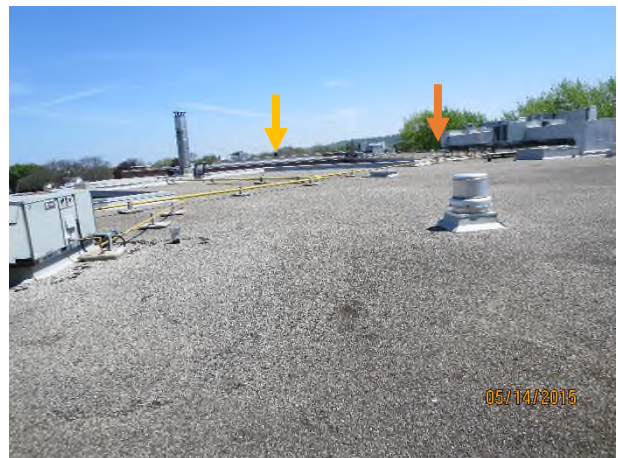
**Photograph 16** – N/E view from centre of Area 502  
**Orange arrow** – Area 503  
**Yellow arrow** – Area 601

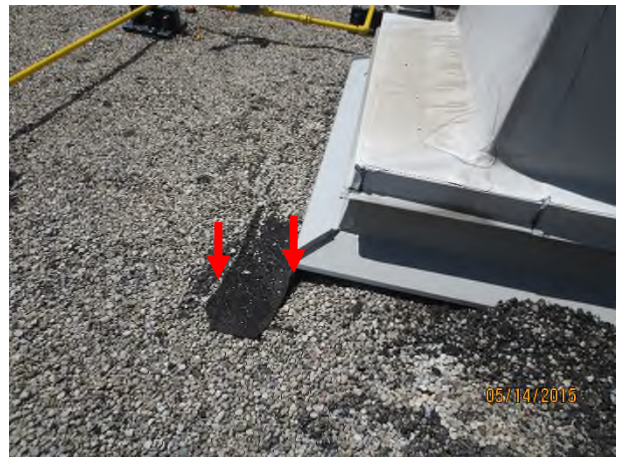
**Photograph 20** – East view of Unit in Photo#19  
**Red arrow** – open FR40 flashing lapstern

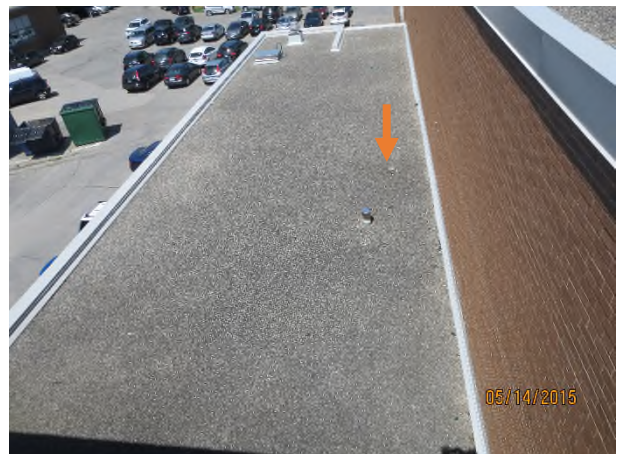
**Photograph 24** – North view of Area 304  
**Orange arrow** – debris/vegetation around drain

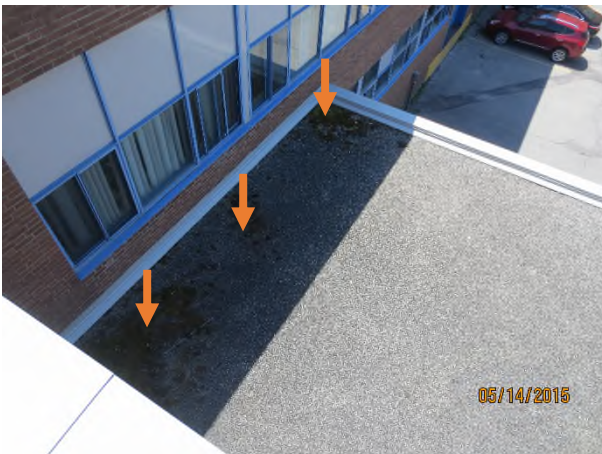
**Photograph 25** – South side of Area 304  
**Orange arrows** – debris/vegetation/moss growth

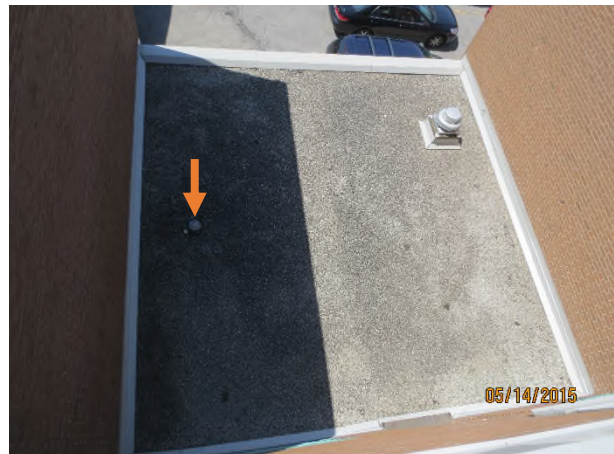
**Photograph 26** – West view of Area 202  
**Orange arrow** – debris around drain

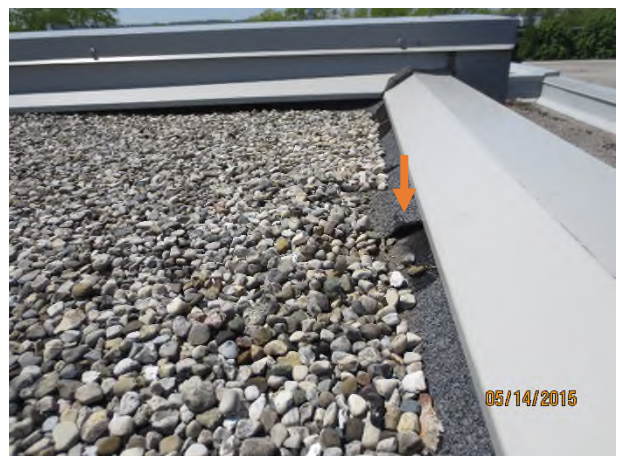
**Photograph 34** – NW corner of Area 701  
**Orange arrow** – mod. bit. cap sheet flashings in asphalt with some side laps open

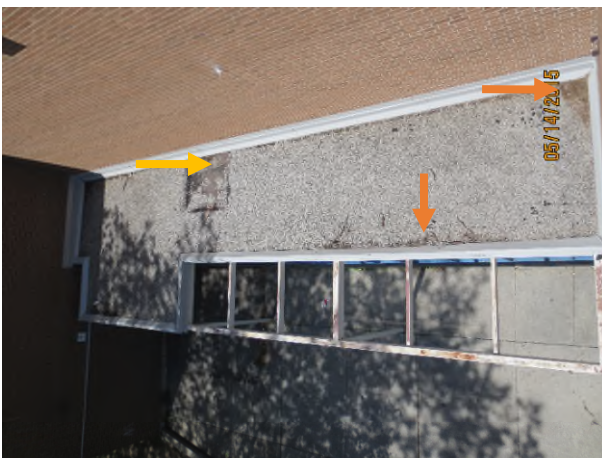
**Photograph 39** – West view of Area 203  
**Orange arrow** – minor debris/vegetation  
**Yellow arrow** – debris/vegetation at scupper

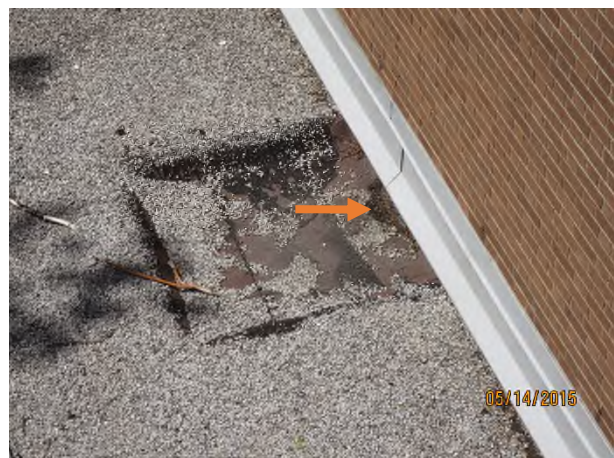
**Photograph 40** – Close-up of depression/sump in Photo#39  
**Orange arrow** – debris/vegetation clogging scupper, cleaning required

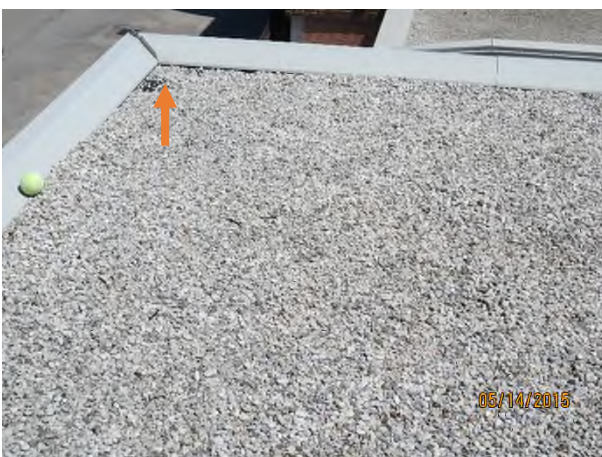
**Photograph 40** – Example of wind scouring at N/E corner on Area 402

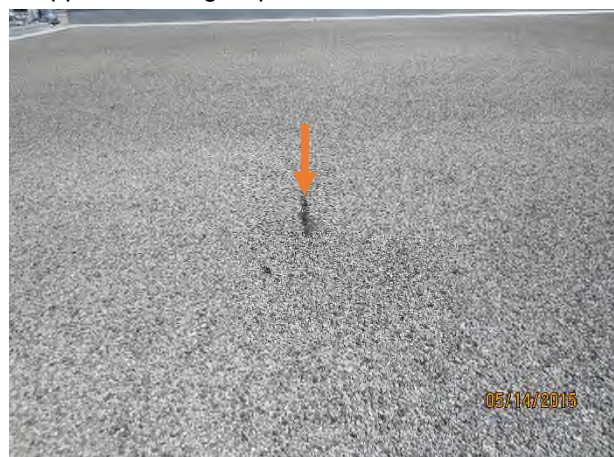
**Photograph 41** – East view on Area 601  
**Orange arrow** – membrane blister on roof surface

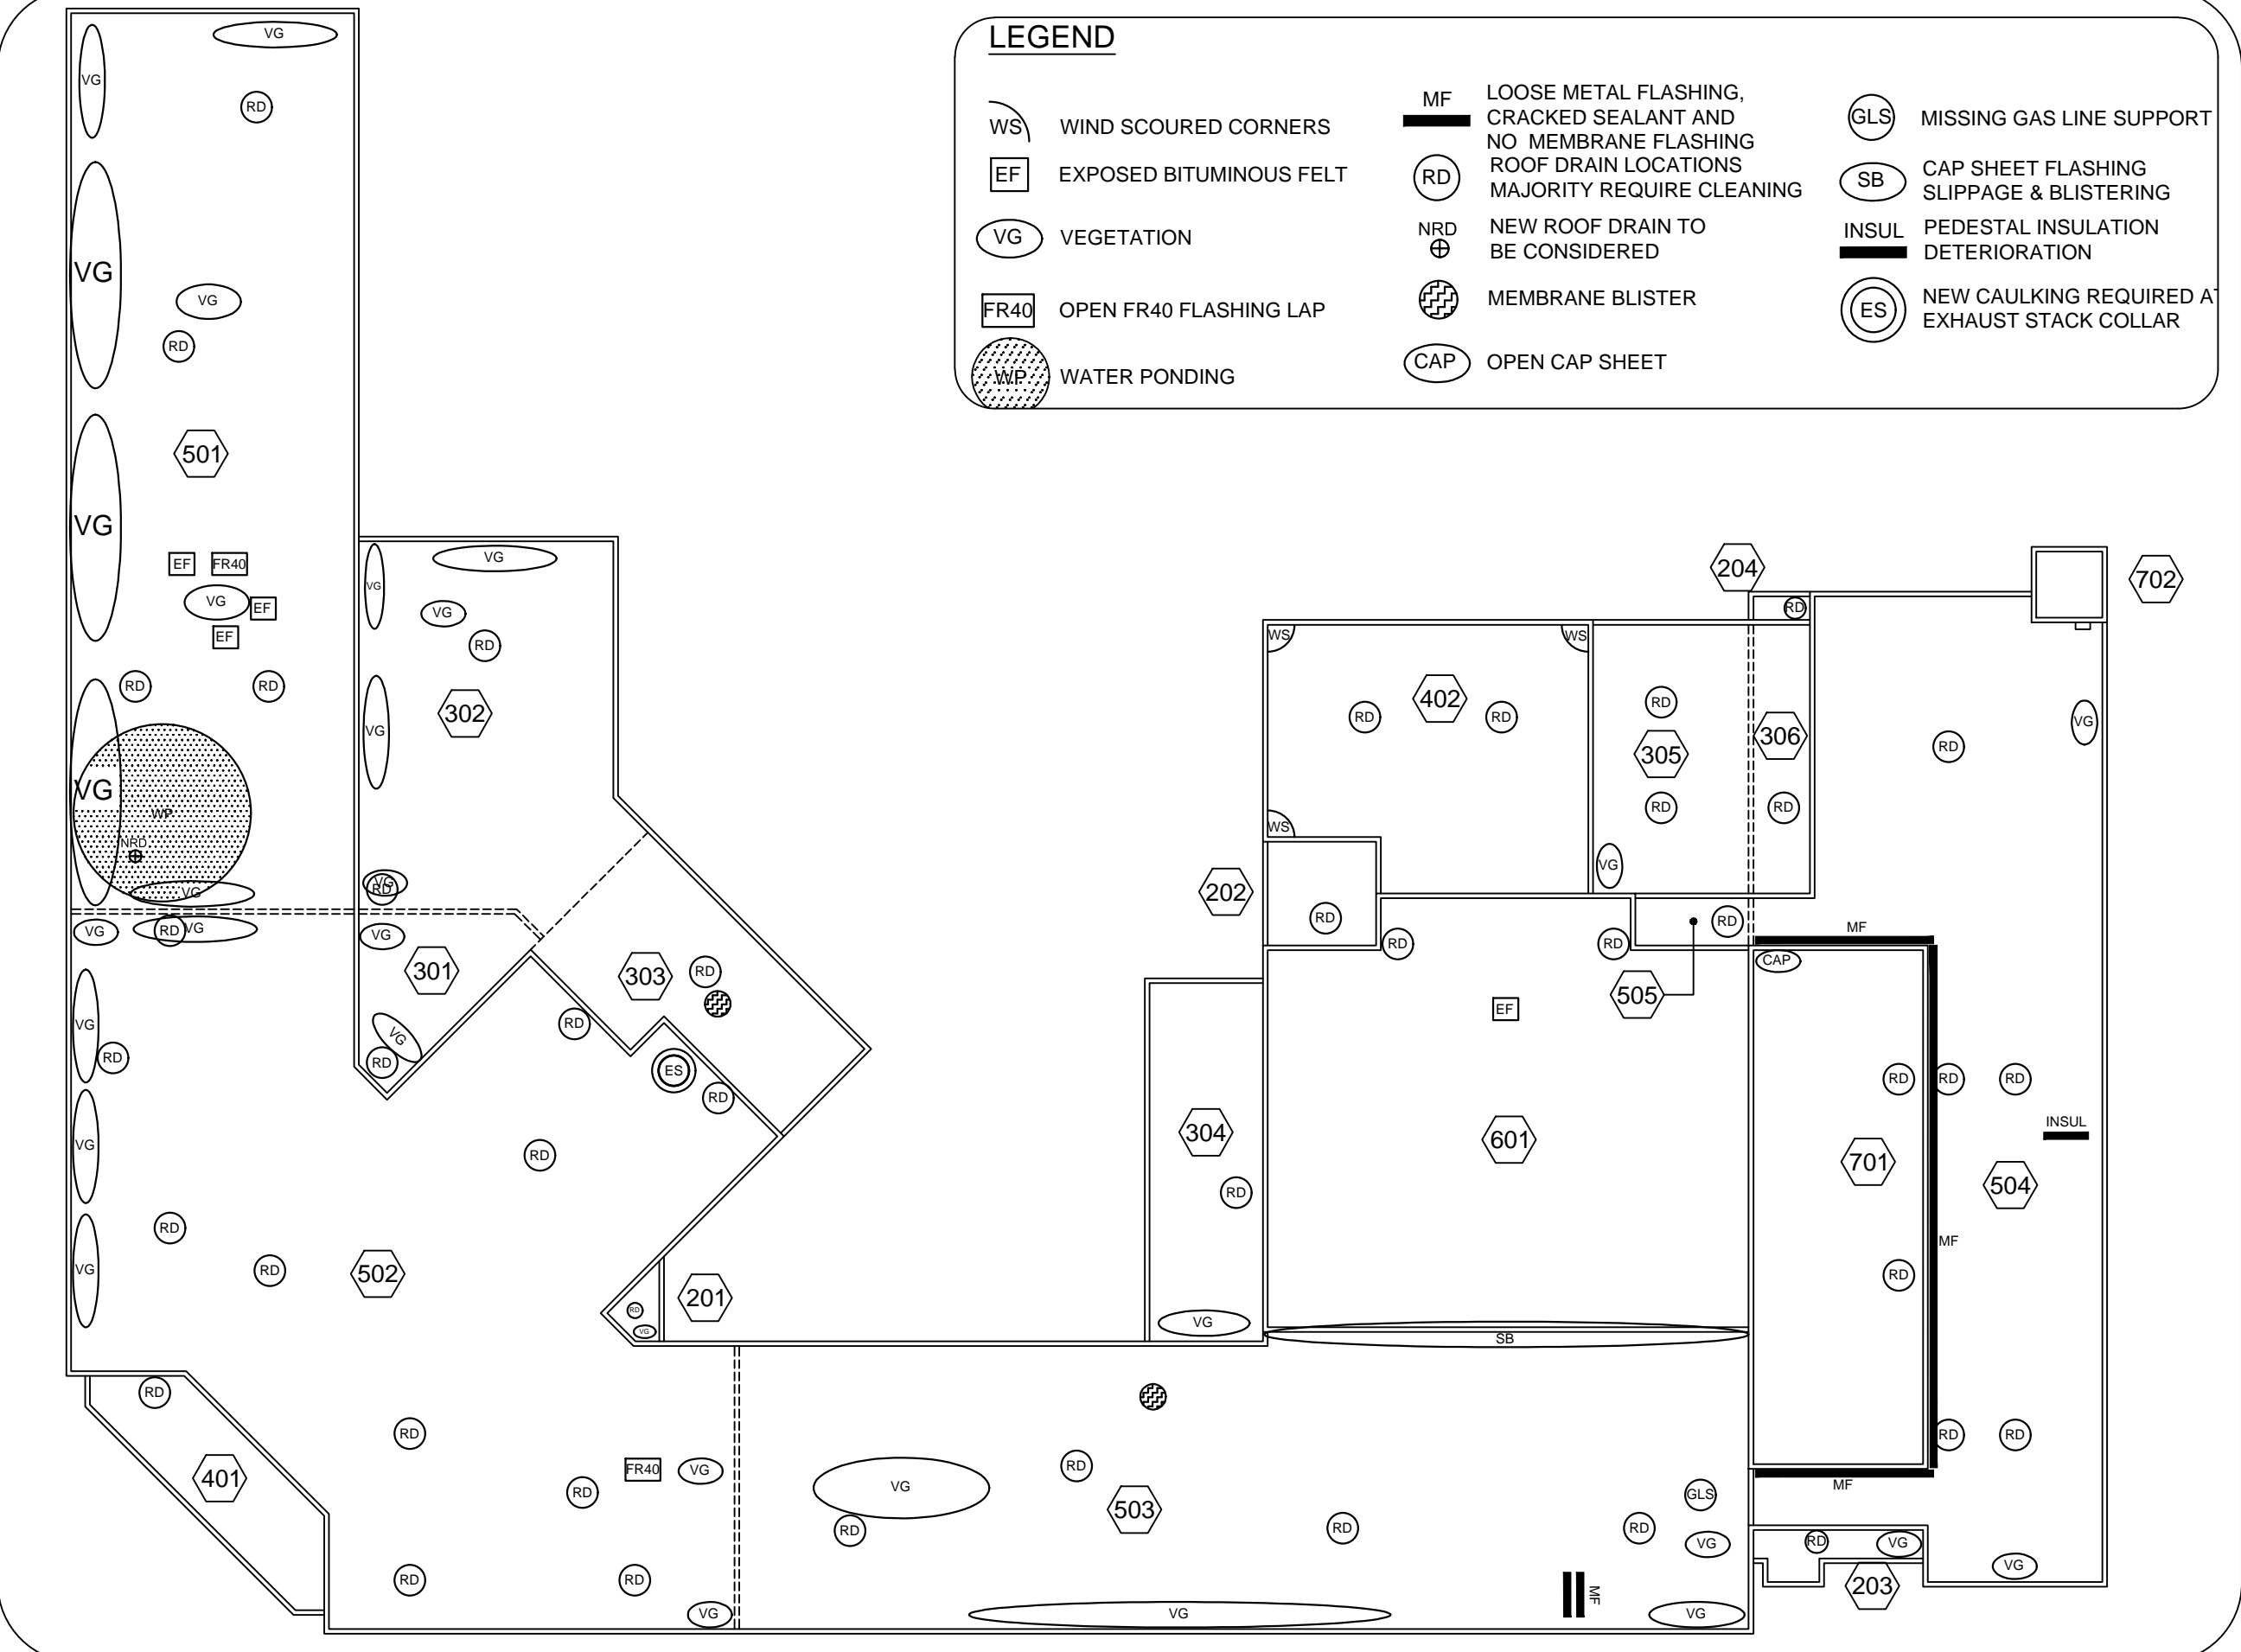
Appendix B  
Roof Plan – Drawing A1

LOOSE METAL FLASHING, CRACKED SEALANT AND NO MEMBRANE FLASHING
- RD

MISSING GAS LINE SUPPORT
- SB

PEDESTAL INSULATION DETERIORATION
- ES

NEW CAULKING REQUIRED AT EXHAUST STACK COLLAR

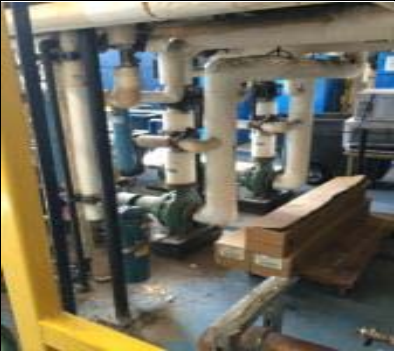
<b>M2.2</b>	<b>PIPING</b>

<p>The existing hot and cold water piping in some parts of the original piping systems may be piped in galvanized steel with screwed fittings. This piping is over 56 years old at this time and is due for replacement. The galvanizing on the internal water surfaces can be eroded away and may cause rust coloured water in some situations. In most areas and in all corridors, piping has been replaced during renovations with copper piping. Piping over drywall or sprayed textured ceilings was not replaced in 1996. New piping branches had ball valves installed in 1996 that are still operable and can isolate sections of the School.</p>	<p>The original remaining piping systems have exceeded their expected lifespan. High city water pressure may cause unpredictable piping failures. Any remaining galvanized potable water piping systems should be replaced with copper piping and lead free soldered joints. All new potable mains should be insulated with over-sized hangers and vapour barriers and new isolation ball valves installed at each riser set.</p>	40		2	\$500,000

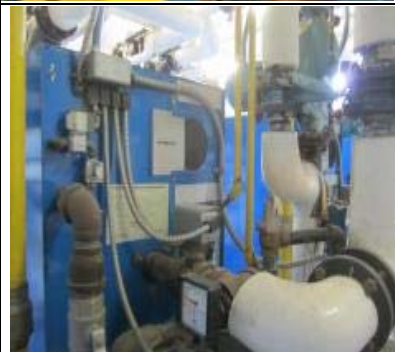
<b>M2.3</b>	<b>INSULATION</b>

<p>Domestic piping insulation on corridor mains is fiberglass insulation dating from the renovations of the year 1996. Original air cell asbestos will still be on some piping located in inaccessible locations such as plaster ceilings.</p>	<p>Asbestos insulation within the Boiler room has been removed by an asbestos abatement firm. All new piping will require new mineral fibre insulation and complete vapour barrier protection.</p>			2	\$200,000

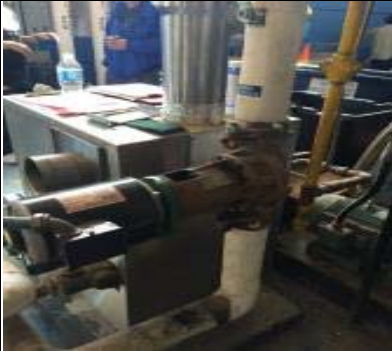
Domestic water is heated in the Boiler room via a gas fired copper tube style heater with three conventional glass lined storage tanks. The water heater is a natural draft venting system to the main chimney. The domestic hot water is piped into the basement level tunnel system of the School and distributed to the washrooms and main Kitchen. There is a recirculation loop and pump on the water mains to the boiler room.	The existing water heating system is acceptable and is recently installed. Demand is met by the systems with minimal standby losses. No changes are foreseen for the next 5 years.	25	5	2	\$40,000
M3	HYDRONIC HEATING							
M3.1	PIPING AND ELEMENTS

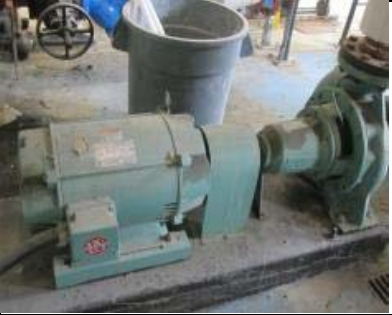
M3.2	PUMPS

In-line and base mounted Heating pumps are located in the Boiler mechanical room. The pumps were new in 1996 as part of the heating plant. No operational difficulties are noted with the pumping systems.	Pumps are acceptable and may be replaced on an as needed basis. Variable speed drives can be added although most pumping loops appear to be constant volume loops.	25	5	2	\$80,000

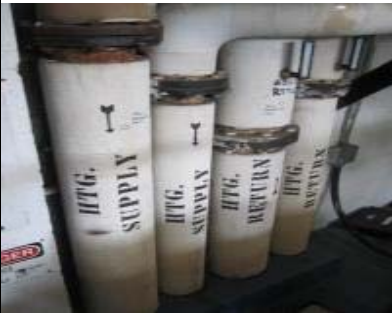
Heating piping thermal insulation in most cases is fiberglass material although there is still significant asbestos insulation within the tunnel systems. All corridor piping and Boiler room piping was re-insulated in 1996 with fiberglass material and is in a suitable condition to continue to provide service for at least 25 years.	All remaining asbestos insulation in the tunnels should be removed by an asbestos abatement company. All new piping will require new mineral fibre insulation and complete vapour barrier protection. Costing for the removal is beyond the scope of this report. Assistance from a speciality consultant is required for estimation.	40	20	2	\$250,000
M3.4	BOILERS

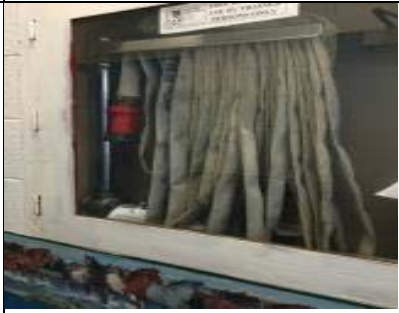
A 1 1/2" fire standpipe system is original to the School and is fed from a combined standpipe /domestic water service in the Boiler room. Hoses in the standpipe cabinets appear to be 75 foot hoses in lieu of the usual 100 foot hoses.	Hose distances should be checked from each cabinet to ensure full coverage of all School areas from the cabinets.	50	30	1	\$50,000
M5	HVAC							
M5.1	VENTILATION

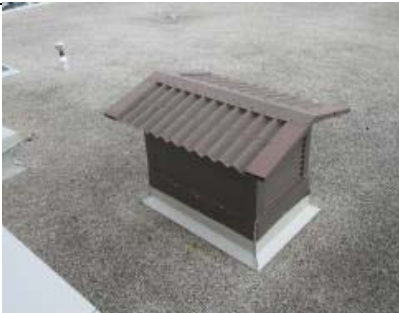
Local aluminum roof type exhaust fans provide washroom ventilation.The Central ventilation systems provides the ventilation air and free cooling for the School.	The original central ventilation system for the School was based on negative pressure ventilation using roof fans and operable windows in each teaching space. In 1996, a multi-phase renovation was completed that converted the School to a mixed air tempering systems with heating and cooling. The temperature of the supply air was tempered in the heating season with gas heat and with DX cooling systems during the cooling season. All new supply and return air ductwork was installed to provide the air distribution. The rooftop HVAC units are now 19 years old and are still in service. Expected service life for this type of equipment is 20 to 25 years.	30	10	2	\$90,000

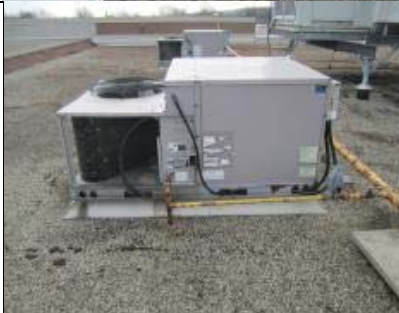
M5.2	COOLING SYSTEMS

Landlocked rooms on the Second floor used for computer rooms are served by HVAC heat / cool units above each room.Units are from 1997 and are in fair condition.	The existing cooling systems all appear to be functional.The condensing units have 1996 and 1997 serial numbers. The drawings from 1996 indicate that the equipment was new.The remaining operational lifespan is estimated at 5 to 10 years.	25	5	3	\$250,000
M5.3	AIR HANDLERS

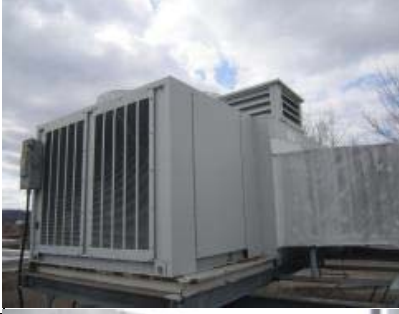
Trane Custom Heat /Cool units are powered on 600 volts and are mounted above the roof on galvanized structural frames. Temperature control is by the BAS and the units are used during occupied periods only.The AHUs are packaged AHUs with side mounted DX condensing units. The units operate on R22 refrigerant. The phase out period for R22 should not affect the servicability of these units. Replacement equipment will utilize a different refrigerant or refrigerant blend.	Custom RTU AHUS were installed in 1997 to provide tempered air during heating and cooling seasons for the ventilation air in the teaching areas. Units can free cool during the winter and provide "neutral" temperature supply air. The systems do not provide heating but tempered air only. Non-condensing gas burners on indirect heat exchangers provide the heating. The units should remain servicable for 5 years and can be directly replaced when warranted with custom replacement units without roofing issues. Natural gas piping on the roof exhibits some surface corrosion that requires painting for piping protection.	25	5	3	\$600,000

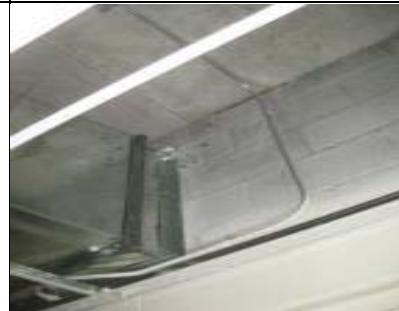
Fire dampers are required in the ductwork that passes through floor or wall fire separations. Existing fire dampers were mostly installed in 1996 during the rough-in phase for the distribution ductwork and the grilles. Corridor supply and return air openings to each teaching space are protected by fire dampers in the vertical plane. Access for the sidewall grille fire dampers are through the grilles. Fire dampers are located at the plaster membranes located on the underside of the steel joists on the roof and second floor levels.	Fire dampers require annual inspection and testing throughout the life span of the dampers. There are frequently missed during regular maintenance and service calls. A schedule and location for all fire dampers is recommended to allow for orderly checking of condition and operation.	40	20	1	\$50,000

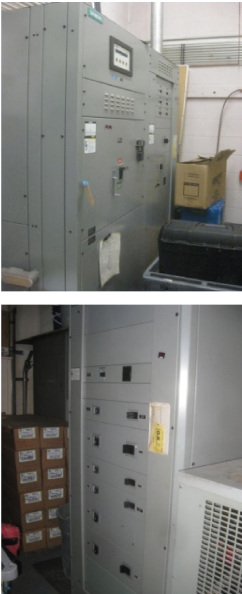
1.2	Main Switchboard

Siemens 1200A, 347/600kV, 3-phase two section switchboard located in the Main Electrical Room. Section 1 contains a 1000A main breaker, Utility C/T compartment and digital meters. Section 2 contains a 1200A, 347/600V, 3-phase distribution board with 9 breakers feeding various 600V loads throughout including one 500A breaker feeding a 500kVA, 600V/120-208V transformer in the adjacent room. This transformer feeds a Siemens 1600A, 120/208V, 3-phase distribution board with 12 breakers feeding various panel boards throughout. This equipment was installed in 1997 to replace existing.	Recommend power shut-down to clean the 1200A switchboard and the 1600A distribution board, inspect and torque all breaker connections. Recommend megger testing of 500kVA transformer. Test and adjust all breakers (replace as necessary). Perform thermal inspection testing of all connections, breakers and bus bars.	\$35,000.00	10 years

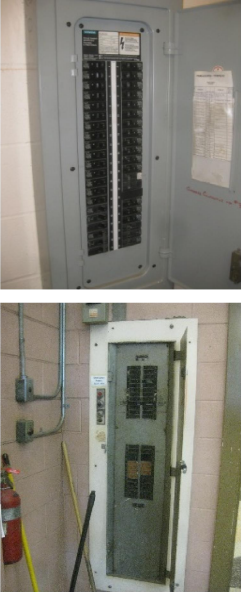
2.1	Panel Boards

Numerous Siemens 100A & 200A, 120/208V 3-phase panel boards throughout. Panel boards in most areas were replaced during 1997 building renovations. Some original 1959 panel boards existing in shop classrooms etc.	Recommend visual inspection of all 1997 panel boards and breakers. Recommend relpacing all remaining 1959 panel boards and updating of panel board index cards.	\$15,000.00 (for 1997 panel boards) + \$50,000.00 (for 1959 panel boards)	10 years for 1979 panel boards. 20 years for replacment panel boards.

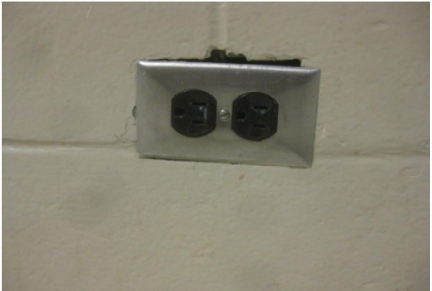
2.2	Receptacles

Numerous grounded receptacles throughout installed during 1997 renovations. Recessed, surface mounted and wireway mounted. Numerous older grounded receptacles throughout. Recessed, surface mounted and wireway mounted.	Recommend visual inspections & testing in areas of concern or high use.	\$5,000.00	Subject to test results.

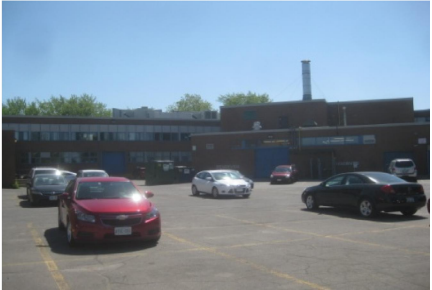
No original parking lot or roadway pole light fixtures.	Recommend review of need for pole lighting in existing parking lot and roadway areas.	\$5,000.00	New

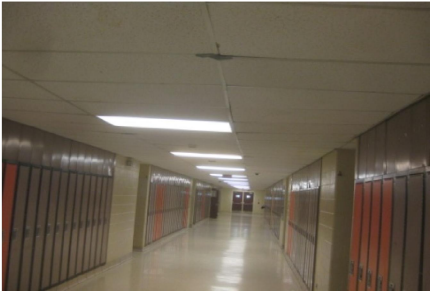
3.2.2	Corridor Fixtures

<p>Newer 1x4 &amp; 2x4 T8 Troffer light fixtures installed in the 1979 renovations.</p>	<p>Recommend replacing all existing fixtures with new LED equivalents. Occupancy sensors should be provided.</p>	\$100,000.00	Original fixtures have reached service life.

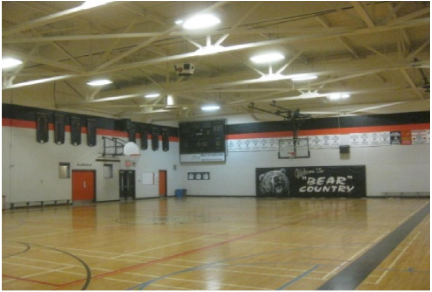
3.2.3	Gymnasium Fixtures

New 2x4 6 lamp T5HO suspended gymnasium fixtures with wire guards. Installed in 2012 in all 3 gymnasiums. Occupancy sensors also provided.	Recommend cleaning, relamping and re-ballesting existing fixtures as required.	\$5,000.00	New

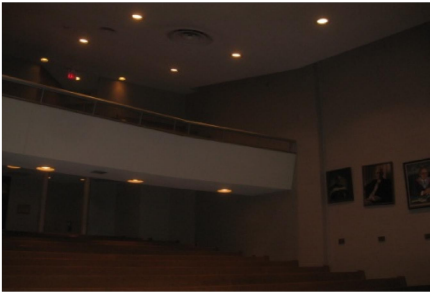
3.2.4	Auditorium Fixtures

Original incandescent downlight fixtures with "Strand" low voltage control system.	Recommend retrofitting existing fixtures with LED light sources. Recommend review and repair of existing low voltage control system as necessary.	\$40,000.00	Original fixture light sources have reached service life.

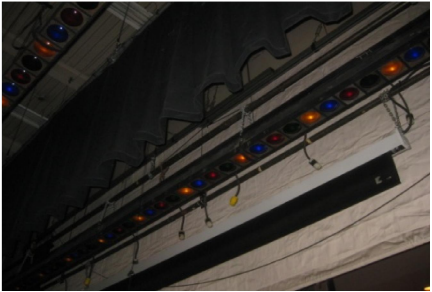
3.2.5	Theatrical Lighting

Existing fixtures, dimmers & controls appear to be approximately 20 years old.	Recommend replacing existing light fixtures, dimmers, controls and dimmer board with new equipment to meet current Board standars.	\$150,000.00	Original equipment has reached service life.

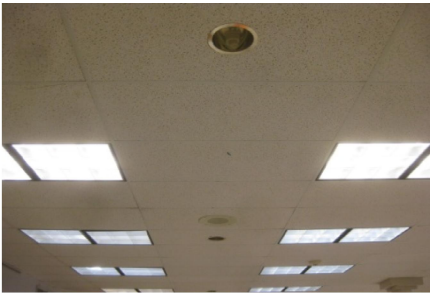
Newer 2x4 T8 Parabolic Troffer 6" cf down light fixtures installed in 1998.	Recommend replacing all existing fixtures with new LED equivalents. Occupancy sensors and dimming controls should be provided.	\$50,000.00	Original fixtures have reached service life.
3.2.7	Shop Classroom & Service Area Fixtures

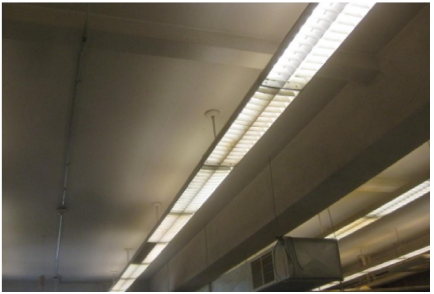
Original suspended "Kawartha" light fixtures upgraded to T8 lamps 20 years ago.	Recommend replacing all original fixtures with new LED equivalents. Occupancy sensors should be provided.	\$30,000.00	Original fixtures have reached service life.

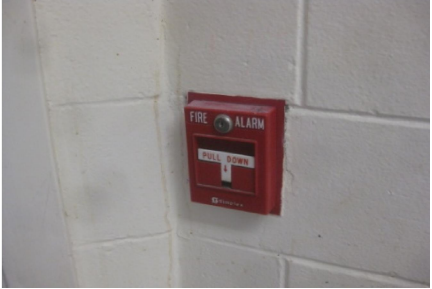
4.1.3	Fire Alarm Devices

Newer Simplex addressable devices throughout. Approximately 20 years old.	Recommend replacing all devices and related wiring with new Simplex units.	\$250,000.00	Original equipment has reached service life.

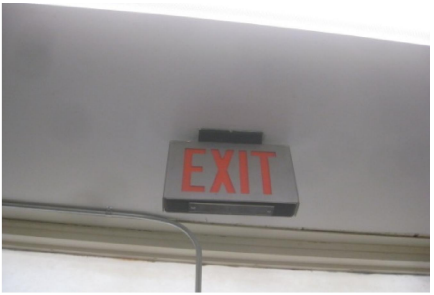
Newer Lumacell self-powered LED exit & combination emergency/exit lighting units throughout. Installed in 1979.	Recommend replacing with new LED units.	\$50,000.00	Original equipment has reached service life.
4.2.2	Emergency Battery Units
