HAMILTON - WENTWORTH DISTRICT SCHOOL BOARD  
CONCEPT DESIGN AND FEASIBILITY STUDY

**GLENDALE SECONDARY SCHOOL**

145 RAINBOW DRIVE, HAMILTON

Grguric Architects Incorporated  
Glendale SS Facility Conditions Assessment Report  
June 26, 2015

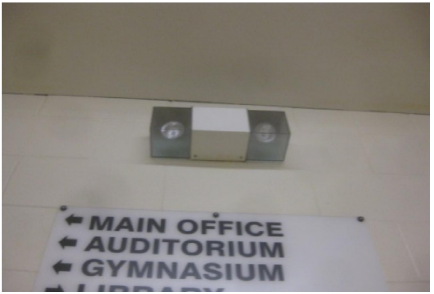
Newer Lumacell self-powered double-head halogen emergency lighting battery units throughout. Installed in 1979.	Recommend replacing with new LED units.	\$50,000.00	Original equipment has reached service life.

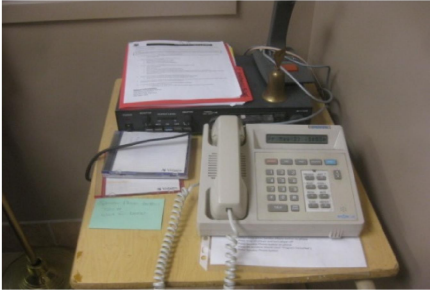
5.1.2	Administrative Units

Two newer Dukane units located on secretary desk in Main Office and in Vice Principal's Office. Approximately 10 years old.	Recommend providing four additional units for Principal, Attendance Secretary, Guidance & one other.	\$4,000.00	Existing - 5 years and New

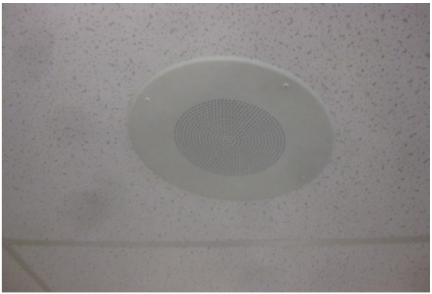
5.1.4	Corridor Speakers

Newer Dukane recessed units throughout. Installed in the 1979 renovations.	Recommend units be inspected, tested & repaired as necessary by equipment manufacturer.	\$8,000.00	5 years

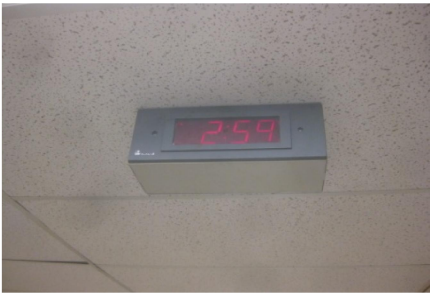
5.1.5	Master Clocks

Newer Dukane Master clock control located in Main P/A Console. Digital clocks in classroom MCP's & on corridor ceilings. Analogue clock in gymnasiums. Installed in the 1979 renovations.	Recommend units be inspected, tested & replaced as necessary by equipment manufacturer.	\$20,000.00	5 years

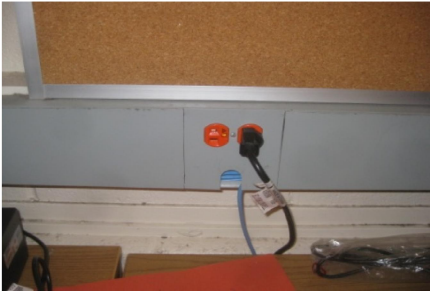
Numerous data outlets throughout building. Most installed in the 1079 renovations.	Recommend reviewing all data outlets within building and upgrading as required.	\$80,000.00	5 years

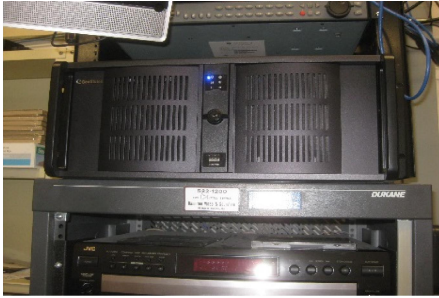
6.2.1	Video Recorder

GeoVision CCTV video recorder and camera multiplexer located in Bookstore Room. Equipment appears to be 10 + years old.	Recommend reviewing all recording, camera multiplexing and TV monitor equipment and upgrading as required.	\$40,000.00	5 years

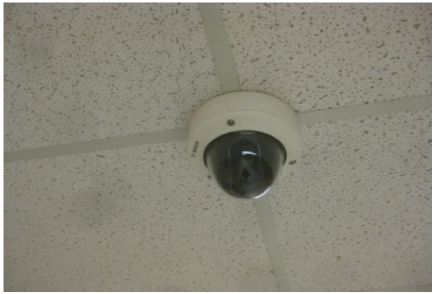
6.2.2	Cameras

Numerous Bosch existing interior & exterior cameras. Equipment appears to be 10 + yrs old.	Recommend new colour digital interior & exterior cameras to provide sufficient coverage & all new wiring.	\$50,000.00	Original equipment has reached service life.

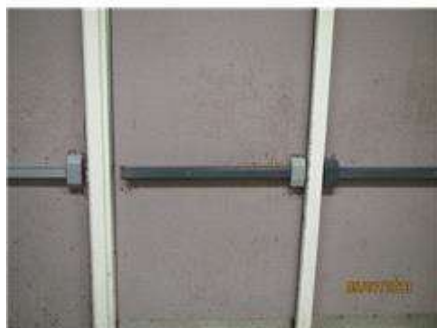
<b>Condition Assessment</b>	2013 - The exterior door hardware was observed to be aged and worn. Corrosion noted on various components.
-----------------------------	--

May2013- Typical exterior door hardware.

2013 - The aged and worn exterior door hardware is suggested be replaced in conjunction with exterior door replacement.

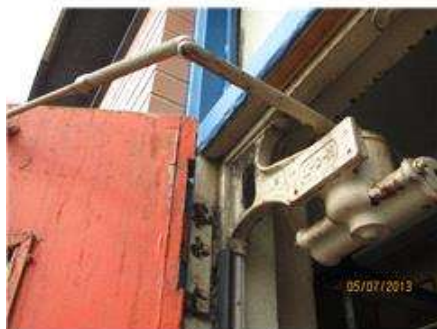
May 2013- Typical exterior door closer.

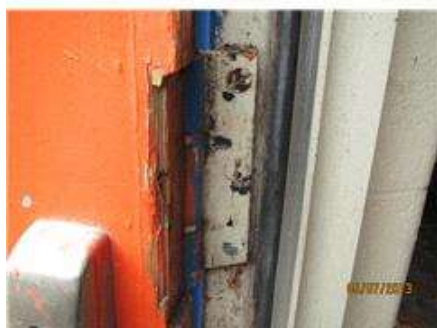
May 2013- Typical exterior door hinges.

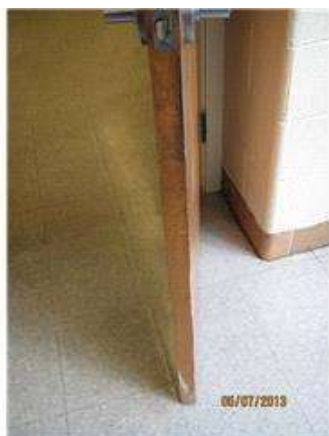
2013 - The majority of doors were observed to be aged and worn beyond useful life. Wood doors had damaged veneers, painted metal doors had chipped paint, some glazing was non tempered .

May 2013- Typical interior door.

2013 - The interior doors have exceeded their useful life. Replacement of the interior doors is suggested.

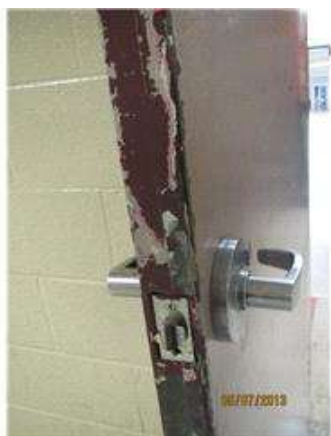
May 2013- Typical interior hollow metal door.

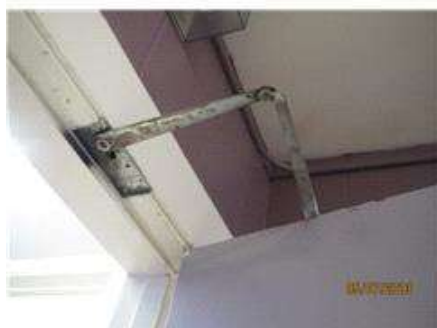
2013 - The interior door hardware is original and has exceeded its effective rated design life. The components are appearing worn with reports of some reliability issues.

May 2013- Typical interior door hinges.

2013 - The interior door hardware has exceeded its effective design rated life. Replacement is recommended.

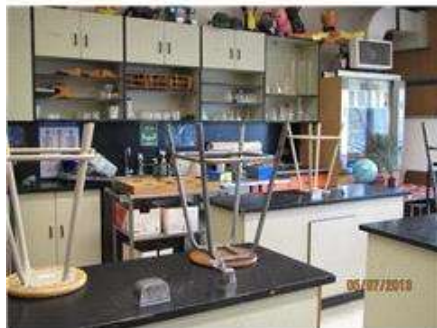
2013 - At the time of the assessment all cabinetry, millwork items, counters and countertops were in a fair condition

May 2013- Worn millwork fitting.

2013 - As all the cabinetry, mill-work items, counters and counter-tops have exceeded their expected useful life and are in fair condition the recommendation is to replace them.

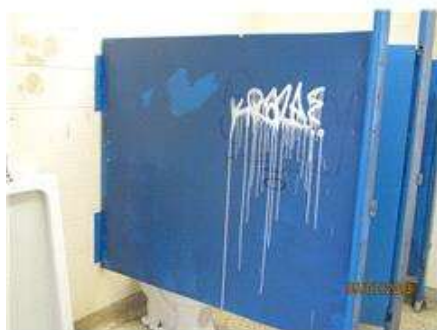
2013 - The painted metal washroom partitions were observed to be aged and worn. Corrosion, damaged finishes and missing hardware was noted.

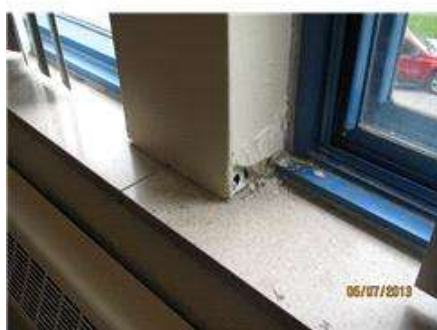
May 2013- Faded interior wall covering.

2013 - The aged and worn interior painted wall finishes suggested to be replaced.

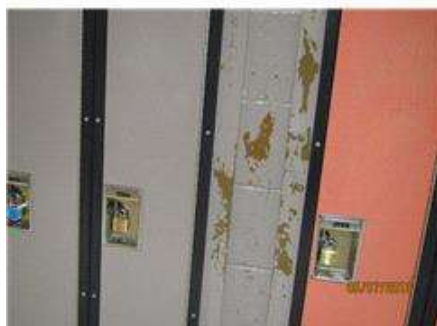
May 2013- deteriorated paint wall covering.

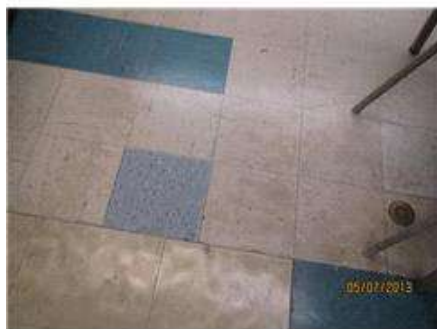
May 2013- Damaged VAT floor covering.

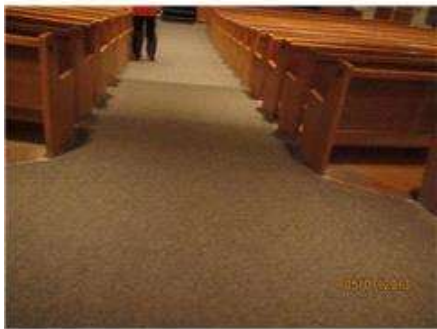
May 2013- Stained carpet floor covering in the music room.

**Recommendation** 2013 - The carpets located in the Resource Center, Music and, auditorium are subjected to frequent foot traffic. Excessive wear was evident in those area. Replacement of carpet is recommended.

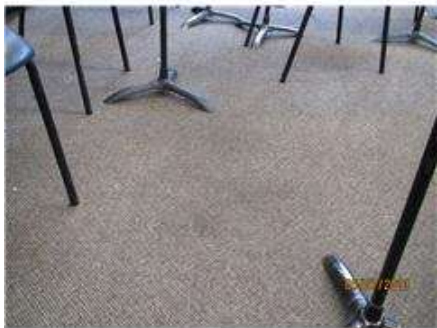
May 2013- Worn carpet flooring in the Library.

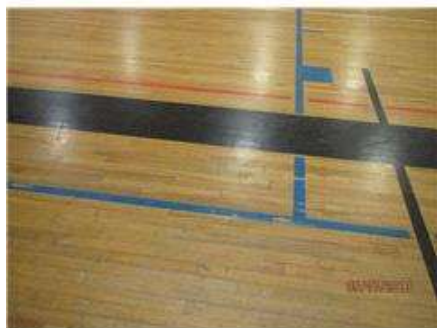
May 2013- Worn hardwood flooring in the GYM area.

2013 - The hardwood strip flooring on the stage is in poor condition. Refinishing or replacement of the hardwood flooring is recommended.

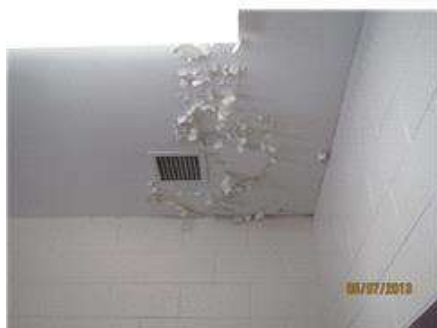
May 2013- Peeling ceiling paint in the classroom.

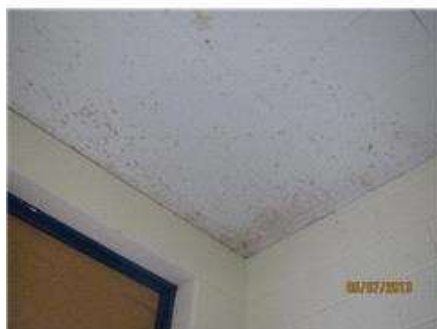
2013 - The 12" x 12" acoustic tile ceiling system has exceeded its useful life and is known to contain asbestos materials. Replacement planning is recommended as to update the appearance of the facility and remove any potential health concerns.

May 2013- Damaged 12x12 ceiling tiles.

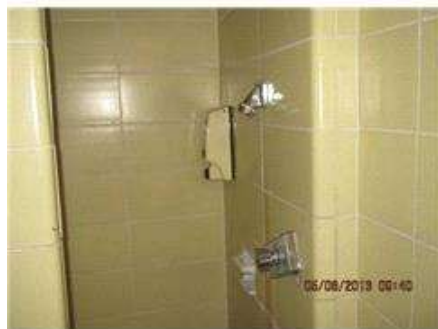
## May 2013 - Aged Shower Fixtures

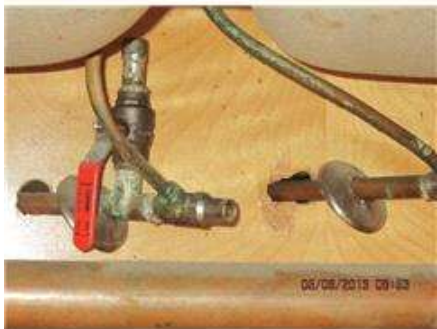
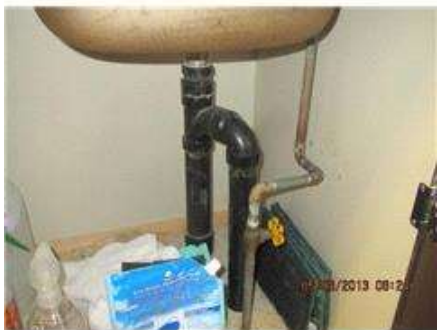
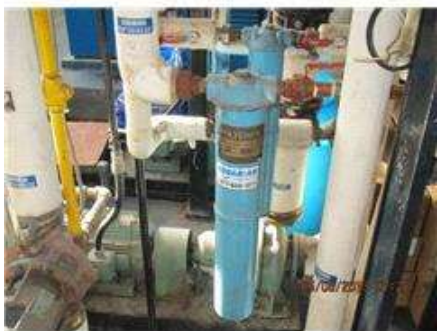
2013 - The domestic piping system is mostly concealed and therefore the current condition is not fully known. However due to the age, the expected wear and the theoretical useful life, the system is assessed as being in fair condition.

May 2013 - Aged Domestic Water Distribution Piping

May 2013 - Aged Domestic Water Piping and Filtration

2013 - Based on the age and theoretical useful life of the domestic water piping system replacement is recommended. A study is recommended to determine the current condition, remaining service life, current service requirements and the cost of replacement.

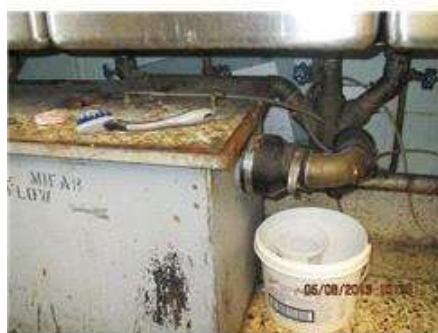
2013 - Much of the sanitary waste water distribution system is concealed with only small areas of the system being visible during the assessment. The visible sections of the piping were observed to be functional but aged. The waste water distribution system is past its rated useful life of 37 years.

## May 2013 - Aged Sanitary Waste Piping

2013 - Planned replacement of the waste water distribution system is recommended based on age and condition.

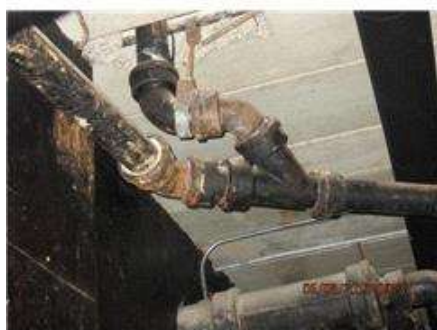
2013 - Much of the rain water drainage system is concealed with only small areas of the system being visible during the assessment. The visible sections of the rain water piping were observed to have minor corrosion. The rain water drainage system is past its rated useful life of 37 years.

May 2013 - Aged Rain Water Drainage Piping

2013 - Planned replacement of the rain water drainage system is recommended based on age and condition.

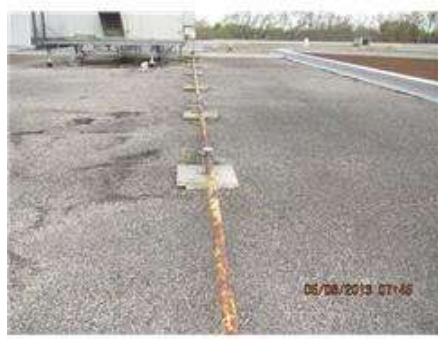
2013 - The exterior sections of the gas piping located on the rooftops is showing signs of rust over the majority of the pipe run. The piping is nearing the end of its anticipated service life and consideration of renewal is recommended.

## May 2013 - Natural Gas Supply Piping - Exterior Section is Corroded

2013 - Replacement of the corroded gas piping is recommended. Event deferral may result in pipe corrosion and leaks.

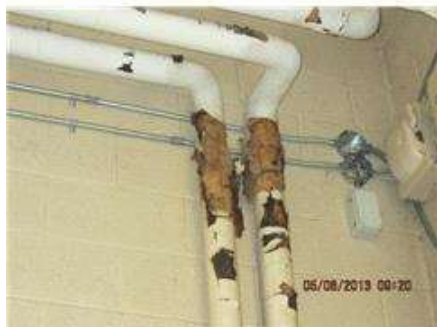
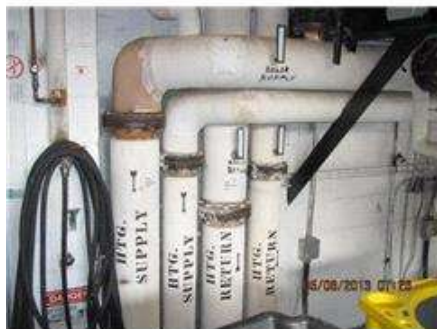
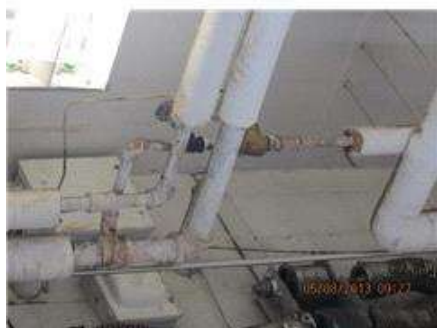
2013 - Partial upgrade of the heating piping was undertaken in 1999 with installation of the boilers, however the quantity and condition of original piping in the Original building and Addition 1 is unknown. As original piping has exceeded its expected useful life, further investigation is recommended to determine current condition and possible need for replacement. With age, piping leaks may occur, damaging the building interiors.

May 2013 - Aged Heating Water Distribution Piping - Worn Insulation

May 2013 - Heating Water Distribution Piping - Aged Piping in Boiler Room

May 2013 - Heating Water Distribution Piping - Aged Piping in Workshops

2013 - Pending the outcome of the recommended study, replacement of the building's heating piping and distribution system may be required. In the current condition piping leaks may occur damaging the building interiors. The work associated with this project is expected to disturb material(s) suspected of containing, or known to contain asbestos, (ACMs). Testing of the suspected ACMs should be conducted prior to the initiation of any demolition and the costs should be adjusted based on the findings. The cost of hazardous materials abatement is not included in the replacement cost.

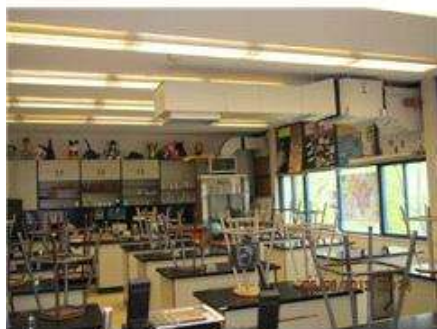
**Condition Assessment** 2013 - At the time of assessment it was reported that when gas is used in the science rooms the smell of gas is spread throughout the ventilation system to other classrooms and the library. The RTU for the library is shut off on a consistent basis to prevent gas from being pulled into the library until the concerns are resolved. The exhaust fans in the science classrooms are either undersized or a rezoning of the ventilation for the science rooms is required.

## May 2013 - Undersized Science Room Exhaust Fans

**Recommendation** 2013 - A study is recommended to determine the best course of action to eliminate the smell of natural gas escaping the science rooms into the ventilation system and into other sections of the school.

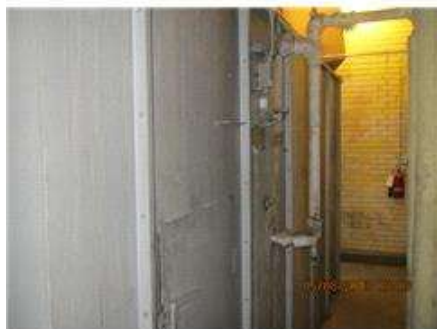
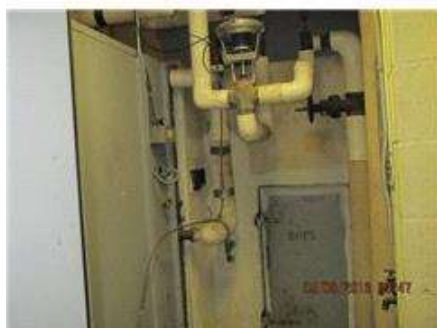
May 2013 - Original Central Air Handler

2013 - Due to age and mechanical wear, the central air handlers should be replaced within the next 5 years for reliability.

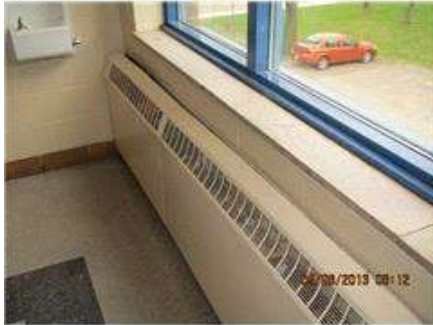
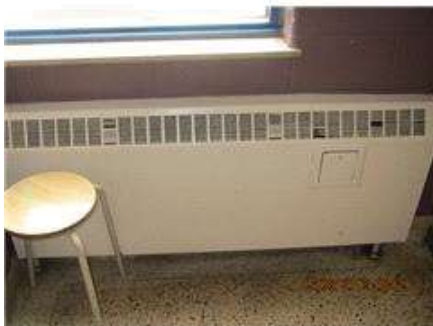
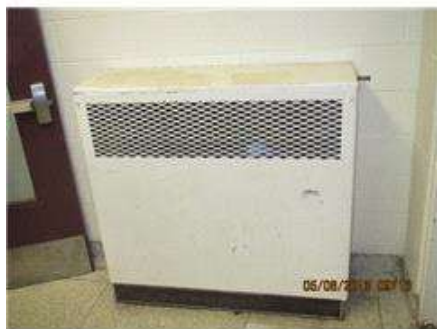
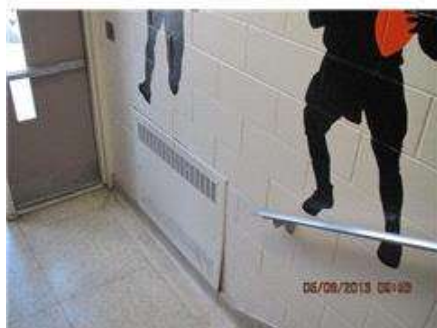
2013 - Although the fin tube radiation units have been properly maintained, the system has degraded in condition over the years. Due to age, wear and tear the units will require replacement soon.

May 2013 - Aged Fin Tube Radiators

May 2013 - Aged Entrance Heaters

May 2013 - Aged Forced Flow Heaters

2013 - Replacement of the aged fin tube radiation units and forced air units is recommended based on condition and theoretical life.

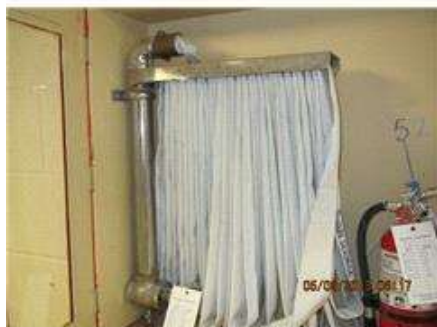
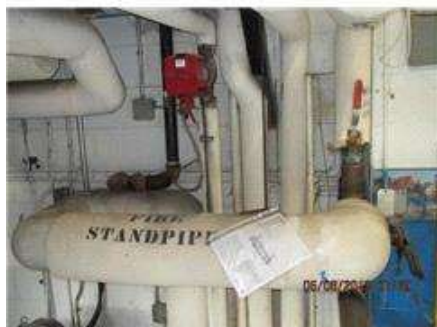
2013 - The standpipe system is generally in fair condition, but is past its useful life. No deficiency was reported during the assessment.

May 2013 - Original Standpipe Fire Cabinet

May 2013 - Original Standpipe System Piping

2013 - Replacement of the standpipe system is recommended based on the age and theoretical useful life of the system. Planning for renewal is recommended to maintain functionality during and emergency.

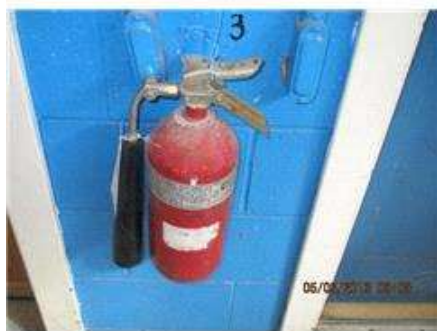
## May 2013 - Aged Fire Extinguishers

**Recommendation** 2013 - Based on the age and theoretical useful life replacement of the outdated and aged fire extinguishers is recommended within the next three years.

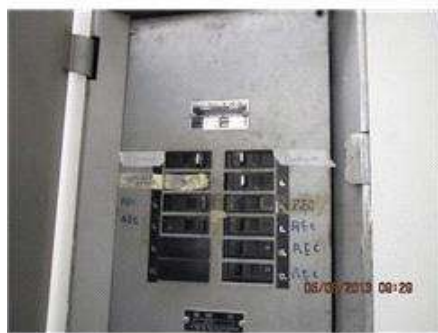
## May 2013 - Original Panel Board

2013 - Based on the age of the branch wiring, replacement is recommended. An in depth study should be conducted to determine the current condition, remaining useful life cost of replacement.

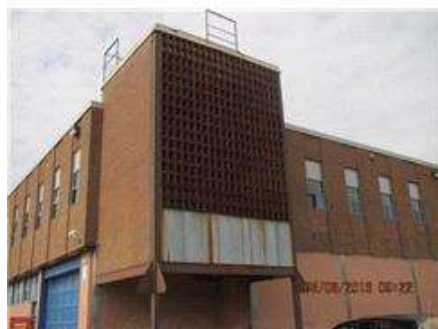
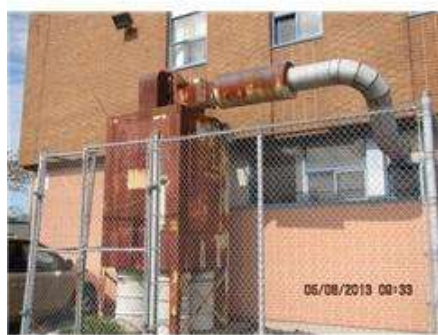
May 2013 - Original Partially Enclosed Dust Collector

May 2013 - Original Dust Collector - Excessive Rusting

2013 - Replacement of the two original dust collectors is recommended based on age and condition.

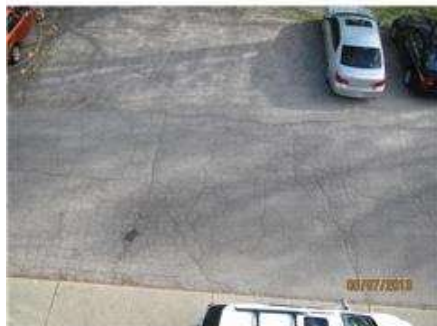
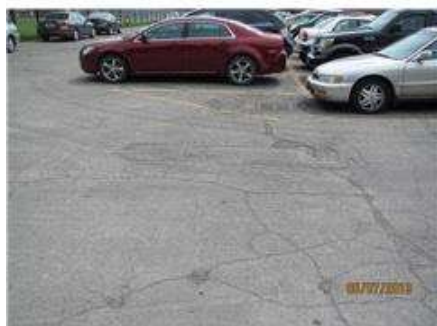
2013 - The asphalt-paved parking lot is in poor condition with pot holes and alligator cracking. Reconstruction of the parking lot recommended.

May 2013- North side Asphalt paved parking with alligator cracking on the surface.

May 2013- Parking lot.

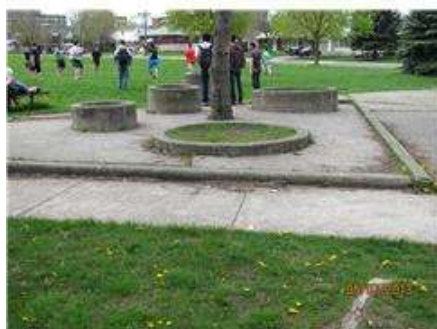
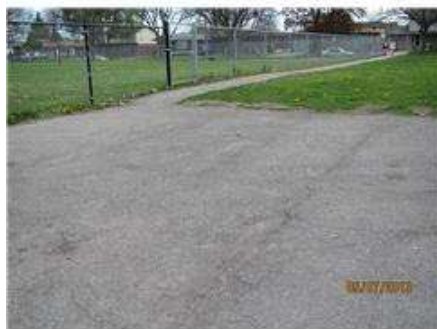
May 2013- Deteriorated concrete pedestrian.

May 2013- Uneven surfaced asphalt sidewalk.

2013 – Based on the observed damage to the concrete and asphalt paved pedestrian repairs are recommended as soon as possible.
