## HAMILTON – WENTWORTH DISTRICT SCHOOL BOARD CONCEPT DESIGN AND FEASIBILITY STUDY

## SIR ALLAN MACNAB SECONDARY SCHOOL

145 MAGNOLIA DRIVE, HAMILTON

Grguric Architects Incorporated:  
Sir Allan MacNab High School Facility Conditions Assessment - June 26, 2015 (63 pages)

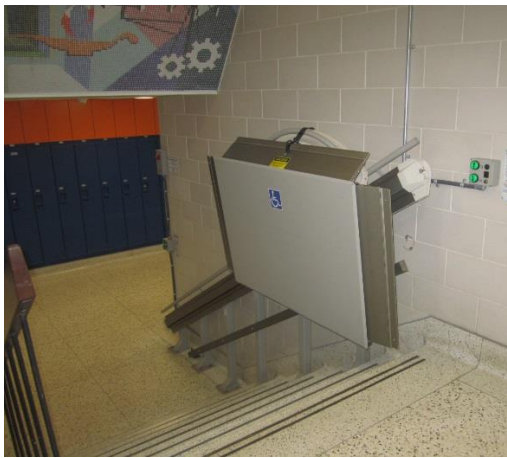
Photo 1.0.A – Corridor 1011

The north wing and ground floor level has existing accessibility provisions to the split levels by means of stair lifts (see Photo 1.0.A) located at stair transitions between the split levels. The second floor of the north wing also has split floor levels, however, there are no stair lifts at the stair transitions as there is no elevator accessibility to any floors. The facility has three accessible entrance points with suitable walkway/ramp access and power door operators located at:

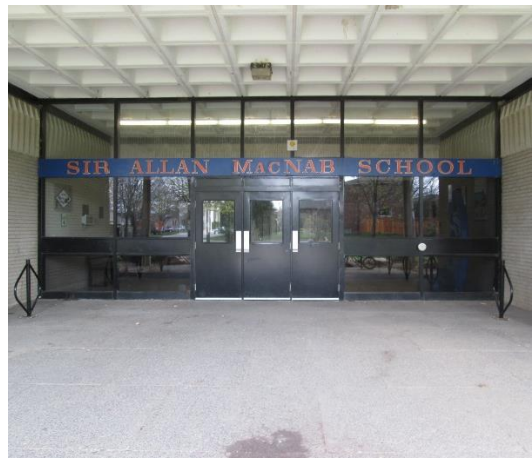
Photo 1.0.B

- 1) the main entrance at Vestibule 1000 (Photo 1.0.B and 1.0.C)
- 2) the north entrance off Corridor 1030 (Photo 1.0.D)
- 3) the south entrance east of the Auditorium to the south parking area

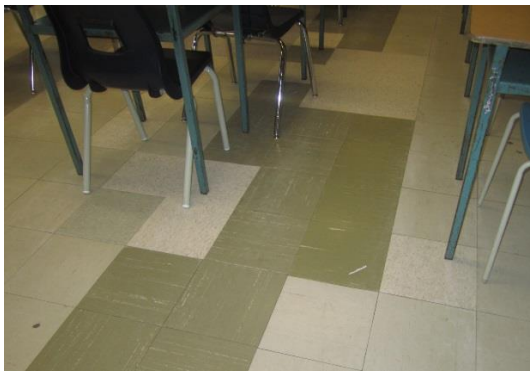
Photo 2.1.A - Classroom 1014 (Room 113A)

- Random pattern of replacement tiles (Photo 2.1.A)
- Surface wear through scuffing and rubbing (Photo 2.1.B)
- Surface staining (Photo 2.1.C)
- Joint separation resulting in uneven joints (Photo 2.1.D)
- Delaminating, missing sections of rubber base (Photo 2.1.E next page)

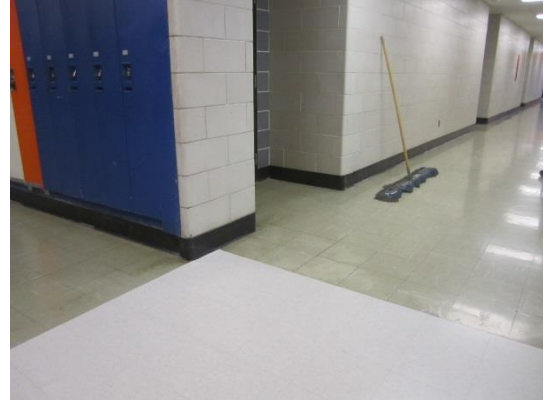
Photo 2.1.F – Corridor 2016

The original vinyl asbestos tiles show signs of advanced wear. Common throughout the facility, damaged tiles have been randomly replaced with newer tiles of differing colour and pattern. In 2014 in the north wing second level some classrooms and parts of the corridors have received new tile replacements. The finish in these corridors lack continuity as illustrated by the breaks between newer and older tiles (Photo 2.1.F next page).

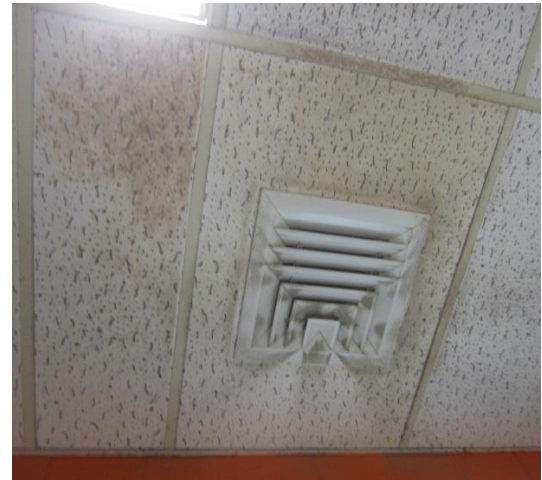
Photo 2.2.B – Classroom 1047 (Room 133a)

- Partial tile replacement resulting in non-uniform ceiling finish (Photo 2.2.A)
- Tiles stained by insufficiently filtered diffuser air supply (Photo 2.2.B)
- Tiles stained from water source (Photo 2.2.C)
- Tiles sustaining surface impact related damage (Photo 2.2.D)

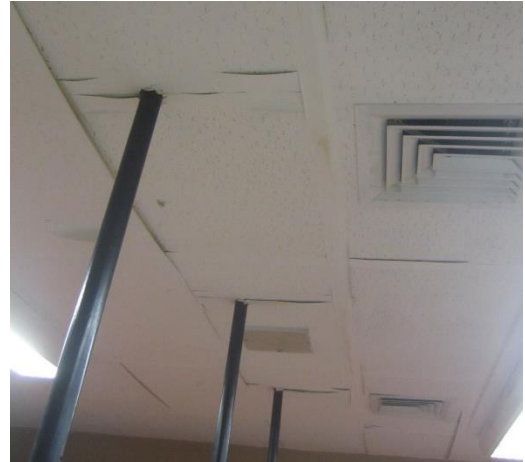
Photo 2.2.F – Girls Change Room 1078D

The Girls Change Room has a suspended acoustic tile ceiling with continuous taping along the T-bar grid sealing the tile perimeters together to the T-bar grid. The ceiling tiles including the taping are painted out. It appears this ceiling was taped to control moisture migration. The tape is delaminating in certain areas and there are signs of tile cracking due to pressure differential. (Photos 2.2.E and 2.2.F)

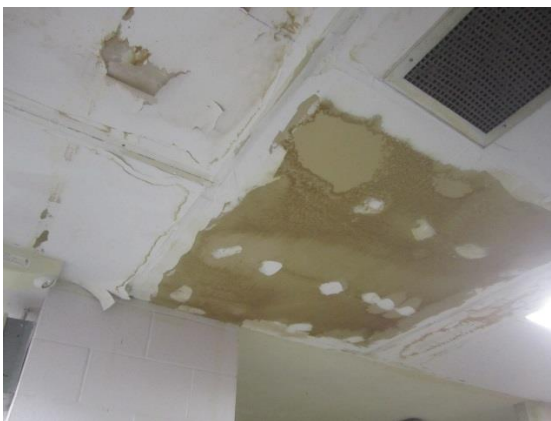
Photo 2.2.G - Boys Change Room 1071A

The gypsum board ceiling in the Boys Change Room is exhibiting signs of surface finish deterioration. The finish deterioration is predominately related to moisture environment and possibly inadequate ventilation. A segment of gypsum board ceiling located at the entrance to the showers has been replaced. (Photo 2.2.G)

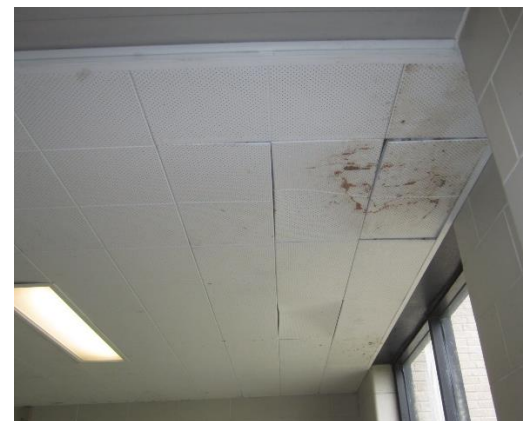
Photo 2.2.H - Stairs 1045 and 2030

The vestibule ceilings are typically finished in a 12x12 perforated metal tile. There are some areas where these tiles have sustained impact type damage resulting in warped tiles. (Photo 2.2.H)

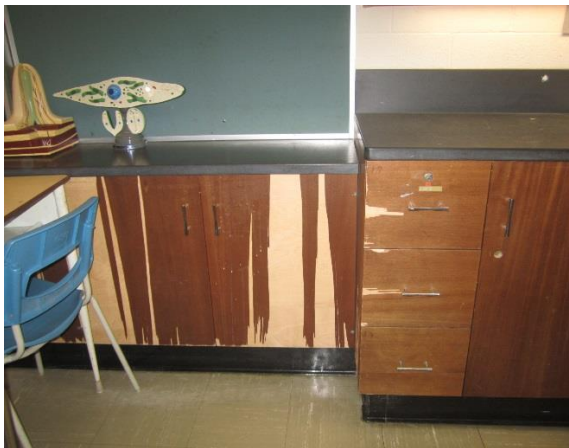
Photo 2.3.G - Science Lab 1024 (Room 118)

**Millwork:** The existing millwork in the facility remains in fair condition. There are examples of millwork that have sustained extensive surface wear or damage (Photo 2.3.G), however, for the most part the original millwork still has an ongoing serviceable lifespan.

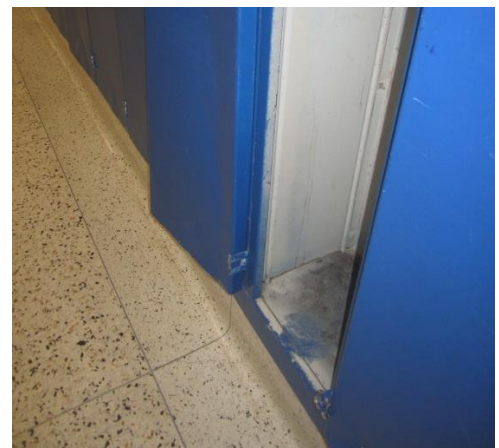
Photo 2.3.H

**Lockers:** The existing lockers remain in fair serviceable condition. There are several examples of missing locker doors and lockers with dented and warped doors from impact damage. (Photo 2.3.H)

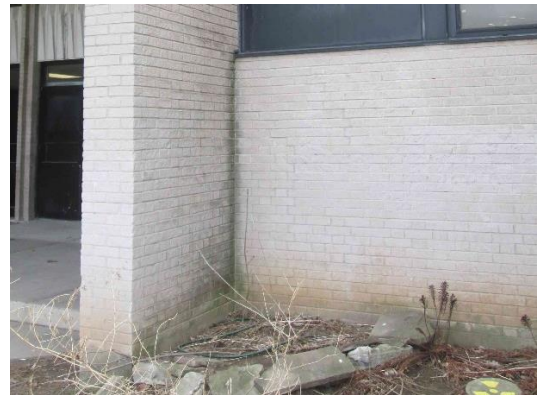
Photo 3.1.B

- Water based stain related to blocked or improper flashing, inadequate venting and drainage out (Photos 3.1.A and 3.1.B)
- Brick cladding at base of wall has absorbed moisture. It appears that the potential source is external; ongoing monitoring would confirm this. (Photo 3.1.C)
- Water based stain due to improper roof drainage from accumulated vegetation debris (Photo 3.1.D)

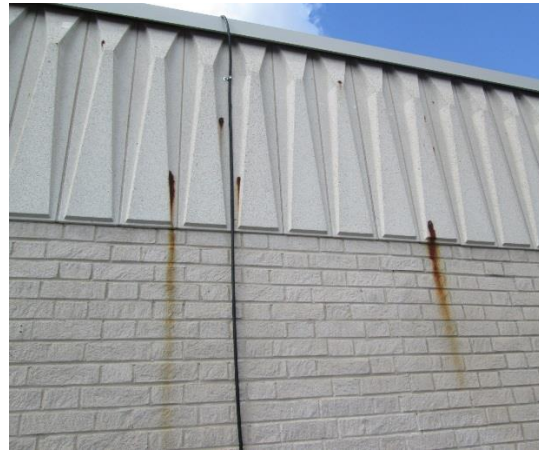
Photo 3.1.F

- South elevation – there were a few areas of brick deterioration due to weathering (Photo 3.1.E)
- Rust spots on precast concrete frieze. Possible causes: exposed rebar or metallic component in aggregate. (Photo 3.1.F)
- Crack and separation in poured concrete foundation wall (Photo 3.1.G)
- Concrete surface finish discoloration (Photo 3.1.H)

Recommended external cladding repairs including cleaning and repointing at deteriorated brick and repairs of other items noted in the assessment.

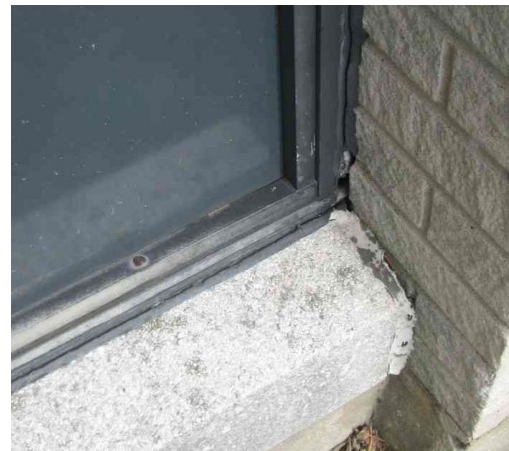
Photo 3.2.B

- Some existing frames are showing signs of corrosion. Corrosion also visible at the spandrel panel edge joint. (Photo 3.2.A)
- Common throughout is the deterioration and delaminating perimeter caulking. In some areas large gaps have been exposed allowing water infiltration. (Photo 3.2.B)
- Hopper window operation is difficult and weatherstripping has deteriorated or is missing (Photo 3.2.C)
- Several windows found permanently closed and taped around hopper window (Photo 3.2.D)

Due to the advanced state of wear and deterioration, the existing windows are at the end of their life cycle and full replacement is recommended. New windows will provide improved energy efficiency.

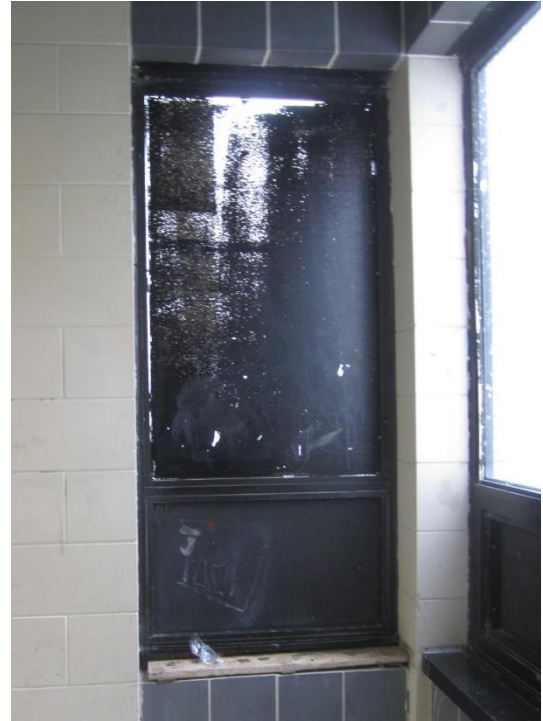
Photo 3.2.F – Stairs 1045 and 2030

- Aluminum finish showing surface wear (Photo 3.2.E)
- Several of the plastic window panes encountered were painted out, having an unsightly appearance (Photo 3.2.F)
- Spandrel panel finish in advance state of wear
- Music Room window bottom sill covered in soil and preventing proper drainage (Photo 3.2.G)
- Exterior entrance doors showing surface wear (Photo 3.2.H)

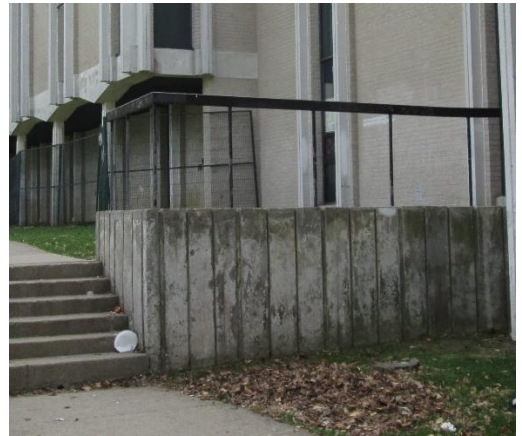
Photo 4.0.B

- Sidewalk settlement along building perimeter poses a tripping hazard and watershed flows back toward building, north elevation of north wing (Photo 4.0.A)
- Concrete retaining wall feature exhibiting surface wear and staining. Existing guard rail is not to current code standards (Photo 4.0.B)
- Walkway continues over sod and exposed soil leading to erosion (Photo 4.0.C)
- Segments of depleted sod to be replaced (Photo 4.0.D)

Recommended site improvements include upgrade of all guard railing to current code standards, repairs or replace sidewalks and eliminate potential surface erosion by re-sodding dead areas and introduce new walkways over travelled areas.

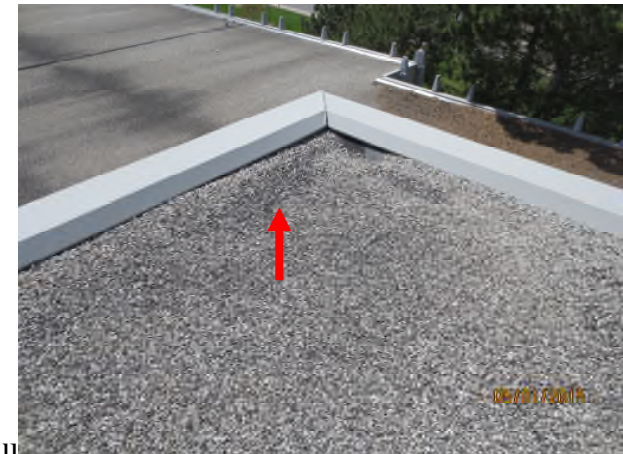
**Photograph 4** – S-W corner on Area A1  
**Red arrow** – view of gravel scoured corner exposing bitumen/felt

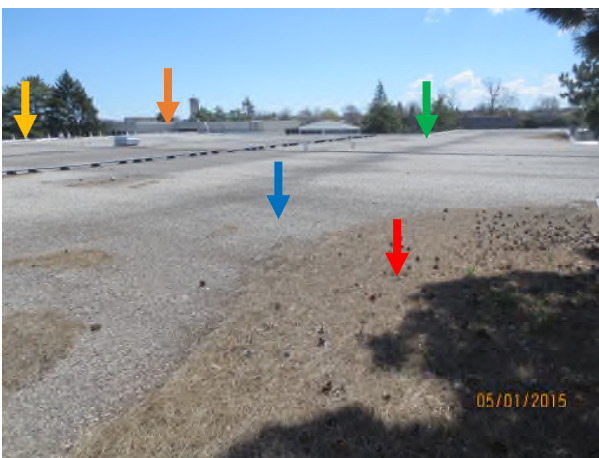
**Photograph 5** – S/E view from area C2  
**Yellow arrow** – Area C1, **Blue arrow** – Area C2  
**Orange arrow** – Area C3, **Green arrow** – Area C4  
**Red arrow** – vegetation

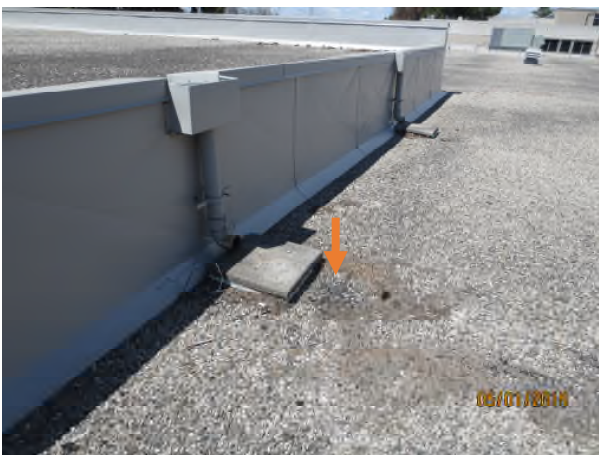
**Photograph 23** – View at east perimeter Area F1  
**Orange arrow** – water discharge from Area F1 washing out gravel on Area E2

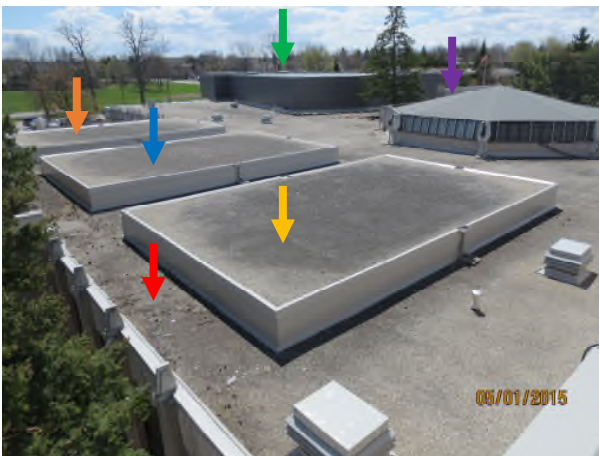
Based on our visual assessment and observations, it is our opinion that only Area K1 is failing and requires replacement within the next 6-12 months.

**Photograph 27** – South-west view from Area D2  
**Orange arrow** – Area H1, **Blue arrow** – Area H2  
**Yellow arrow** – Area H3, **Green arrow** – Area G1  
**Purple arrow** – Area K1, membrane weathered  
**Red arrow** – extensive vegetation/debris

Year	Recommendation	Area	Size	Scope of Work	Preliminary Budget
2015-2016	Roof Replacement (Does not include repairs to concrete)	K1	169 m <sup>2</sup>	Provide insulated 2-Ply Modified Bituminous Membrane	\$70,000.00 to \$80,000.00
2015	Repairs - Clean all drains and scuppers - Remove vegetation - Reinstall missing metal cap flashing - Spray foam and caulk all conduit sleeves and pitch-pans - apply cold adhesive and gravel at 'wind scoured corners' - repair membrane flashings - repair damaged downspout - apply cold adhesive, membrane felt and gravel, where felt is exposed - replace damaged vent sleeves	All Areas and where noted		Cash Allowance	\$8,000.00 to \$12,000.00

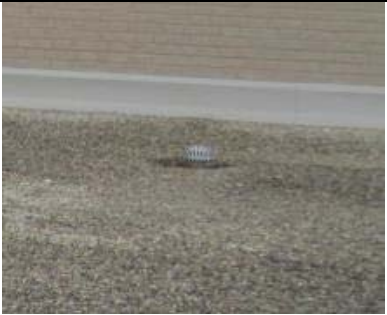
<p>The existing sewer is a separate from the Administration Wing and the Gym Wing as 15" storm sewers running out to the North East Municipal sewers. The sewers have not been recently traced and videoed and all of the original rain water leaders are piped to this original sewer. The sewers are original vintage 1967 interior cast iron and exterior vitreous clay tile. Storm sewers within the building are run down the centre of the ground floor corridors. Rain water leaders are piped in vertical chases to roof drains. Roof drains were changed with the last roof replacement.</p>	<p>In the future, the under ground sewer system should be lined or replaced completely. Lining of the larger sized pipe will be more economical than replacement. The sewer should be reconditioned out to the city sewer(s). During any renovations to the building, it should be planned to replace the storm sewers. This would necessitate saw cutting the ground floor with significant excavation outdoors.</p>	60	12	2	\$800,000

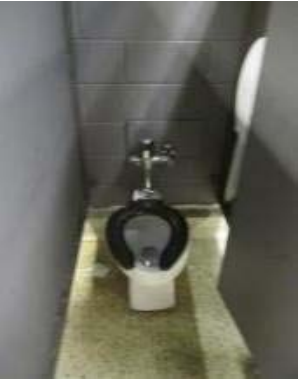
<p>The existing interior above grade sanitary drainage material is cast iron with leaded joints. Buried sanitary sewers are indicated as cast iron on the original building drawings. Sanitary sewer mains run down the centre of the corridors and out to the municipal sewer. The sewers have not been recently traced and videoed and all of the original sanitary risers are piped to this original sewer. The sewers are original vintage 1967 interior cast iron and exterior vitreous clay tile.</p>	<p>In the future, the under ground sewer system should be lined or replaced completely. The sewer should be reconditioned out to the city sewer(s). During any renovations to the building, it should be planned to replace the sanitary sewers. This would necessitate saw cutting the ground floor with significant excavation indoors and outdoors.</p>	60	12	2	\$1,100,000
M1.3	PLUMBING FIXTURES AND TRIM

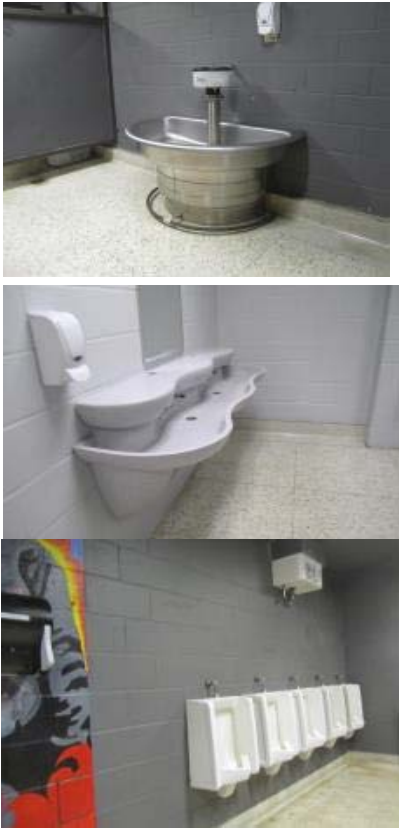
<p>Washrooms on the Third floor have been renovated within the past 2 years. These washrooms were inactive for years prior to the 2014 renovations. After the renovations there were drainage leaks due to the poor condition of the drainage piping. These leaks are typical of older cast iron systems that have not been used regularly.</p> <p>The plumbing fixtures are generally original within the main washrooms. Condition is average with some new washfountains and WCs.</p>	<p>Many of the original plumbing fixtures are in good condition and could be retained however cosmetically, the washroom require upgrading. On the ground floor north washrooms, the fixtures are original and should be replaced.</p>	50	2	4	\$250,000

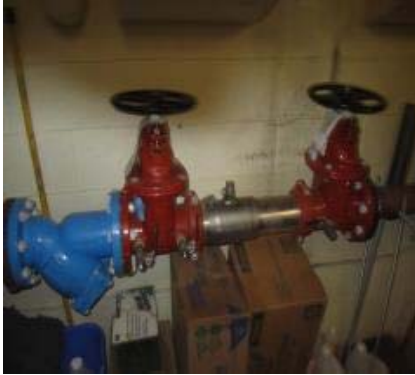
<p>The 4" main city / fire water service enters from the North via a buried meter chamber into the Ground floor Custodians room at the North end of the Admin Wing. A main 4" supply runs in the corridor system from there to the Boiler room. The 4" potable meter and water service is original and a new 4" Watts St.St. 757 double check assembly backflow preventer has been installed in the Boiler Room on the potable water system.</p> <p>It is assumed that the 4" incoming water main is ductile iron.</p> <p>The Recreation centre has a separate 6" municipal water supply that comes onto the site from the South of the High School.</p>	<p>The potable water piping systems are copper pipe and fittings. The plumbing mains passing through the ground floor ceiling space appear to be original piping dating from 1967. For existing piping greater than 25 years old, there is likely a component of leaded solder on the joints and fittings. Any sections of main cold water supply that are more than 25 years old should be replaced. Annual testing of the backflow preventer is required by Code. The incoming water service should be pressure tested since the meter is remote from the building and any leakage is being charged to the Board.</p>	60	12	3	\$80,000

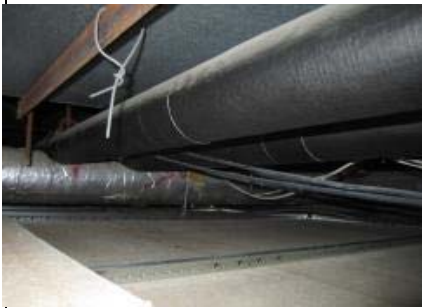
<p>The existing hot and cold water piping in some parts of the original piping systems may have some galvanized steel with screwed fittings. This should be confirmed. This piping is over 48 years old at this time and is due for replacement. The galvanizing on the internal water surfaces can be eroded away and may cause rust coloured water in some situations. Piping over drywall or sprayed textured ceilings was not replaced in 1996. Piping branch valves installed in 1967 are not operable and cannot be used to isolate sections of the School.</p>	<p>The original remaining piping systems have exceeded their expected lifespan. High city water pressure may cause unpredictable piping failures. Any galvanized potable water piping systems should be replaced with copper piping and lead free soldered joints. All new potable mains should be insulated with over-sized hangers and vapour barriers and new isolation ball valves installed at each riser set. Sectional isolation valves are recommended.</p>	50	2	2	\$500,000

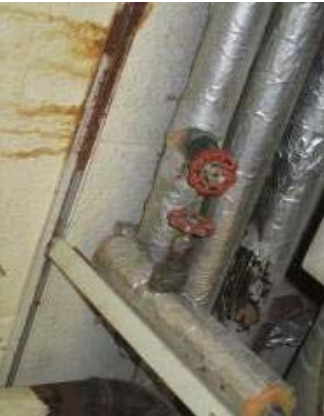
<p>Domestic piping insulation on corridor mains is fiberglass insulation dating from the original year 1967. Original fiberglass insulation with tar vapour barrier is used in the corridors. Services and directions of flow are not well marked. asbestos will still be on some piping located in inaccessible locations such as plaster ceilings.</p>	<p>Asbestos insulation within the Boiler room has been removed by an asbestos abatement firm. Any new piping will require new mineral fibre insulation and complete vapour barrier protection.</p>	60	12	2	\$150,000
M2.4	WATER HEATING SYSTEMS	 	<p>Domestic water is heated in the Boiler room via 6 gas fired instantaneous copper tube style water heaters with no conventional storage tank. The water heater is a forced draft venting system to the South exterior wall of the Boiler room. The domestic hot water is piped into the lower level corridor ceiling space system of the School and distributed to the washrooms and main Kitchen. There is a recirculation loop on the water mains to the boiler room. A main thermostatic mixing valve sets the maximum hot water temperature leaving the heating system.</p>	<p>The existing water heating system is acceptable and is recently installed. Demand is met by the systems with minimal standby losses. No changes are foreseen for 5 years. The sequencing panel set up should be checked annually to ensure the proper set points are active.</p>	15	10	2	\$50,000

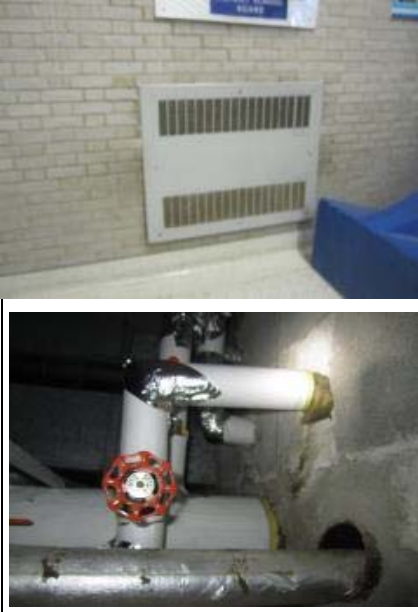
<p>The School contains a average amount of hydronic heating and relies on the Ground floor ceiling space of the corridors for the main distribution piping loops for the heating energy. Entrance heaters at the stairwells and main entrances do contain hydronic heaters and these units should be repiped with new piping.The hydronic heating piping appears to be original 1967 vintage piping material and is steel with screwed joints. The piping has exceeded it's service life and requires replacement.</p>	<p>Replacement of the hydronic piping and horizontal mains in ceiling spaces to the Boiler Room will be expensive. Architectural finishes and pipe routing will dictate the routing of the heating mains and the reheat coils. In the Administration wing, the VAV boxes and the reheat coils were replaced in 2007 and should be servicable for another 20 years. Direct buried piping for the Auditorium wing runs from the Boiler room. 6" steel piping dates from 1967 , is buried in a 24" tile and is due for replacement.</p>	60	5	2	\$850,000

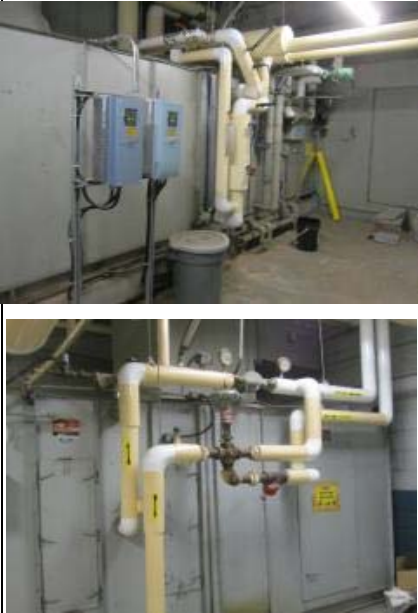
The original 1967 Air Handling Units remain and are in fair condition. Cooling coils for the three Third Floor AHUS were replaced in 2007. The balance of the coils, fans and casings are original and may remain servicable for the next 10 years.	Replacement of fan belts, bearing s and replacing failed coils is a viable maintenance approach for the central AHUS. The fans have variable speed drives installed in 2007. The AHUS can be replaced with modular sectional AHUS if required however, the most economical approach is to maintain the fans and to repalce the coils as required.	60	10	3	\$350,000

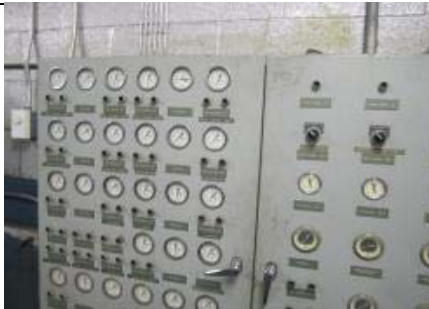
The existing Heating and cooling control system is a Johnson Direct Digital Controls (DDC) system which controls the Cooling controls, the Boilers, pumps, the ventilation dampers and the supply fans.	This DDC BAS control system has been installed and functional. All major mechanical equipment is connected and controlled by the BAS system. Replacement of terminal controllers when failures occur is the usual method of gradually upgrading the BAS system to newer hardware.	25	5	2	\$150,000

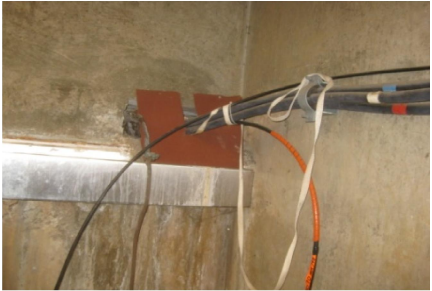
1.1	Incoming HV Cables

Underground 15kV single circuit, 3-phase cables in conduit to Electrical Room then free-air to main switchboard. Likely owned by Horizon Utilities. Cables appear to have been replaced in the last 10 years.	Recommend power shut-down to megger test each conductor. Perform thermal inspection testing of HV terminations.	\$10,000.00	5 years

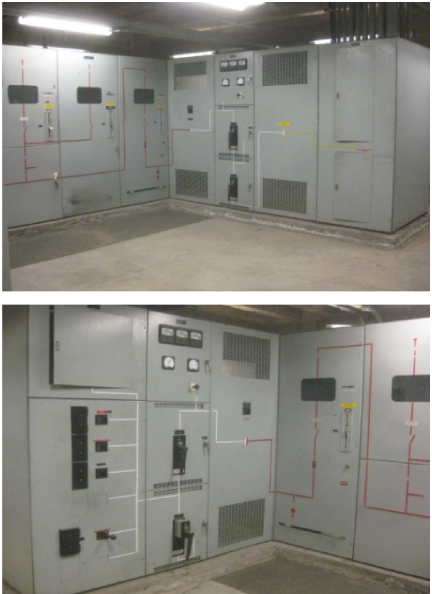
1.2	Main Switchboard

Westinghouse 13.8kV, 3-phase with two main utility 13.8kV, 600A, 40kA Fault Interruptor switches tied to a common bus (one is locked out with no incoming feed cables). Two main Owner 13.8kV, 600A 40kA Fault Interruptor switches each feeding a 1000kVA, 13.8kV/600V transformer (north & south switchboard sections). North transformer feeds a 1000A fused switch to various 600V load switches & a 1000A fused tie-switch to the south section. South transformer feeds a 1000A fused switch to a 500kVA, 600V/120-208V transformer & a 1000A fused tie-switch to the north section. The North section has four 600V load breakers & a 600V distribution panel board. The South section has two 120/208V distribution panel boards. Switchboard is original from 1969.	Recommend power shut-down to clean entire switchboard, inspect and torque all bus-bar connections. Perform megger testing of each transformer. Test and replace as necessary all fuses. Perform thermal inspection testing of all connections, disconnects, breakers and panel boards.	\$35,000.00	Subject to test results.

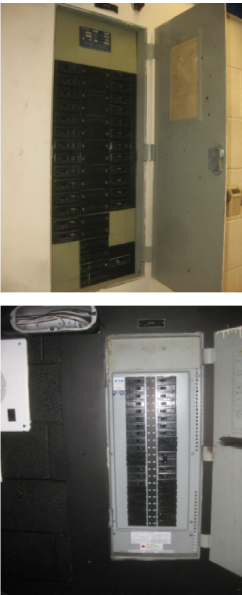
No.	Description	Photograph	Existing Condition	Proposed Changes/Recommendations	Budget Costs	Est. Remaining Service Life (Years)
2.0	<b>POWER DISTRIBUTION</b>					
2.1	Panel Boards

Numerous Westinghouse 100A & 200A, 120/208V 3-phase panel boards throughout (original from 1969). Several newer panel boards of various manufacturers from several building renovations of various ages up to 2014 (Auditorium).	Recommend thermal inspection testing of all original panel boards, visual inspection of all newer panel boards & updating of panel board index cards.	\$20,000.00 (for original panel boards) + \$5,000.00 (for newer panel boards)	Subject to test results for original panel boards (5 years for newer panel boards).

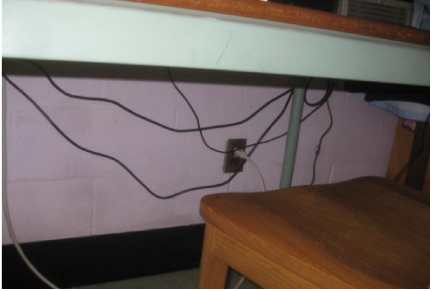
Numerous original grounded receptacles throughout. Recessed, surface mounted and wireway mounted. Numerous new grounded receptacles throughout. Recessed, surface mounted and wireway mounted.	Recommend visual inspections & testing in areas of concern or high use.	\$5,000.00	Subject to test results.

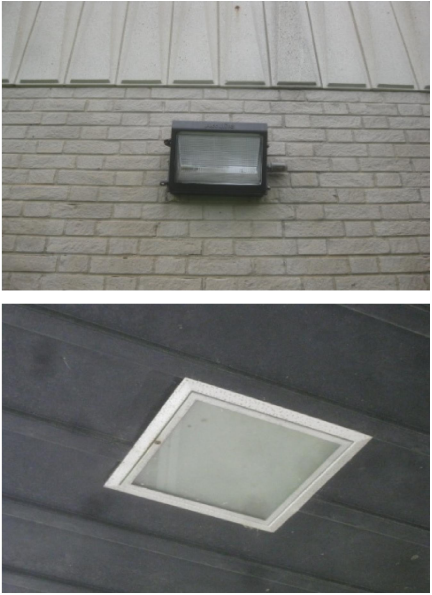
No.	Description	Photograph	Existing Condition	Proposed Changes/Recommendations	Budget Costs	Est. Remaining Service Life (Years)
3.0	<b>LIGHTING</b>					
3.1	Exterior Lighting:					
3.1.1	Building Fixtures

Some original mercury vapour wall pack fixtures. Some original incandescent down light fixtures in canopies. Some older high pressure sodium wall pack fixtures. Several new LED wall pack fixtures.	Recommend replacing all fixtures with new LED wall pack fixtures and down light fixtures. Recommend new exterior lighting control system.	\$70,000.00	Original fixtures have reached service life.
3.1.2	Parking Lot / Roadway Fixtures

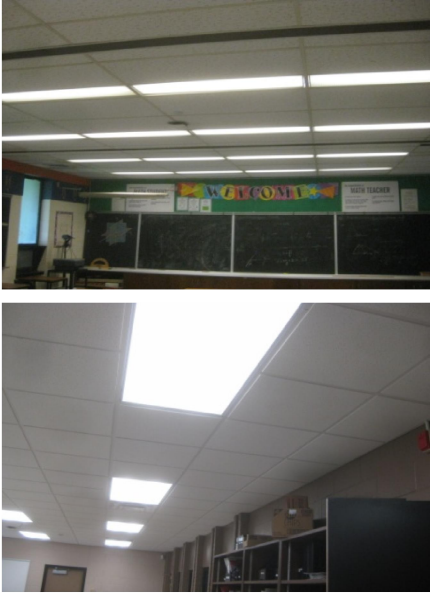
3.2.1	Classroom / Office Fixtures

<p>Most classrooms have original 1x4 Troffer fixtures upgraded to T8 lamps 20 years ago. 10% of classrooms have new 1x4 LED Troffer fixtures installed in the last couple of years. Most office areas have original 1x4 &amp; 2x4 Troffer fixtures upgraded to T8 lamps 20 years ago. 5% of offices have new LED Troffer fixtures installed in the last couple of years.</p>	<p>Recommend replacing all original fixtures with new LED equivalents. Existing new LED fixtures to remain. Occupancy sensors should be provided.</p>	\$250,000.00	Original fixtures have reached service life.

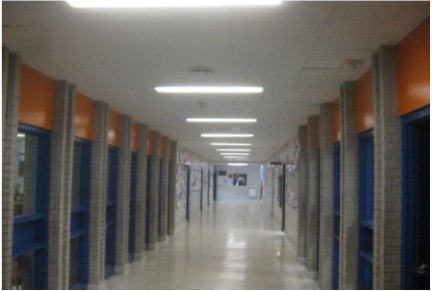
3.2.2	Corridor Fixtures

<p>Original 1x4 &amp; 2x4 Troffer fixtures upgraded to T8 lamps 20 years ago.</p>	<p>Recommend replacing all original fixtures with new LED equivalents. Occupancy sensors should be provided.</p>	\$100,000.00	Original fixtures have reached service life.

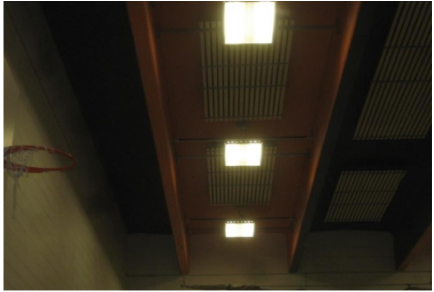
No.	Description	Photograph	Existing Condition	Proposed Changes/Recommendations	Budget Costs	Est. Remaining Service Life (Years)
3.2	Interior Lighting (continued):					
3.2.3	Gymnasium Fixtures

Newer 3x4 surface T8 caged gymnasium fixtures. Installed in 2009.	Recommend replacing all fixtures with new LED 2-level gymnasium fixtures. Controls & occupancy sensors should be provided.	\$150,000.00	Original fixtures have reached service life.
3.2.4	Auditorium Fixtures

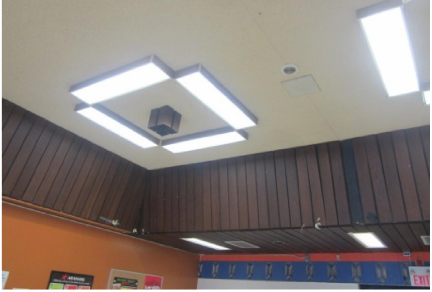
No.	Description	Photograph	Existing Condition	Proposed Changes/Recommendations	Budget Costs	Est. Remaining Service Life (Years)
3.2	Interior Lighting (continued):					
3.2.6	Cafeteria Fixtures

Original 1x4 Troffer & surface box fixtures upgraded to T8 lamps. Original incandescent down light & decorative cube fixtures.	Recommend replacing all original fixtures with new LED equivalents. Occupancy sensors should be provided.	\$50,000.00	Original fixtures have reached service life.
3.2.7	Shop Classroom & Service Area Fixtures

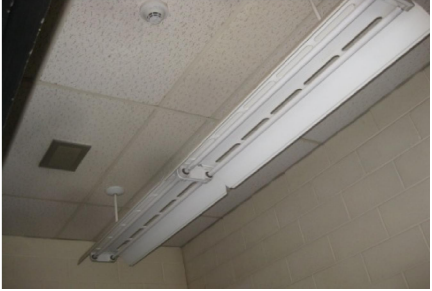
Original 4 ft. industrial & strip fixtures upgraded to T8 lamps.	Recommend replacing all original fixtures with new LED equivalents. Occupancy sensors should be provided.	\$20,000.00	Original fixtures have reached service life.

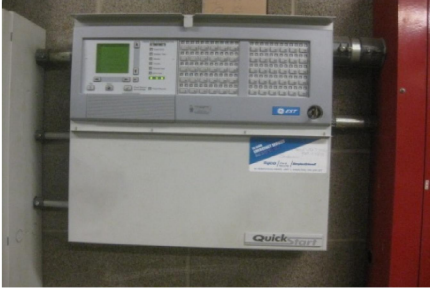
No.	Description	Photograph	Existing Condition	Proposed Changes/Recommendations	Budget Costs	Est. Remaining Service Life (Years)
4.0	<b>LIFE SAFETY SYSTEMS</b>					
4.1	Fire Alarm System:					
4.1.1	Main Fire Alarm Panel

Newer Edwards EST QuickStart addressable panel located in Basement Electrical Room. Installed in 2001.	Recommend panel to be inspected & tested by equipment manufacturer.	\$1,000.00	5 years
4.1.2	Fire Alarm Annunciators

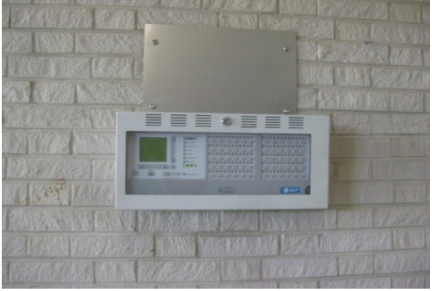
Newer Edwards EST QuickStart units located in Front Vestibule, Main Office & Caretaker's Office. Installed in 2001.	Recommend units to be inspected & tested by equipment manufacturer.	\$2,000.00	5 years
4.1.3	Fire Alarm Devices

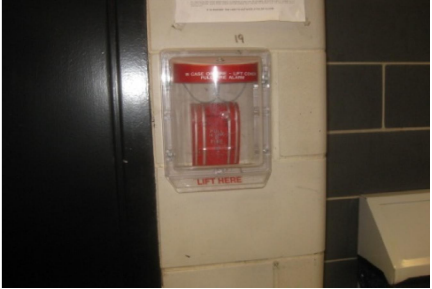
Newer Edwards devices. Installed in 2001.	Recommend units to be inspected & tested by equipment manufacturer.	\$8,000.00	5 years

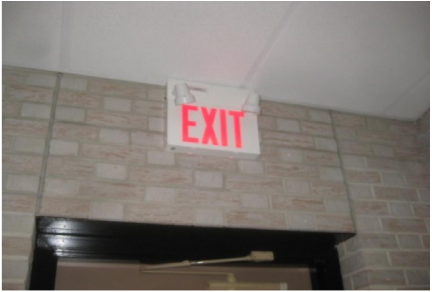
No.	Description	Photograph	Existing Condition	Proposed Changes/Recommendations	Budget Costs	Est. Remaining Service Life (Years)
4.2	Emergency / Exit Lighting:					
4.2.1	Exit Signs

Newer Lumacell self-powered LED exit & combination emergency/exit lighting units. Installed in 2001.	Recommend units to be inspected & tested.	\$5,000.00	5 years
4.2.2	Emergency Battery Units

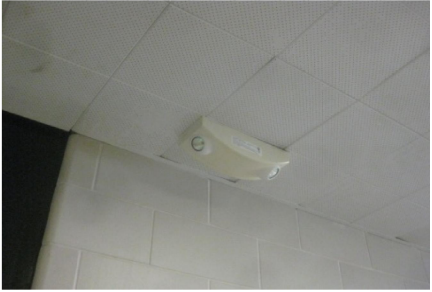
Newer Lumacell self-powered double-head emergency lighting battery units. Installed in 2001.	Recommend units to be inspected & tested.	\$5,000.00	5 years
4.2.3	Inverter Units

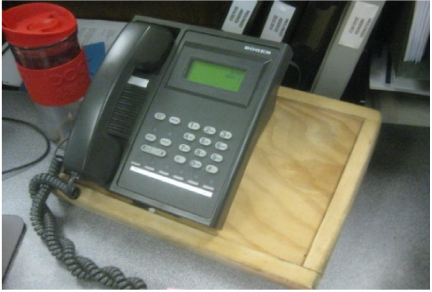
Two newer Bogen units located on secretary desks in Main Office. Installed in 2012.	Recommend providing four additional units for Principal, Vice-Principal, Guidance & one other.	\$4,000.00	New
5.1.3	Classroom Units

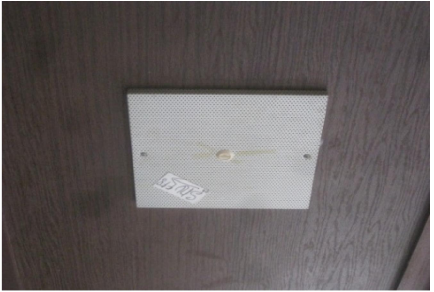
No.	Description	Photograph	Existing Condition	Proposed Changes/Recommendations	Budget Costs	Est. Remaining Service Life (Years)
5.1	P/A and Clock System (continued):					
5.1.4	Corridor Speakers

Numerous original Electrovox speakers.	Recommend replacing all units & related wiring with new.	\$20,000.00	Original units have reached service life.
5.1.5	Master Clocks

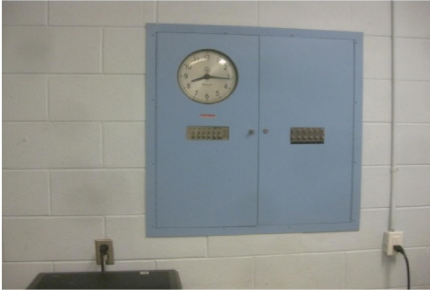
Original Simplex Master clock control located in Main Office. Most original slave clocks throughout. System abandoned.	Recommend removing all original clock equipment & related wiring and providing new digital clock system throughout.	\$60,000.00	Abandoned
5.1.6	Modular Control Panels (MCP's)

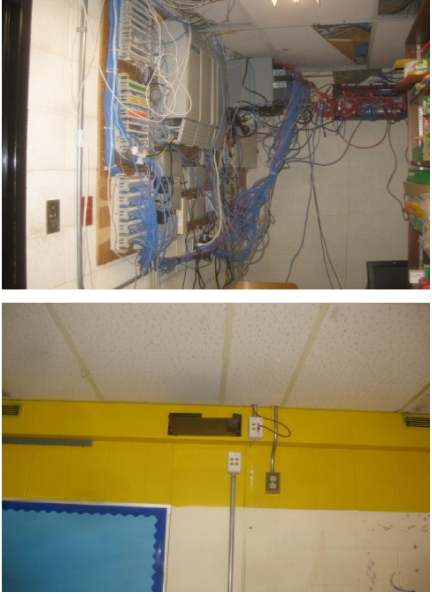
No.	Description	Photograph	Existing Condition	Proposed Changes/Recommendations	Budget Costs	Est. Remaining Service Life (Years)
5.2	Data and Telephone Wiring (continued):					
5.2.3	Main Server

Existing main Data Server equipment is located in Server Closet in Guidance Area. Numerous remote DAP's throughout building. Some new DPA's installed in 2014 renovations.	Recommend reviewing all data wiring within building and upgrading as required.	\$40,000.00	5 years
5.2.4	Data / Telephone Outlets

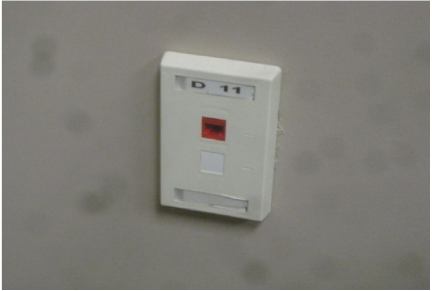
Numerous data outlets throughout building. Some upgraded in 2014 renovations.	Recommend reviewing all data outlets within building and upgrading as required.	\$30,000.00	5 years

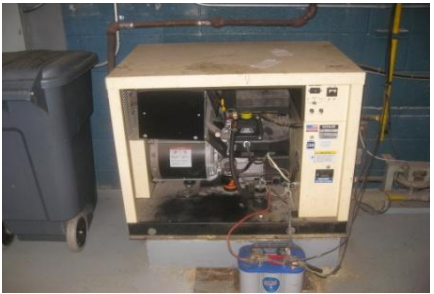
No.	Description	Photograph	Existing Condition	Proposed Changes/Recommendations	Budget Costs	Est. Remaining Service Life (Years)
7.0	<b>MISCELLANEOUS SYSTEMS</b>					
7.1	Emergency Generator

Original small natural gas emergency generator & related transfer switch located in Boiler Room. Provides back-up power for sump pumps only.	Recommend replacing all related equipment with new.	\$25,000.00	Original equipment has reached service life.

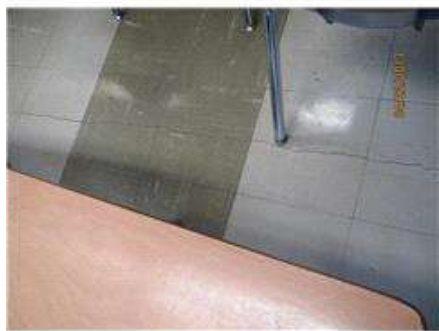
**Condition Assessment** 2013 - The structure frame assembly is showing signs of settlement and cracks on the exterior wall and floors from inside of the building.

Apr 2013- Evidence of recent floor cracking in the Classroom 308 on the thrid floor east side of the building.

**Recommendation** 2013 - Evidence of settlement and cracks on the walls floor. Conduct a study/review to determine the cause, course of corrective action and, cost.

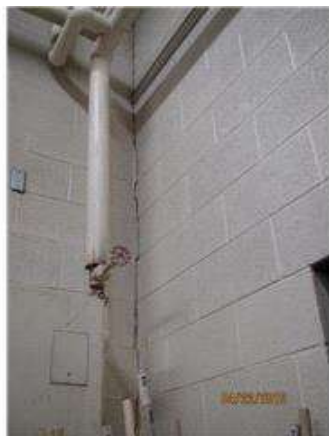
Apr 2013-Crack in the exercis room.

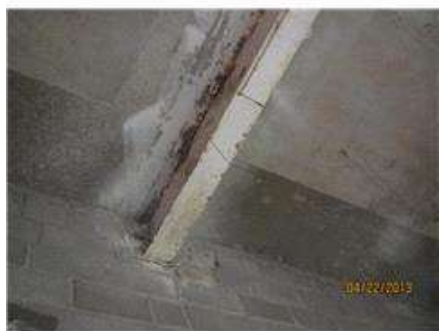
Apr 2013- Evidence of structural Pressure in the GYM storage.

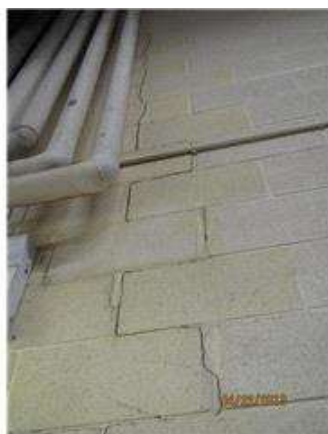
Apr 2013- Crack in the GYM on stage wall.

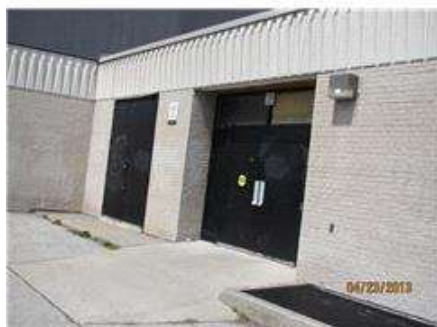
2013 - The majority of the exterior door assemblies are original, with worn finish, corroded frames, deteriorated door seals, single glazed vision lites and have exceeded their effective design rated life.

Apr 2013- Typical exterior doors.

2013 - The majority of the exterior door assemblies are original and have exceeded their effective design rated life. Replacement of the door assemblies is recommended.

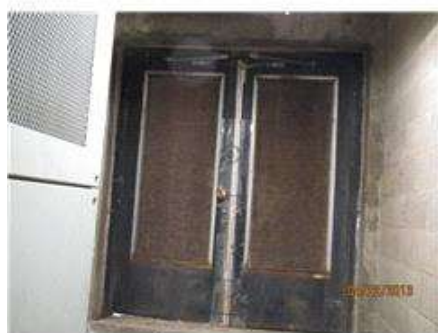
Apr 2013- Deteriorated exterior door.

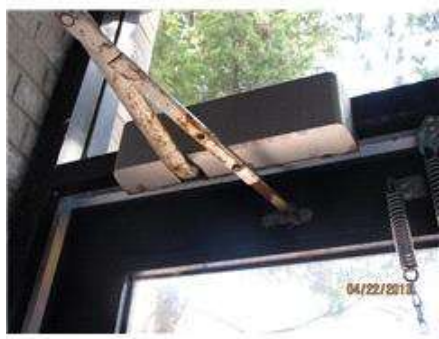
**Condition Assessment** 2013 - At the time of the assessment the exterior door was in poor condition, showing signs of wear and tear due to use.

Apr 2013- Typical exterior door hardware.

2013 - It recommended that the exterior door hardware should be replaced at the time the exterior doors are replaced.

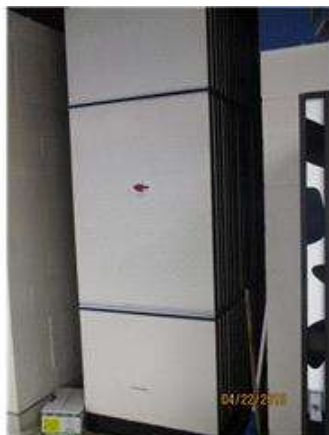
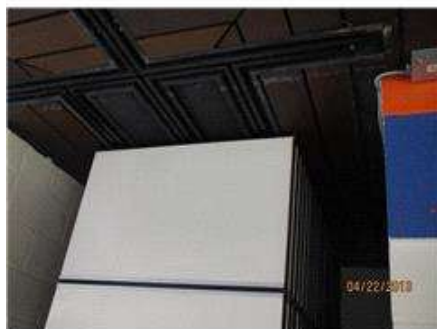
2013 - The moveable partition located in the double cafeteria are in fair condition.

Apr 2013- Movable partition in the cafeteria.

2013 - The moveable partition has surpassed its EUL Planning for renewal is recommended for the latter portion of 5 year planning window.

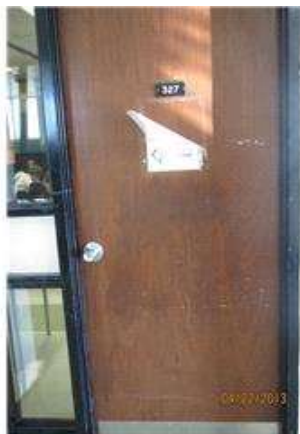
2013 - At the time of the assessment the interior doors were in fair condition, they were showing signs of age and they had past expected useful life.

Apr 2013- Typical wood veneer interior door.

2013 - The interior doors have exceeded their effective design rated life with the majority of the doors exhibiting damage. Replacement of the interior doors is recommended.

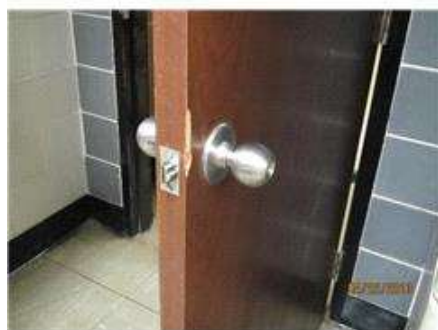
Apr 2013- Damage interior door.

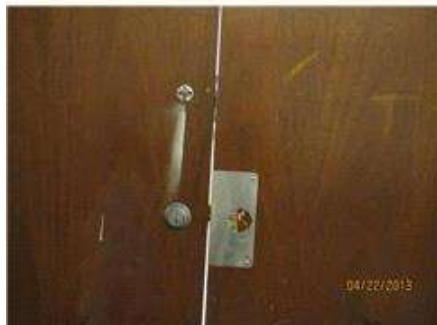
**Condition Assessment** 2013 - The interior door hardware are in fair. The components are appearing worn.

Apr 2013- Worn interior hardware.

2013 - The interior door hardware has worn out. Replacement is recommended.

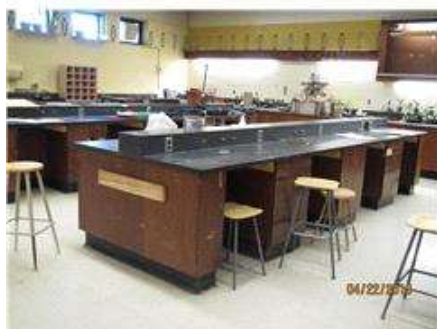
2013 - At the time of the assessment all cabinetry, millwork items, counters and countertops were in a poor condition

Apr 2013- Typical millworks in the Sience classrooms.

2013 - As all the cabinetry, millwork items, counters and countertops have exceeded their expected useful life and are in fair condition the recommendation is to replace them

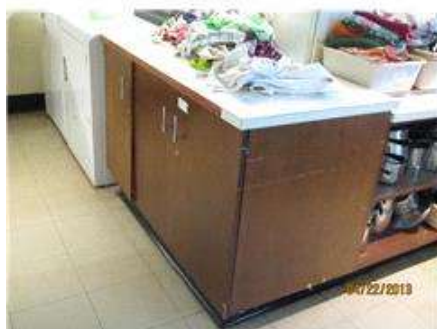
Apr 2013- Damaged Millwork in the home maker classroom.

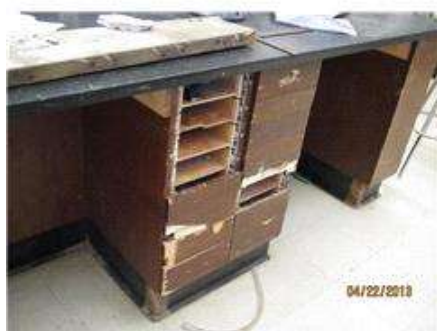
Apr 2013- Damaged Millwork in the art shop classroom..

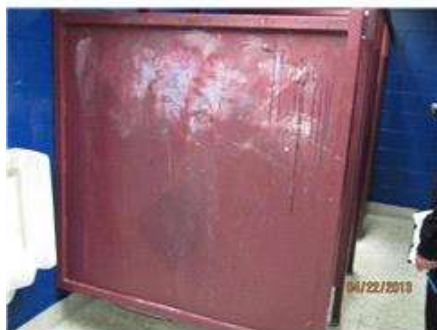
**Condition Assessment** 2013 - At the time of the assessment the painted metal toilet partitions are original and are showing signs corrosion, damage worn finish and unreliable or missing hardware.

Mar 2013- Typical worn floor mounted washroom partitions in the original building.

**Recommendation** 2013 - The original floor mounted painted toilet partitions have exceeded their effective rated design life. Replacement is recommended.

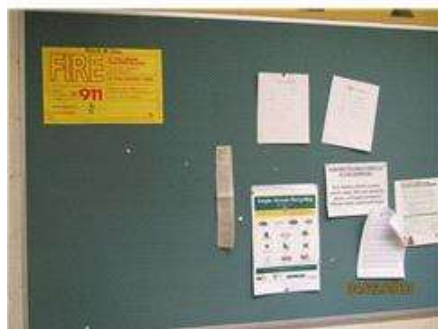
2013 - Lockers are generally in poor condition throughout the school, the chalkboards are from the original build

Apr 2013- Typical Chalk board in the classrooms.

2013 - Recommend lockers and chalkboards be replaced

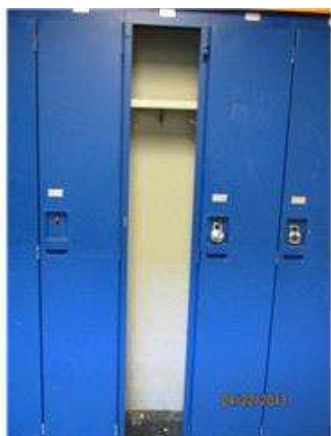
Apr 2013- Typical worm lockers in the school.

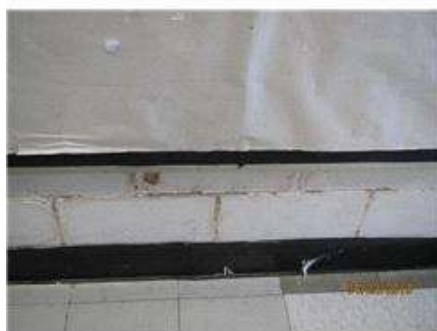
**Condition Assessment** 2013 - At the time of the assessment the typical painted wall finish on CMU and GWB walls was starting to look worn from normal day to day use.

Apr 2013-Damaged and worn wall covering.

**Recommendation** 2013 - The painted wall finishes throughout the school are starting to look worn from normal day to day use with some faded and peeling areas. Refinishing of the school is recommended.

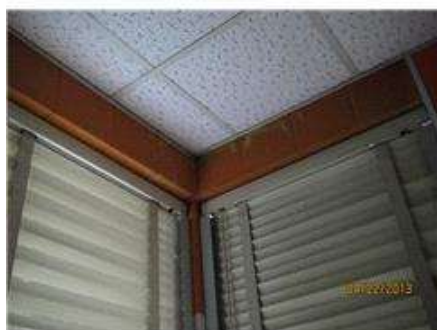
Apr 2013- damaged wall covering.

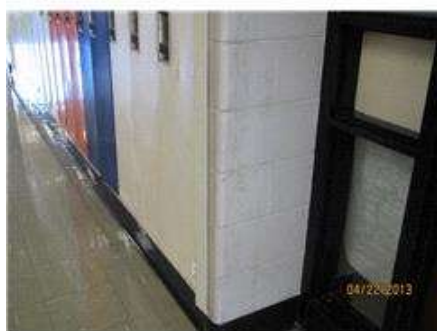
Apr 2013- Worm wall covering.

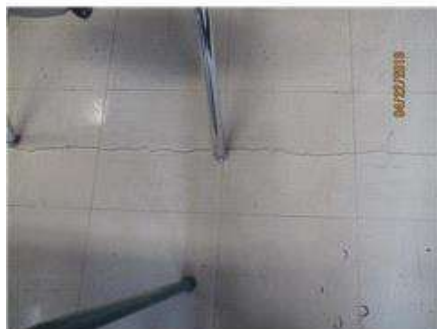
2013 - The vinyl composite floor tile is showing signs of wear and discoloration.

Apr 2013- Deteriorated VCT.

2013 - The vinyl composite floor tile and vinyl base is exhibiting signs of wear and has exceeded its effective rated design life. Replacement planning is recommended.

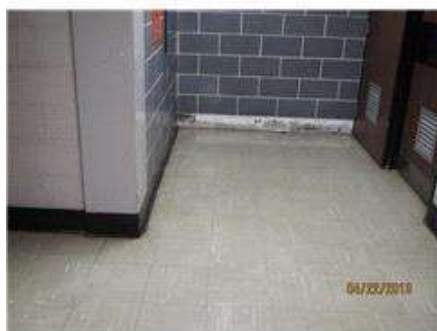
Apr 2013- Worn VCT and missing base board.

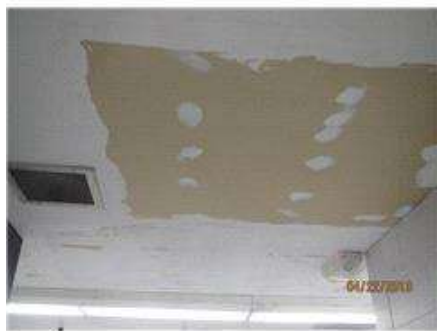
Apr 2013- repaired but un-finished gypsum board ceiling.

**Recommendation** 2013 - Gypsum board ceilings are un-finished. Paint refinishing recommended.

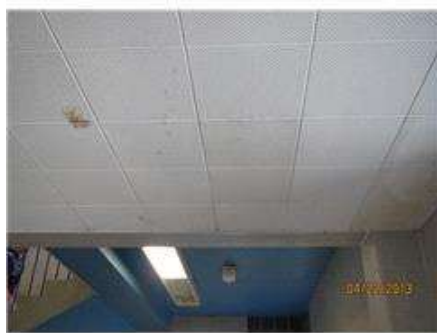
**Condition Assessment** 2013 - The ACT suspended ceiling system is showing signs of wear and damage.

Apr 2013- Stained ceiling tiles.

**Recommendation** 2013 - The acoustical suspended ceiling tile system is showing signs of wear. Replacement is recommended.

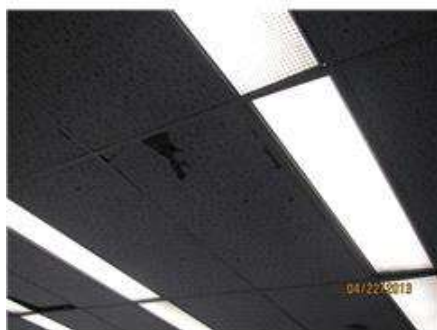
Apr 2013- Worn ceiling tile.

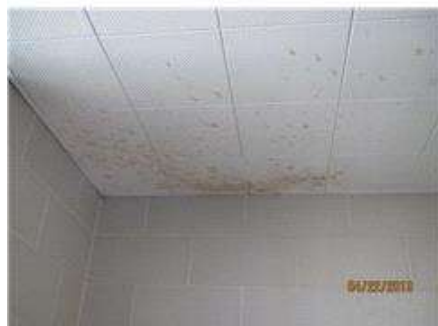
**Condition Assessment** 2013 - The ACT suspended ceiling system is showing signs of wear and damage.

Apr 2013- Stained acoustic ceiling tiles.

2013 - The acoustical suspended ceiling tile system is showing signs of wear. Replacement is recommended.

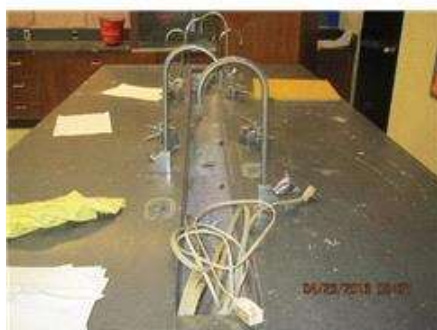
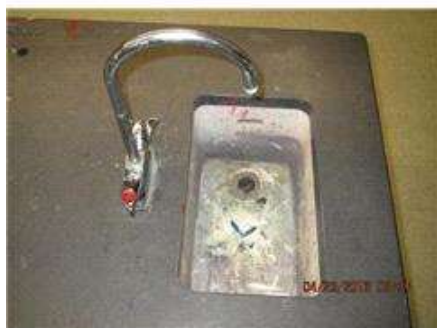
2013 - The majority of the plumbing fixtures appear to be functioning and are in fair to good condition. Some fixtures (40%) have been replaced overtime. The majority of the fixtures have surpassed their normal service life and are inefficient. Planning for renewal is recommended. The Bradley basins and water closets are in fair condition. The science lab sinks are aged stained and in poor to fair condition.

April 2013 - Aged Science Lab Sinks

2013 - Replacement of the aged science lab sinks is recommended based on age and condition.

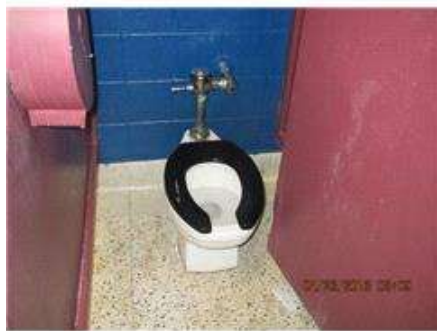
April 2013 - Typical Aged Water Closets

2013 - The Bradley basins and water closets in the school are aged and past their rated useful life. Replacement is recommended.
