## HAMILTON – WENTWORTH DISTRICT SCHOOL BOARD CONCEPT DESIGN AND FEASIBILITY STUDY

## SIR ALLAN MACNAB SECONDARY SCHOOL

145 MAGNOLIA DRIVE, HAMILTON

Grguric Architects Incorporated:  
Sir Allan MacNab High School Facility Conditions Assessment - June 26, 2015 (63 pages)

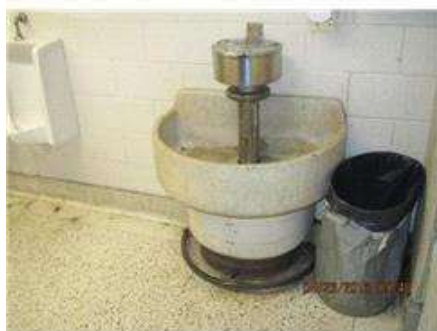
April 2013 - Typical Aged Bradley Basin

2013 - The Bradley basins and water closets in the school are aged and past their rated useful life. Replacement is recommended.

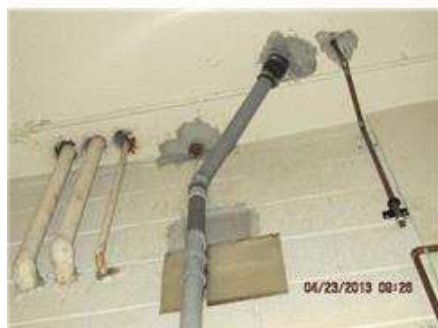
2013 - The domestic piping system is mostly concealed and therefore the current condition is not fully known. However due to the age, the expected wear and the theoretical useful life, the system is assessed as being in fair condition.

April 2013 - Domestic Water Distribution Piping

2013 - Based on the age and theoretical useful life of the domestic water piping system replacement is recommended. A study is recommended to determine the current condition, remaining service life, current service requirements and the cost of replacement.

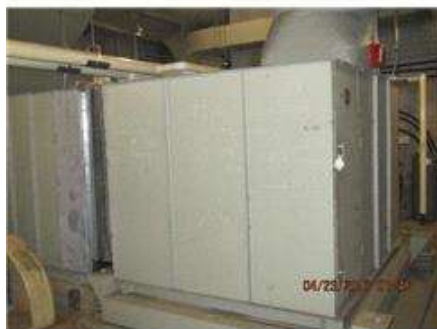
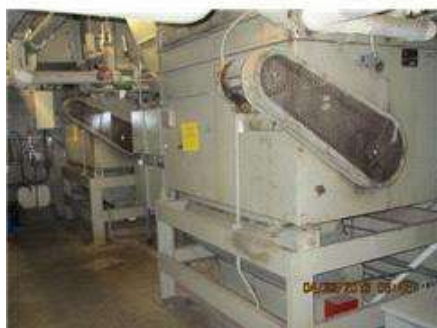
April 2013 - Original Air Handling Unit

April 2013 - Original Air Handling Units

2013 - Due to age and mechanical wear, the central air handlers should be replaced within the next 5 years for reliability.

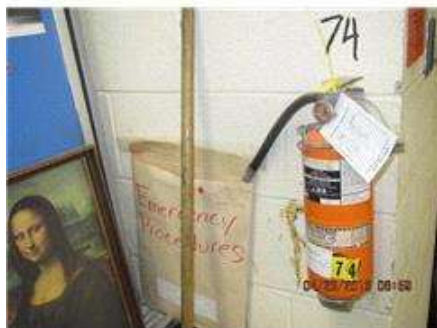
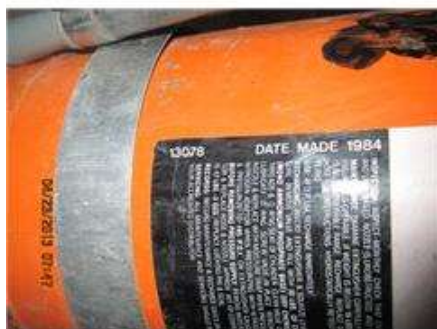
April 2013 - Aged Fire Extinguishers

April 2013 - Fire Extinguishers Manufacture Date 1984

2013 - Based on the age and theoretical useful life of the fire extinguishers replacement of the outdated and aged fire extinguishers is recommended within the next three years.

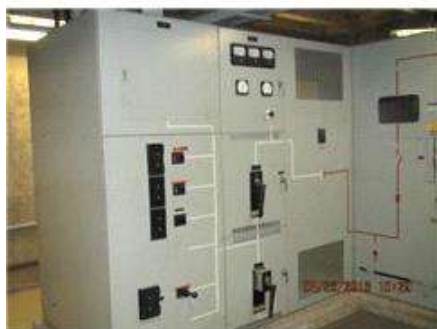
April 2013 - Original Main Switchboard

<b>Recommendation</b>	2013 - Replacement of the aged main switchboard is recommended based on age.
-----------------------	--

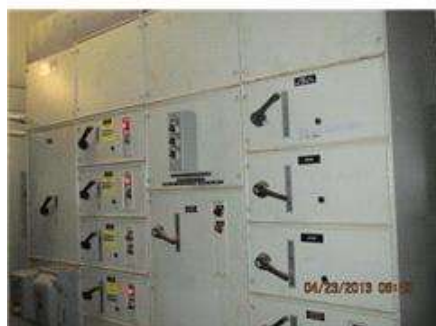
April 2013 - Aged Motor Control Centre

**Recommendation** 2013 - Planned replacement of the motor control centers is recommended within the next 5 years.

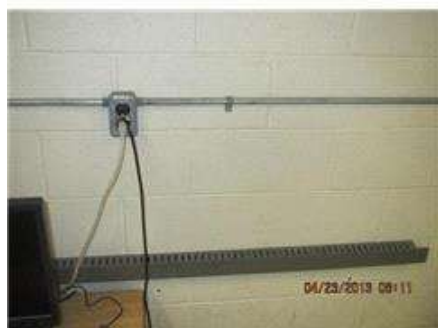
April 2013 - Original Branch Wiring Conduit

2013 - Based on the age of the branch wiring, replacement is recommended. An in depth study should be conducted to determine the current condition, remaining useful life cost of replacement.

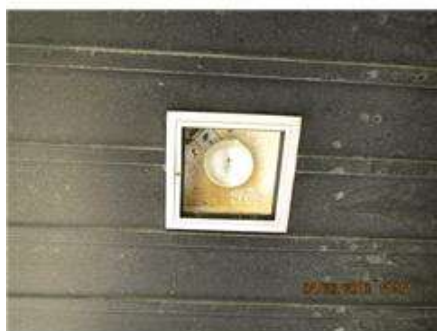
April 2013 - Original Soffit Lighting Fixture

2013 - The exterior lighting fixtures are original and appear to be functional at this time, but have surpassed their anticipated service life. Replacement of existing aged lamps and fixtures with higher efficiency lamps and fixtures is recommended.

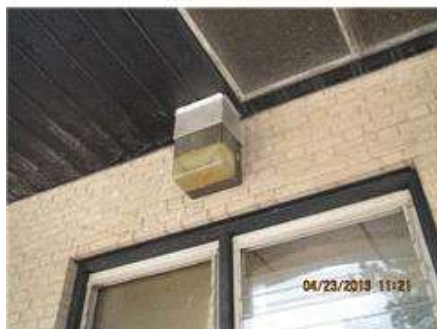
April 2013 - Original Wall Mounted Lighting Fixture

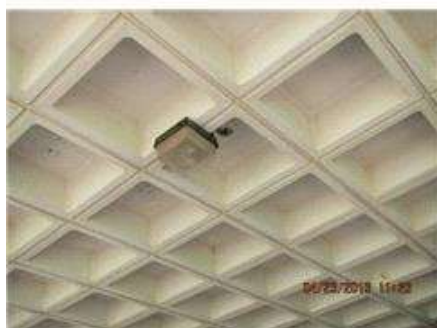
April 2013 - Aged Lighting Fixture Main Entrance Overhang

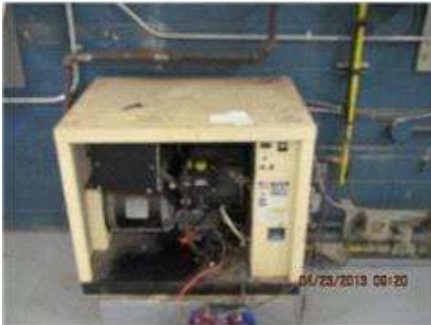
April 2013 - Aged Generator

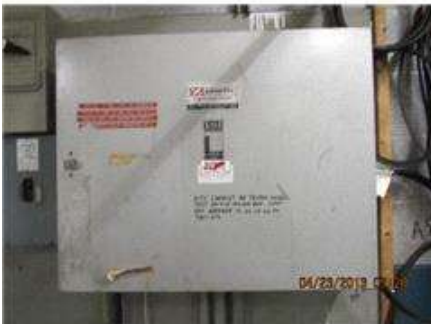
April 2013 - Original ATS

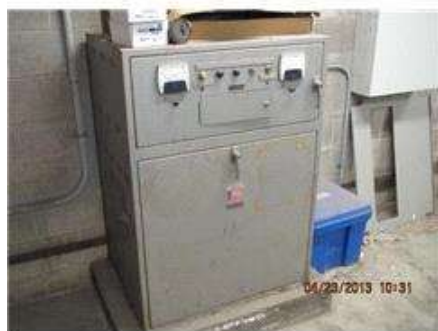
## April 2013 - Aged Emergency Lighting Battery Bank

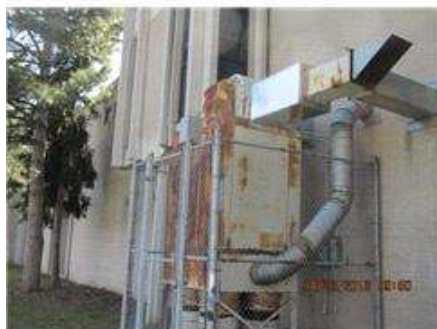
April 2013 - Aged and Corroding Dust Collector

2013 - Replacement of the aged and corroding dust collector is recommended.

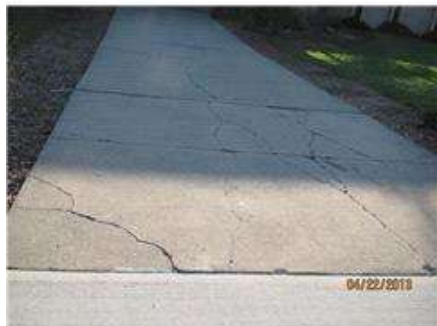
2013 - The concrete sidewalks are showing signs of uneven and cracked surfaces with signs of vegetation growth and spalling sections of concrete. Replacement is recommended.

Apr 2013- Cracked concrete pedestrian.

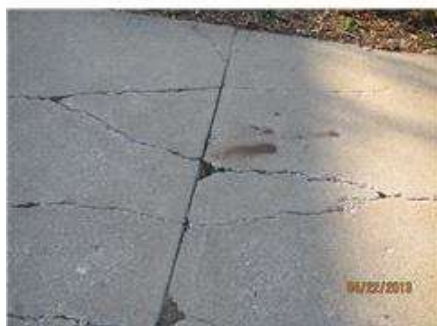
Apr 2013- Cracked concrete pedestrian.
