HAMILTON-WENTWORTH DISTRICT SCHOOL BOARD

FEASIBILITY STUDY and CONCEPT DESIGN

Orchard Park Secondary School
200 DeWitt Road, Hamilton, ON

November 2015

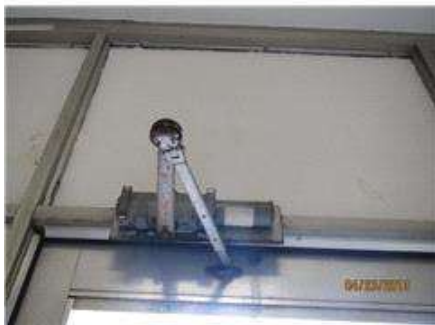
Apr 2013- Typical worn and outdated exterior door hardware.

2013 - It is recommended that the exterior door hardware should be replaced at the time the exterior doors are replaced.

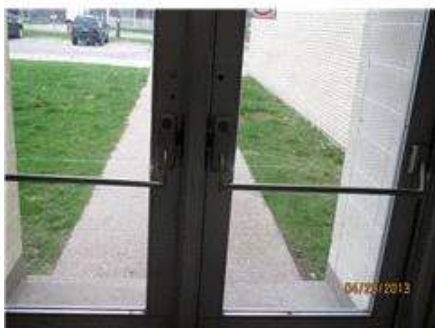
Apr 2013- Worn Exterior door hardware.

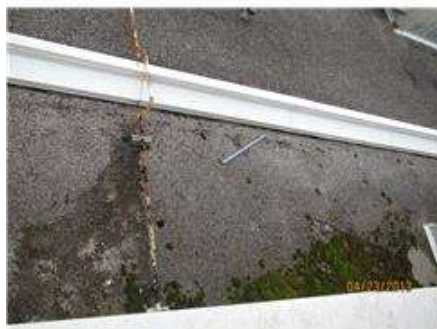
2013 - The condition of the original building roof assembly is consistent with its age and is in fair overall condition, with patches, blisters, ridging, discoloration, wind scour and cracking of the cap sheet noted at the time of the assessment. roof leaks were reported which have been resolved.

Apr 2013- Evidence of vegetation growth due to age of the roof and water ponding.

2013 - The roof assembly system of original building is beyond its expected service life and is no longer performing as intended. Replacement is recommended.

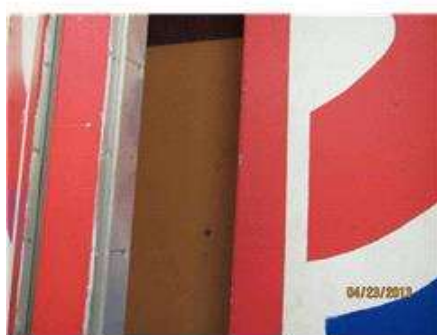
Condition Assessment 2013 - The moveable folding partition in the gymnasium is peeling, damaged, and has surpassed its expected useful life. Replacement is recommended.

Apr 2013- movable partition.

Recommendation 2013 - The moveable partition in the gymnasium has surpassed its expected useful life. Replacement is recommended.

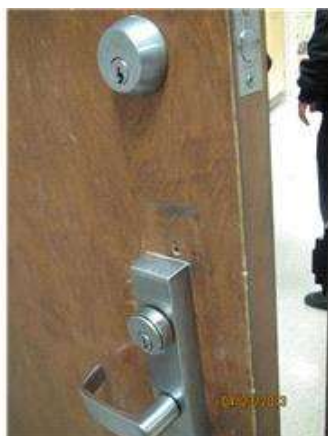
Condition Assessment 2013 - The interior door hardware is original and has exceeded its effective rated design life. The components are appearing worn with reports of some reliability issues.

Apr 2013- Typical interior door hardware.

Apr 2013- Worn interior hardware.

2013 - The interior door hardware has exceeded its effective design rated life. Replacement planning is warranted.

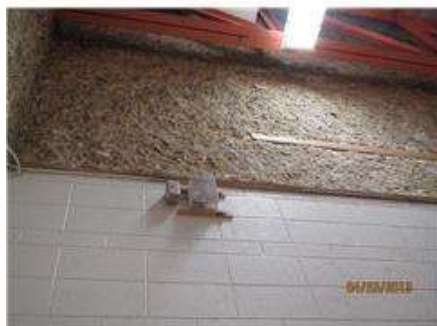
Apr 2013- Aged and corroded acoustic wall covering in the GYM.

2013 - Recommend all the interior acoustic wall covering in the GYM to be restored as the finishes are fading and showing signs of age.

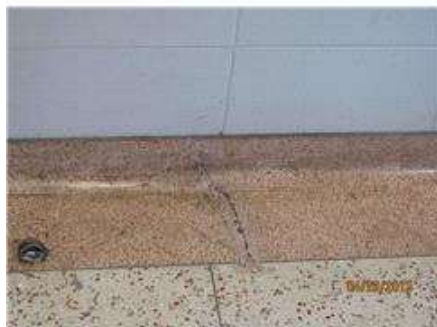
Apr 2013- Cracked terrazzo in the corridor.

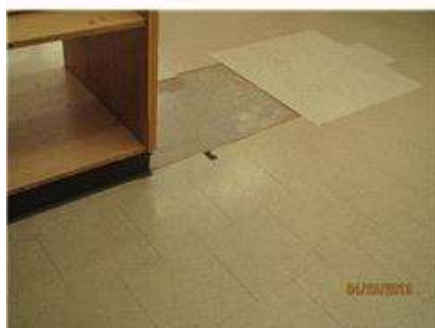
Apr 2013- Evidence of VCT deterioration.

2013 - The vinyl composite floor tile and vinyl base is exhibiting signs of wear and has exceeded its effective rated design life. Replacement planning is recommended.

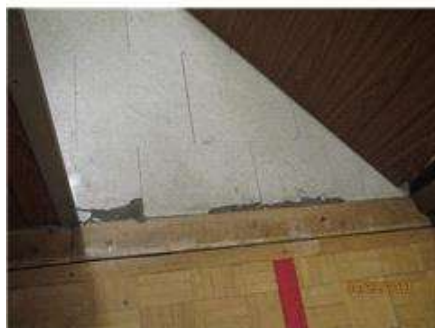
Apr 2013- Evidence of VCT deterioration.

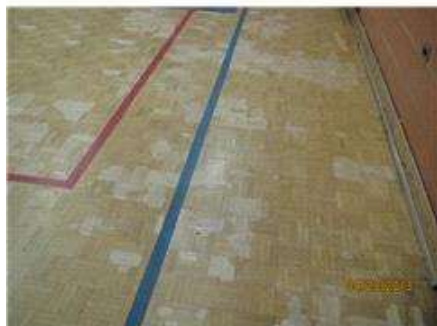
2013 - The hardwood strip flooring on the stage and, in GYM are in poor condition. Refinishing or replacement of the hardwood flooring is recommended.

Apr 2013- Worn hardwood flooring in the GYM.

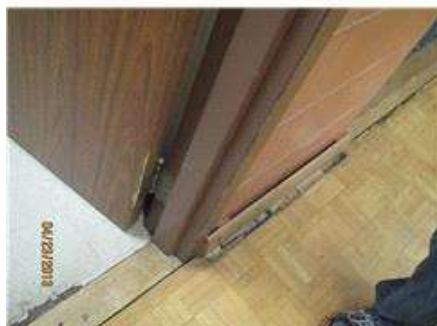
Apr 2013- Worn Hardwood flooring in the GYM.

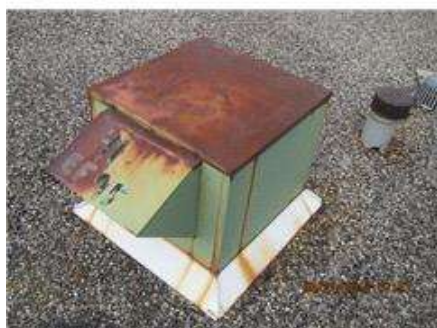
April 2013 - Original Rooftop Exhaust Fan - Aged and Weathered

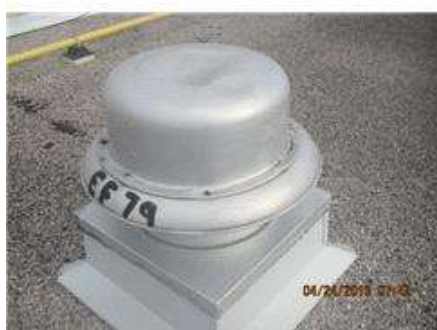
April 2013 - Original Rooftop Exhaust Fan - Aged and Weathered

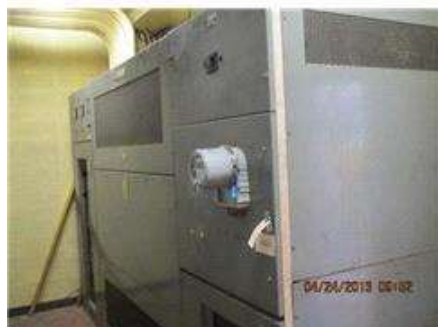
April 2013 - Original Main Switchgear

2013 - Replacement of the aged main switchboard is recommended based on age and remaining useful life.

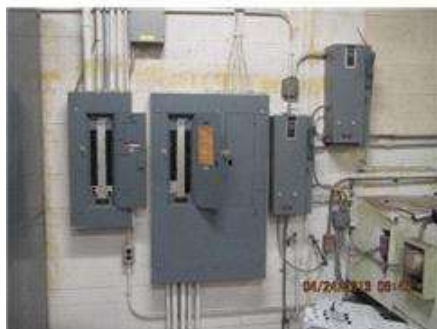
April 2013 - Original Panel Boards

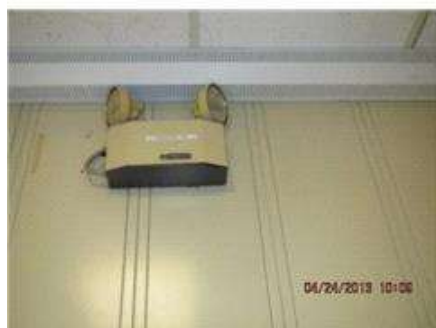
March 2013 - Aged Emergency Lighting Battery Pack Fixture

2013 - Replacement of existing aged emergency lighting lamps and fixtures (50%) with higher efficiency lamps and batteries is recommended.

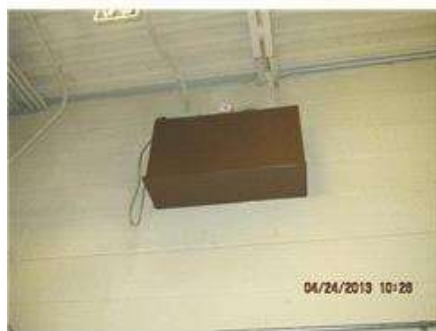
March 2013 - Aged Emergency Lighting Battery Pack Fixture

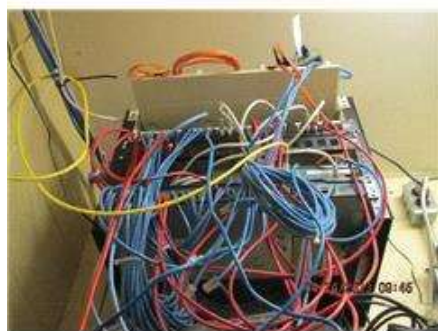
April 2013 - Information Technology Equipment

2013 - Planned replacement of the school's IT system is recommended to keep the system up to date and in working condition.

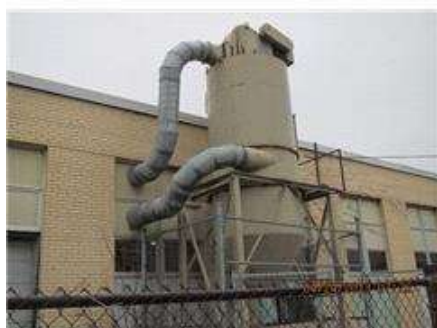
April 2013 - Newer Dust Collector

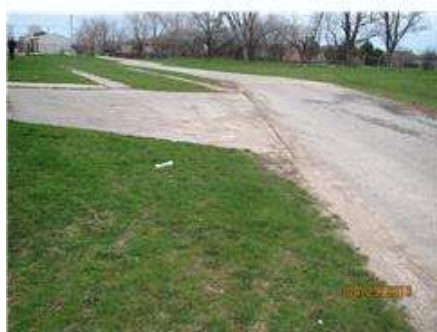
2013 - The asphalt paved roadway is showing signs of alligator cracking. Replacement is recommended.

Apr 2013- Typical roadway around the building.

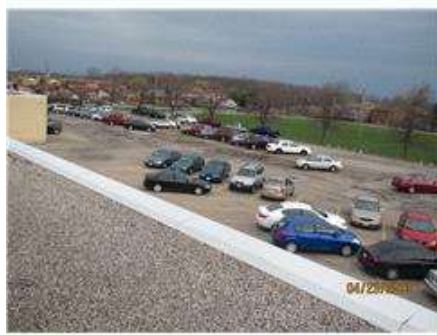
2013 - The asphalt paved parking lot is in poor condition with pot holes and alligator cracking. Reconstruction of the parking lot is recommended.

Apr 2013- Parking lot on the north side of the building.
