HAMILTON WENTWORTH DISTRICT SCHOOL BOARD
FEASIBILITY STUDY AND CONCEPT DESIGN

SHERWOOD SECONDARY SCHOOL
25 High Street, Hamilton, ON

Condition Assessment

Sherwood SS, Building ID 9143-1

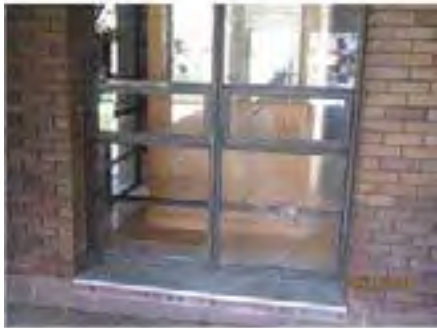
Mar 2013- Exterior window.

Recommendation 2013 - The windows of the building are beyond their expected service life. Based on the windows performance and observed condition, age, design and thermal properties, replacement of the building windows is recommended.

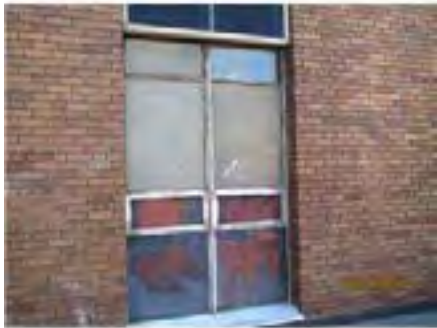
Mar 2013- Deteriorating exterior window.

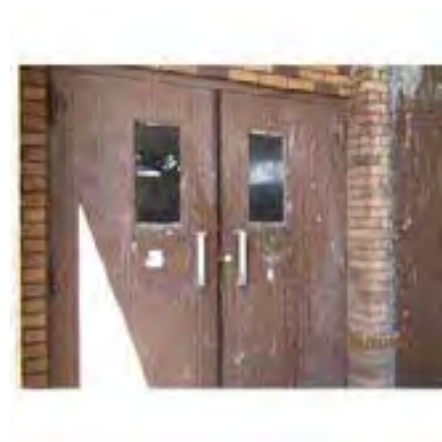
Apr 2013- Main entrance doors.

2013 - The majority of the exterior door assemblies are original and have exceeded their effective design rated life. Replacement of the door assemblies is recommended.

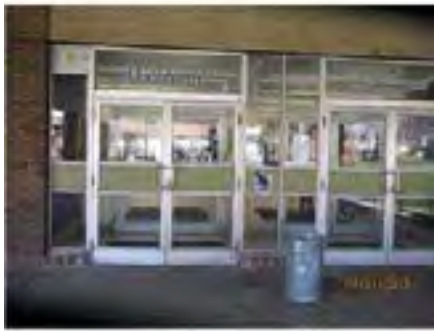
Apr 2013- Worn exterior hollow metal door.

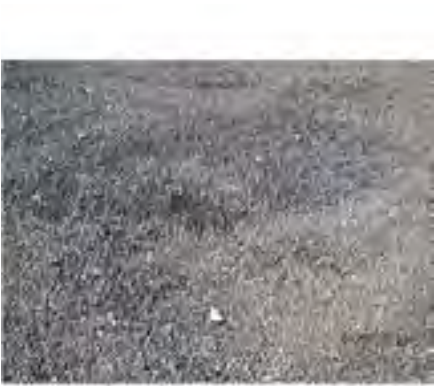
Apr 2013- Evidence of blister and ballast dis placement.

Recommendation 2013 - The roof assembly system of roof is beyond its expected service life and is no longer performing as intended. Replacement is recommended.

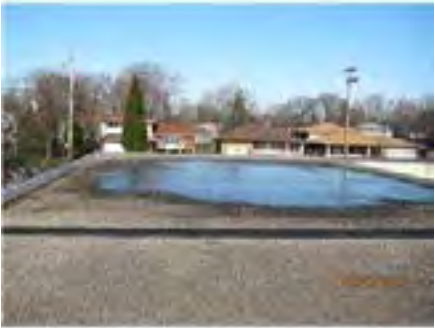
Apr 2013- Water pooling due to roof membrane settlement.

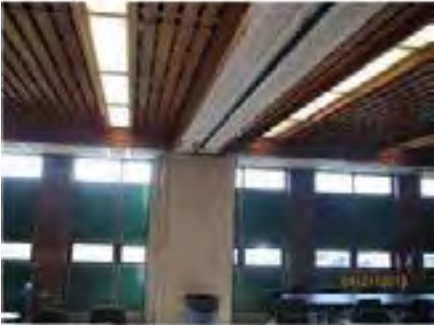
Apr 2013- Damaged track of movable partition in cafeteria.

2013 - The moveable folding partition in the cafeteria is peeling, damaged, and has surpassed its expected useful life. Replacement is recommended.

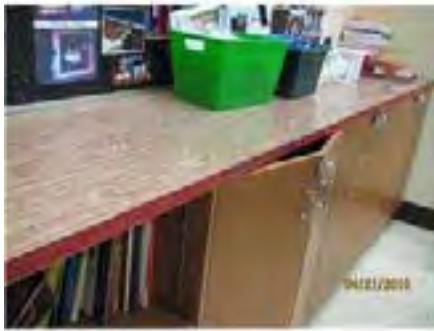
Apr 2013- Typical millwork in the school.

Recommendation	2013 - As all the cabinetry, millwork items, counters and countertops have exceeded their expected useful life and are in fair condition the recommendation is to replace them
----------------	--

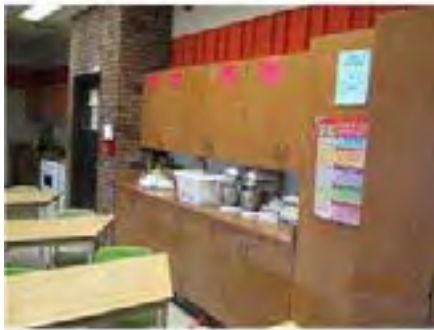
Apr 2013- Damaged millwork.

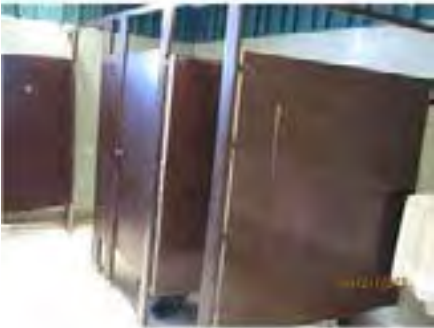
Apr 2013- Typical washroom partitions in the school.

Recommendation	2013 - The original floor mounted painted toilet partitions have exceeded their effective rated design life. Replacement is recommended.
-----------------------	--

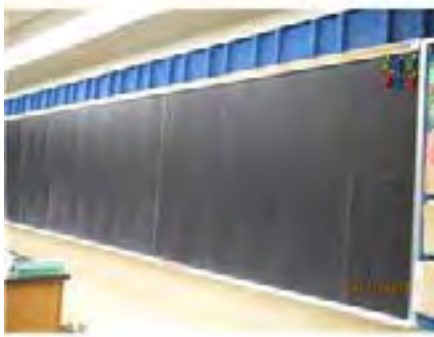
Recommendation The lockers are from original construction and have exceeded their theoretical useful life. Damage to door panels and sidings, and corrosion of the hardware and shelving was evident. Full replacement is required based on age and condition.

Apr 2013- Typical old worn lockers in the school.

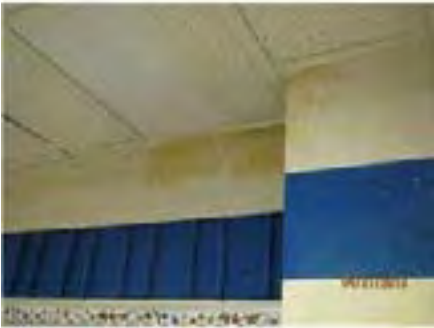
Condition Assessment2013 - At the time of the assessment the interior wall finishes were in poor condition

Apr 2013- Stained wall covering.

Recommendation 2013 - Recommend all interior wall finishes be repainted as the finishes are fading and showing signs of age

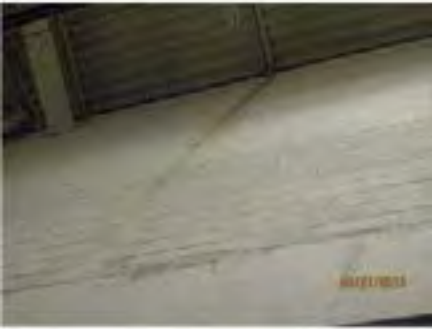
Apr 2013- Peeling wall covering in the GYM.

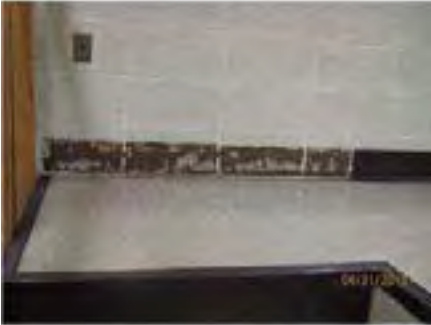
2013 - The vinyl composite floor tile and vinyl base is exhibiting signs of wear and has exceeded its effective rated design life. Replacement planning is recommended.

Apr 2013- Missing vinyl base board on the stage.

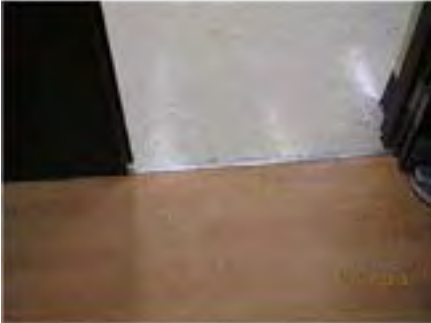
Apr 2013- Worn VCT.

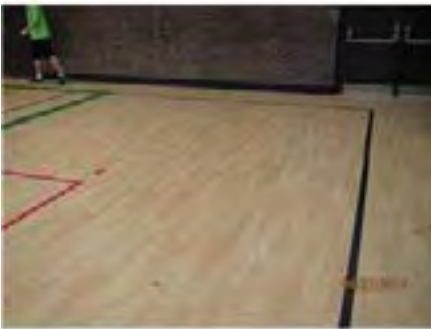
Condition Assessment2013 - The sheet vinyl goods is showings signs of wear, separated seams and has aged beyond its effective design rated life.

Apr 2013- evidence of blistering on the vinyl sheet flooring in the GYM.

Recommendation2013 - The vinyl sheet goods and vinyl base is worn and aged beyond its effective design rated life. Replacement is recommended.

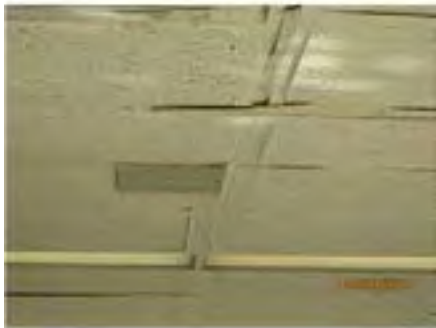
Condition Assessment 2013 - At the time of assessment the acoustical ceiling tiles were in fair condition with signs of age and deterioration

Apr 2013- Typical third floor ceiling tiles.

2013 - The 2'x4' acoustic tile ceiling system has exceeded its useful life and is known to contain asbestos materials. Replacement planning is recommended as to update the appearance of the facility and remove any Chrysotile asbestos spray fireproofing present which presents potential health concerns. especially an third floor ceiling space, refer to asbestos report that has been done in Nov 2012..

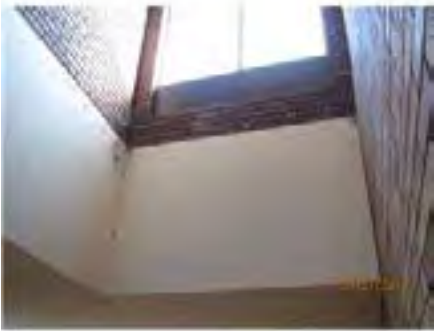
Description		2013 - Gypsum board ceilings	
Condition Assessment		2013 - At the time of the assessment the gypsum board ceilings were in fair condition	
Last Replacement Year		1967	
Theoretical Life		15	
Ceiling Finishes Type		Unspecified	
Technical Condition		Fair	
Replacement [C3030 Ceiling Finishes - Original Building]			
Event Type:	Replacement	Priority:	Medium
Brief Description		Replacement [C3030 Ceiling Finishes - Original Building]	
Estimated Cost		\$24,798	
Fiscal Event Year		2015	
2011-2015 Cost		\$24,798	
2011-2015 Priority		Medium	
2011-2015 Year		2015	
Recommendation		2013 - Gypsum board ceilings are original and have passed there EUL and should be replaced.

Apr 2013- Aged drywall ceiling.

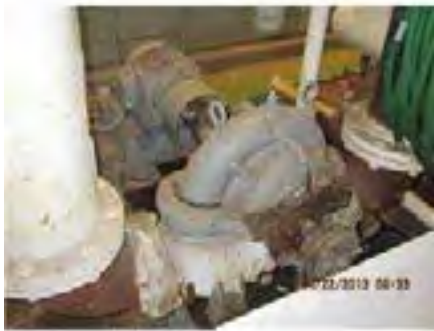
April 2013 - Aged HVAC Pumps

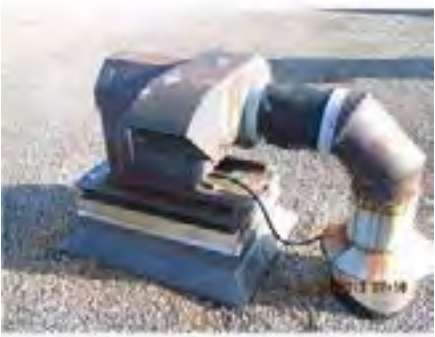
April 2013 - Original Weathered Rooftop Exhaust Fan

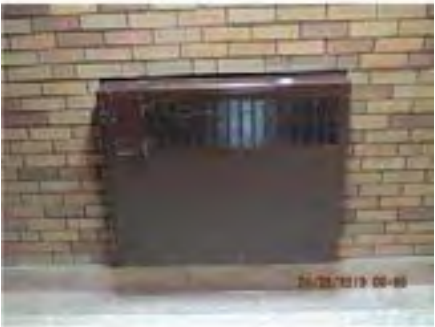
April 2013 - Original Forced Flow Heaters

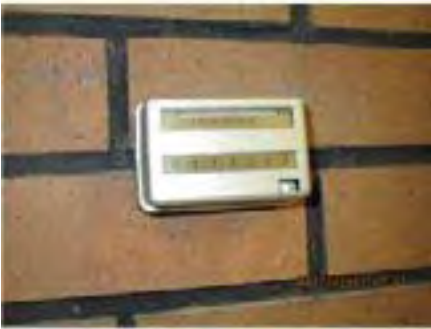
April 2013 - Aged Pneumatic Thermostat

2013 - Replacement of the remaining aged pneumatic controls and upgrade of the BAS system is recommended.

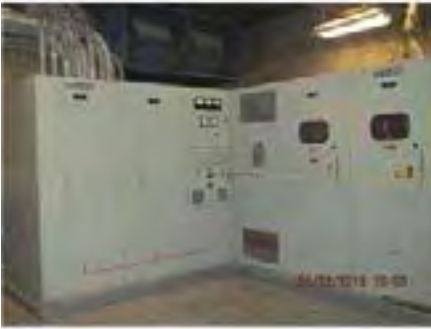
April 2013 - Original Main Switchboards

Recommendation 2013 - Planned replacement of the original MCC is recommended within the next 5 years.

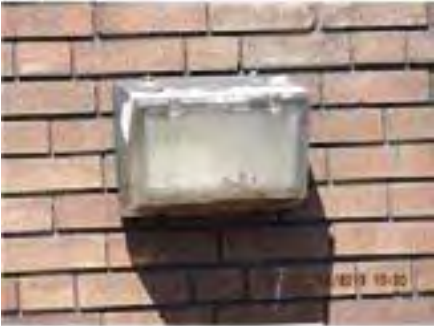
April 2013 - Typical Aged Wall Mounted Exterior Lighting Fixture

Recommendation	2013 - The exterior lighting fixtures are original and appear to be functional at this time, but have surpassed their anticipated service life. Replacement of existing aged lamps and fixtures with higher efficiency lamps and fixtures is recommended.
-----------------------	---

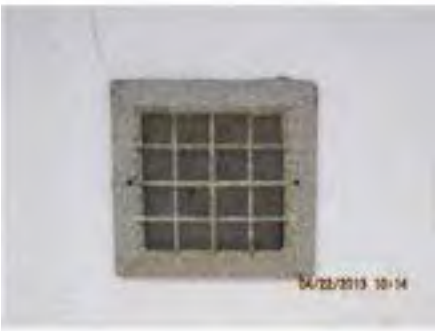
April 2013 - Aged Exterior Lighting Fixture - Soffit

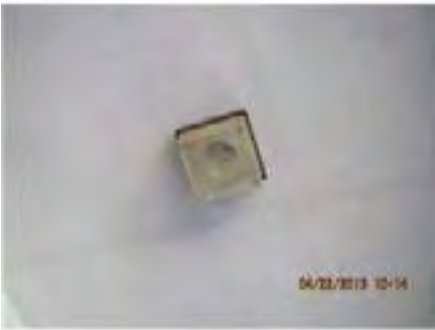
April 2013 - Aged Exterior Lighting Fixture - Main Entrance Overhang

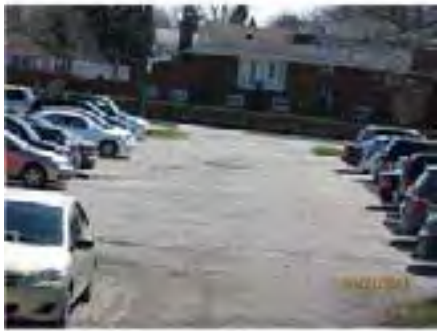
Apr 2013- Parking lot on the south east of the building.

Recommendation 2013 - The asphalt paved parking lot is in poor condition with pot holes and alligator cracking. Reconstruction of the parking lot is recommended.

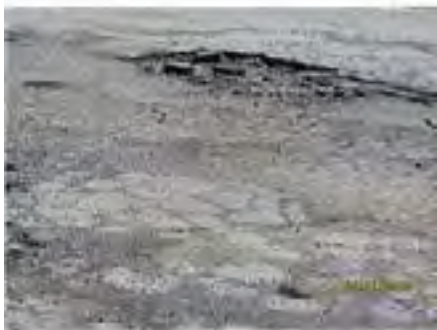
Apr 2013- Evidence of pothole and alligator craning.

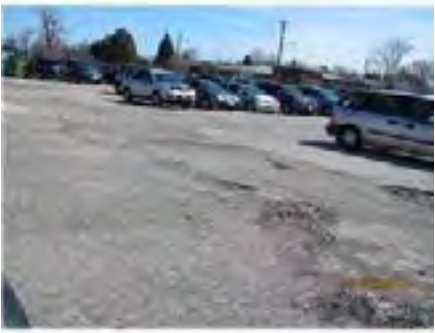
Apr 2013- Evidence of pothole and alligator craning.

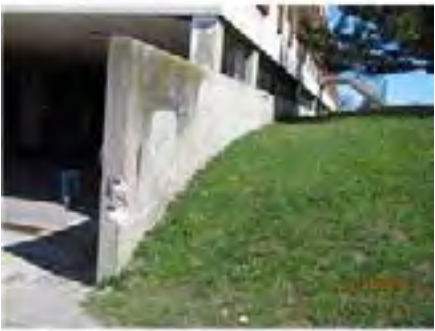
Apr 2013- Concrete retaining wall on the north side of the building.

2013 - The concrete retaining wall is original to the construction of the property and has exceeded its effective design rated life. Replacement of the fence is recommended.

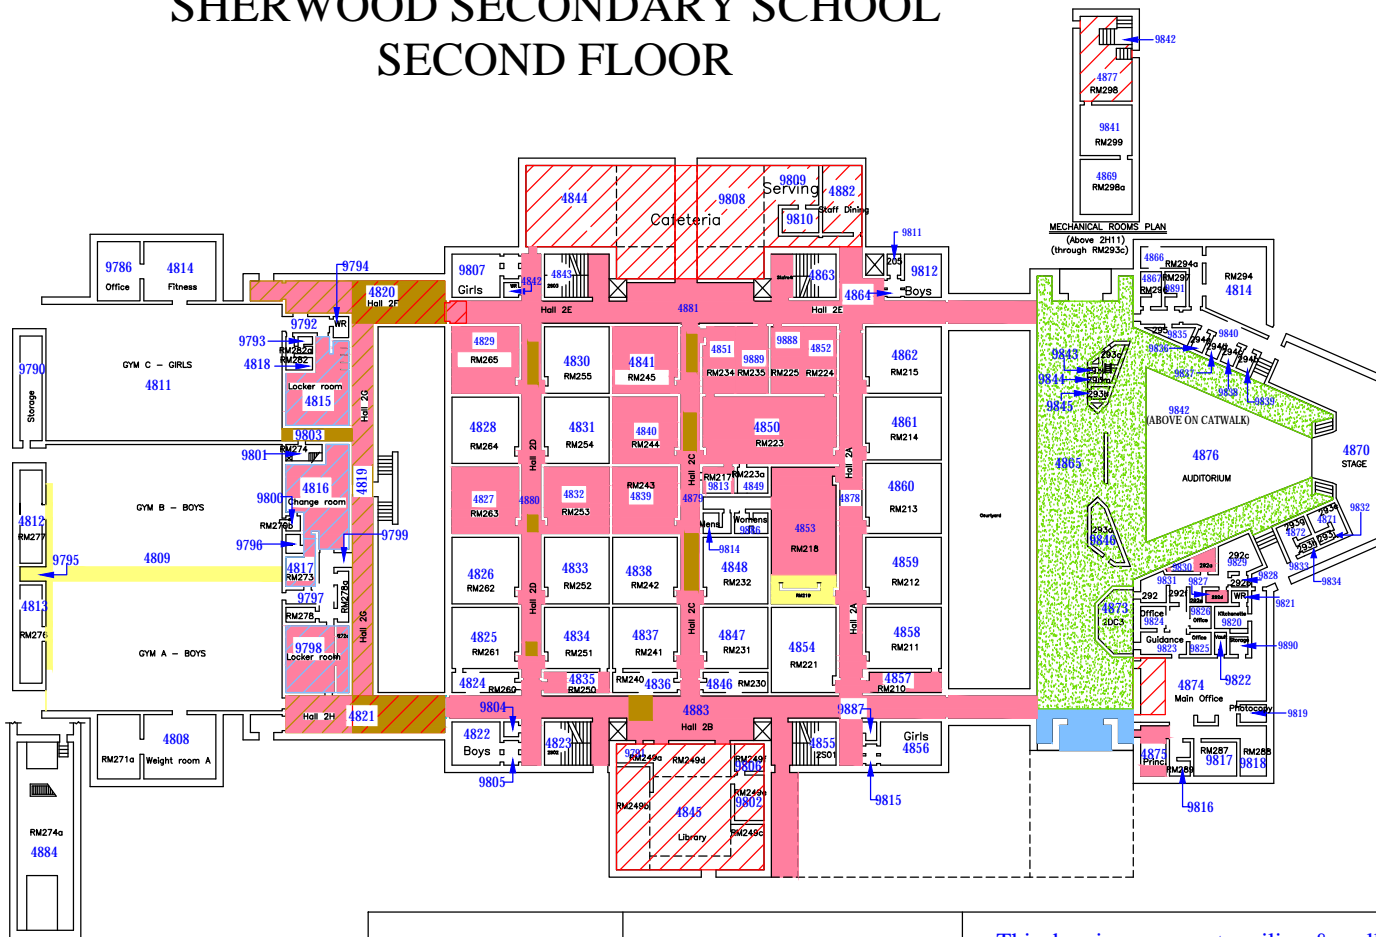
SHERWOOD SECONDARY SCHOOL SECOND FLOOR

Transite asbestos panels present.	
Asbestos ceiling tiles present.	
Asbestos present on mechanical insulation above ceiling tiles.	
Asbestos present on mechanical insulation above asbestos ceiling tiles.	
Applied asbestos ceiling texture coat present.	
Drywall joint compound contains asbestos.	
Chrysotile asbestos sprayed fireproofing present.	
Asbestos present on mechanical insulation above Transite asbestos ceiling tiles.	
Asbestos present on mechanical insulation above asbestos ceiling tiles.	
Chrysotile asbestos sprayed fireproofing present above asbestos ceiling tiles.
