**HAMILTON-WENTWORTH DISTRICT SCHOOL BOARD**  
FEASIBILITY STUDY and CONCEPT DESIGN

**Sir Winston Churchill Secondary School**  
1715 Main Street E, Hamilton, ON

November 2015

Sir Winston Churchill SS, Building ID 9149-1

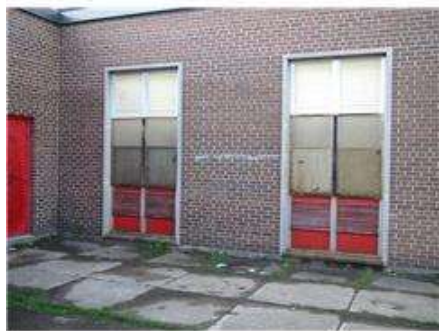
**Condition Assessment** 2013 - The building windows are in poor overall condition, with an aged appearance, deteriorating seals and reported water and air infiltration. Water staining was noted on interior window sills, verifying the occurrence of water leakage.

Apr 2013- Deteriorated exterior window.

**Recommendation** 2013 - The windows of the building are beyond their expected service life. Based on the windows performance and observed condition, age, design and thermal properties, replacement of the building windows is recommended.

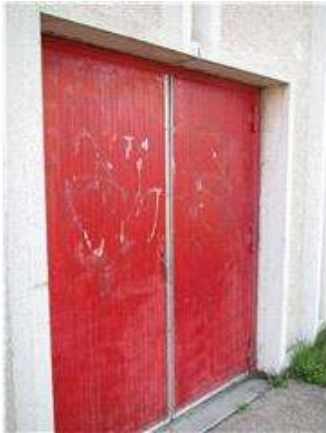
**Condition Assessment** 2013 - The majority of the exterior door assemblies are original, with worn finish, damaged frames, deteriorated door seals, single glazed vision lites and have exceeded their effective design rated life.

Apr 2013- Typical Exterior doors at school.

**Recommendation** 2013 - The majority of the exterior door assemblies are original and have exceeded their effective design rated life. Replacement of the door assemblies is recommended.

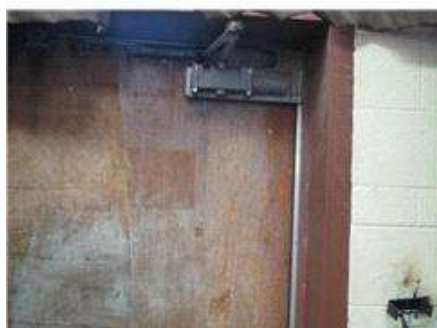
Apr 2013- Typical exterior door hardware.

2013 - It is recommended that the exterior door hardware should be replaced at the time the exterior doors are replaced.

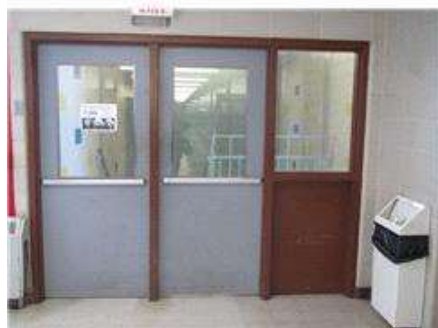
2013 - The interior doors have exceeded their effective design rated life with the majority of the doors exhibiting damage. Replacement of the interior doors is recommended.

Apr 2013- Typical interior hollow metal door.

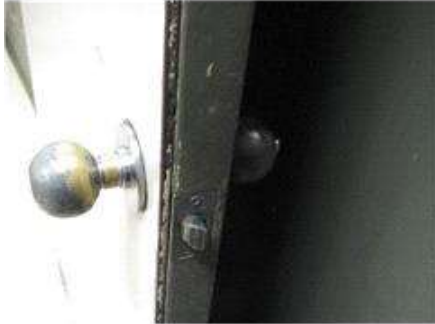
2013 - The interior door hardware has exceeded its effective design rated life. Replacement planning is warranted.

Apr 2013- Typical interior door hardware.

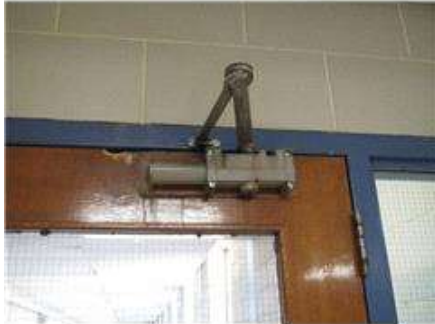
Apr 2013- typical interior door closer.

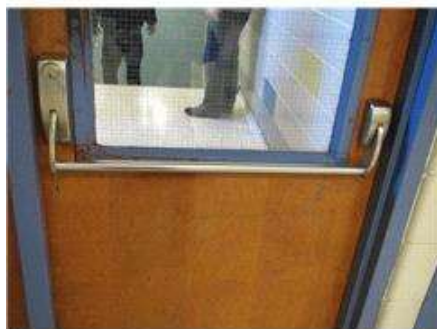
Apr 2013- Interior door hardware.

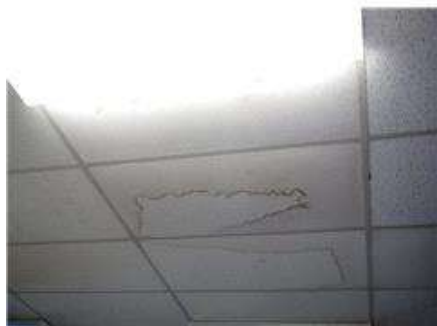
2013 - The acoustical suspended ceiling tile system is showing signs of wear. Replacement is recommended.

Apr 2013- Stained and worn ceiling tile.

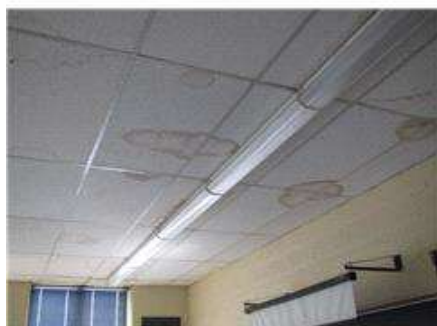
Apr 2013- Stained and worn ceiling tile.

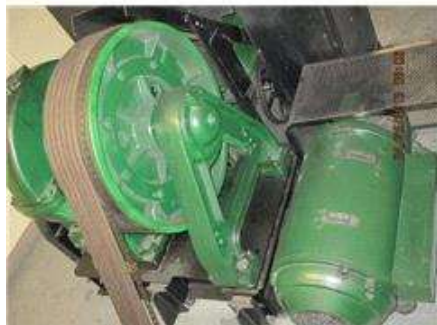
2013 - The unit appears to be well maintained but as this unit continues to age, repair and service will become more expensive while parts will become increasingly harder to obtain. Replacement of the aged traction elevator including controls and drive unit is recommended.

April 2013 - Original Elevator Hoist and Invertor

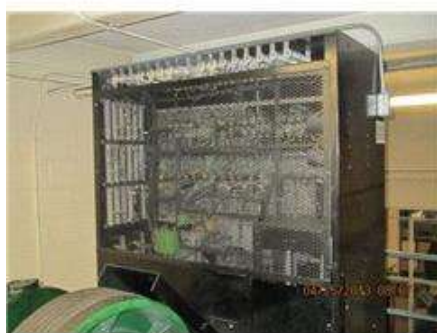
April 2013 - Original Elevator Controls

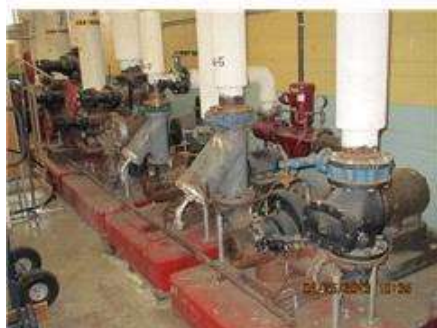
April 2013 - Five Original HVAC Pumps

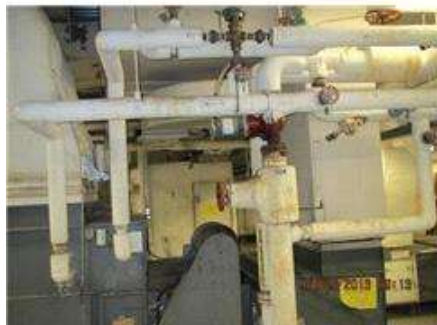
April 2013 - Aged Heating Piping

**Recommendation** 2013 - Pending the outcome of the recommended study, replacement of the building's heating piping and distribution system may be required. In the current condition piping leaks may occur damaging the building interiors. The work associated with this project is expected to disturb material(s) suspected of containing, or known to contain asbestos, (ACMs). Testing of the suspected ACMs should be conducted prior to the initiation of any demolition and the costs should be adjusted based on the findings. The cost of hazardous materials abatement is not included in the replacement cost.

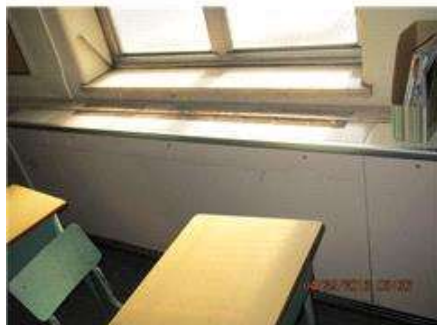
April 2013 - Typical Aged Unit Ventilator

2013 - Replacement of the aged unit ventilators is recommended. Consideration should be made to replace them with high energy efficient units.

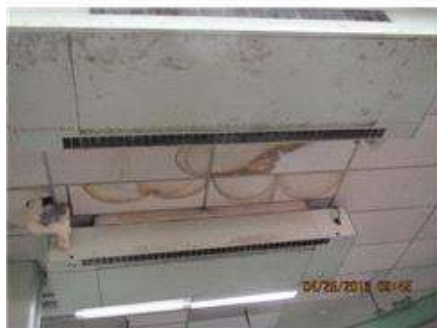
April 2013 - Ceiling Mounted Unit Ventilators - Tech Wing

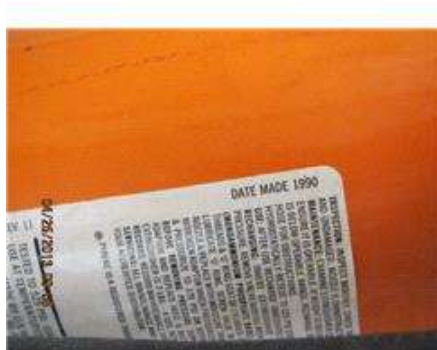
April 2013 - Aged Fire Extinguishers

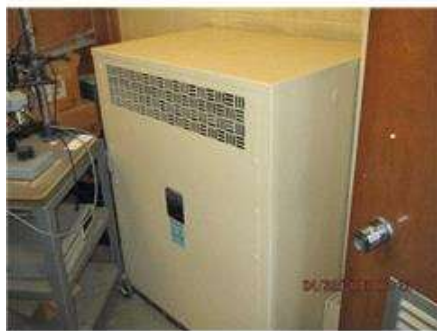
April 2013 - Original Secondary Transformer

**Recommendation** 2013 - Based on the age and theoretical useful lives of the secondary transformers replacement is recommended.

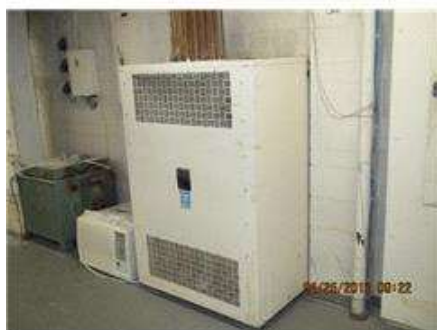
April 2013 - Original Secondary Transformer

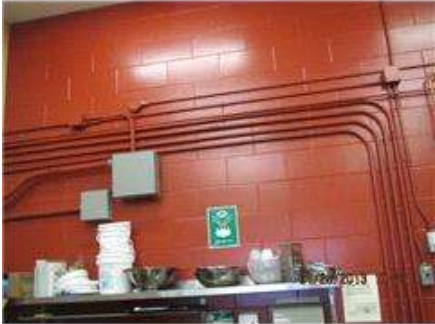
April 2013 - Aged Branch Wiring

2013 - Based on the age of the branch wiring, replacement is recommended. An in depth study should be conducted to determine the current condition, remaining useful life cost of replacement.

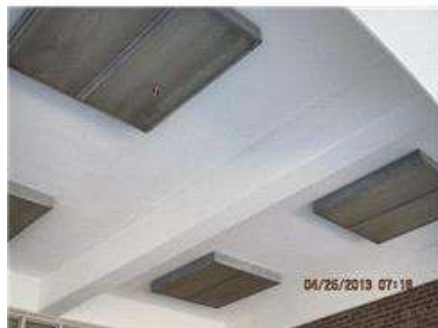
2013 - Approximately 20% of the exterior lighting fixtures are aged but appear to be functional at this time. Replacement of existing aged lamps and fixtures with higher efficiency lamps and fixtures is recommended.

April 2013 - Fluorescent Lighting Fixtures

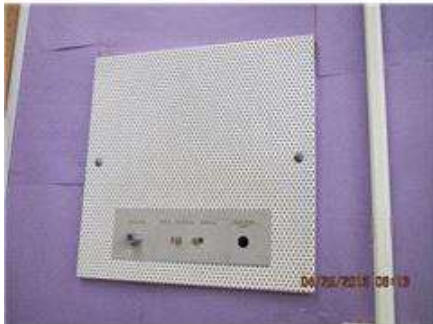
2013 - The public address system speakers and wiring are aged and beyond their rated life. Replacement is recommended.

April 2013 - Original PA Speakers

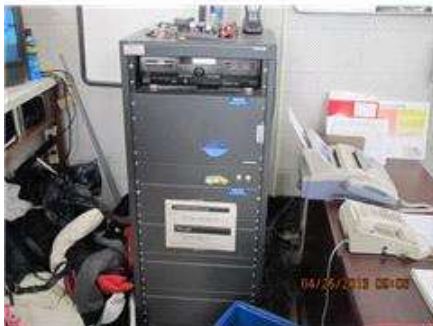
April 2013 - New PA Console

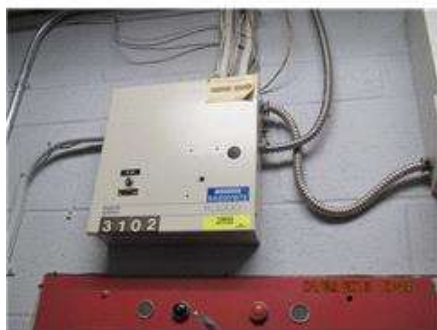
April 2013 - Security Panel

**Recommendation** 2013 - Based on age and theoretical useful life the planned replacement of the security system is recommended.

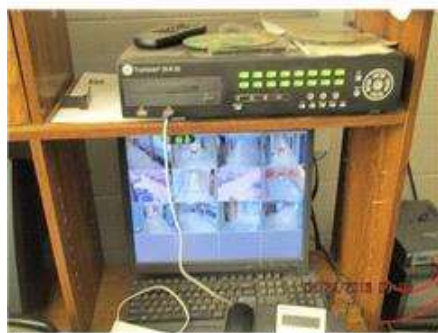
April 2013 - Surveillance System

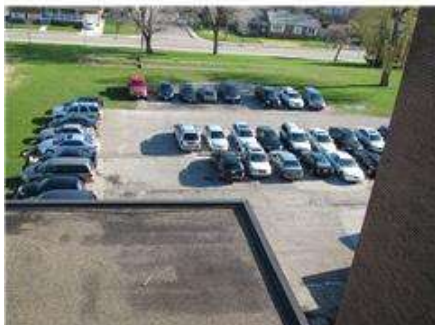
2013 - The asphalt paved parking lot is in poor condition with pot holes and alligator cracking. Reconstruction of the parking lot is recommended.

Apr 2013-Parking lot on the south side of the building.

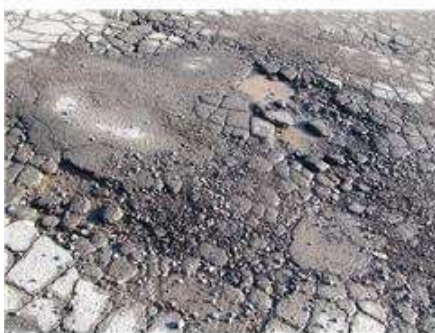
APR 2013- Sign of pot holes on the surface of parking lot.

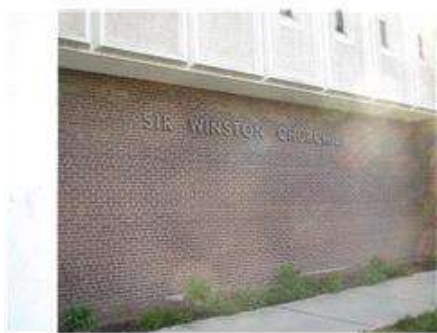
Apr 2013- School wall mounted sign.

**Recommendation** 2013 - As the identification signage appears faded and aged, and has exceeded its typical service life. Replacement is recommended

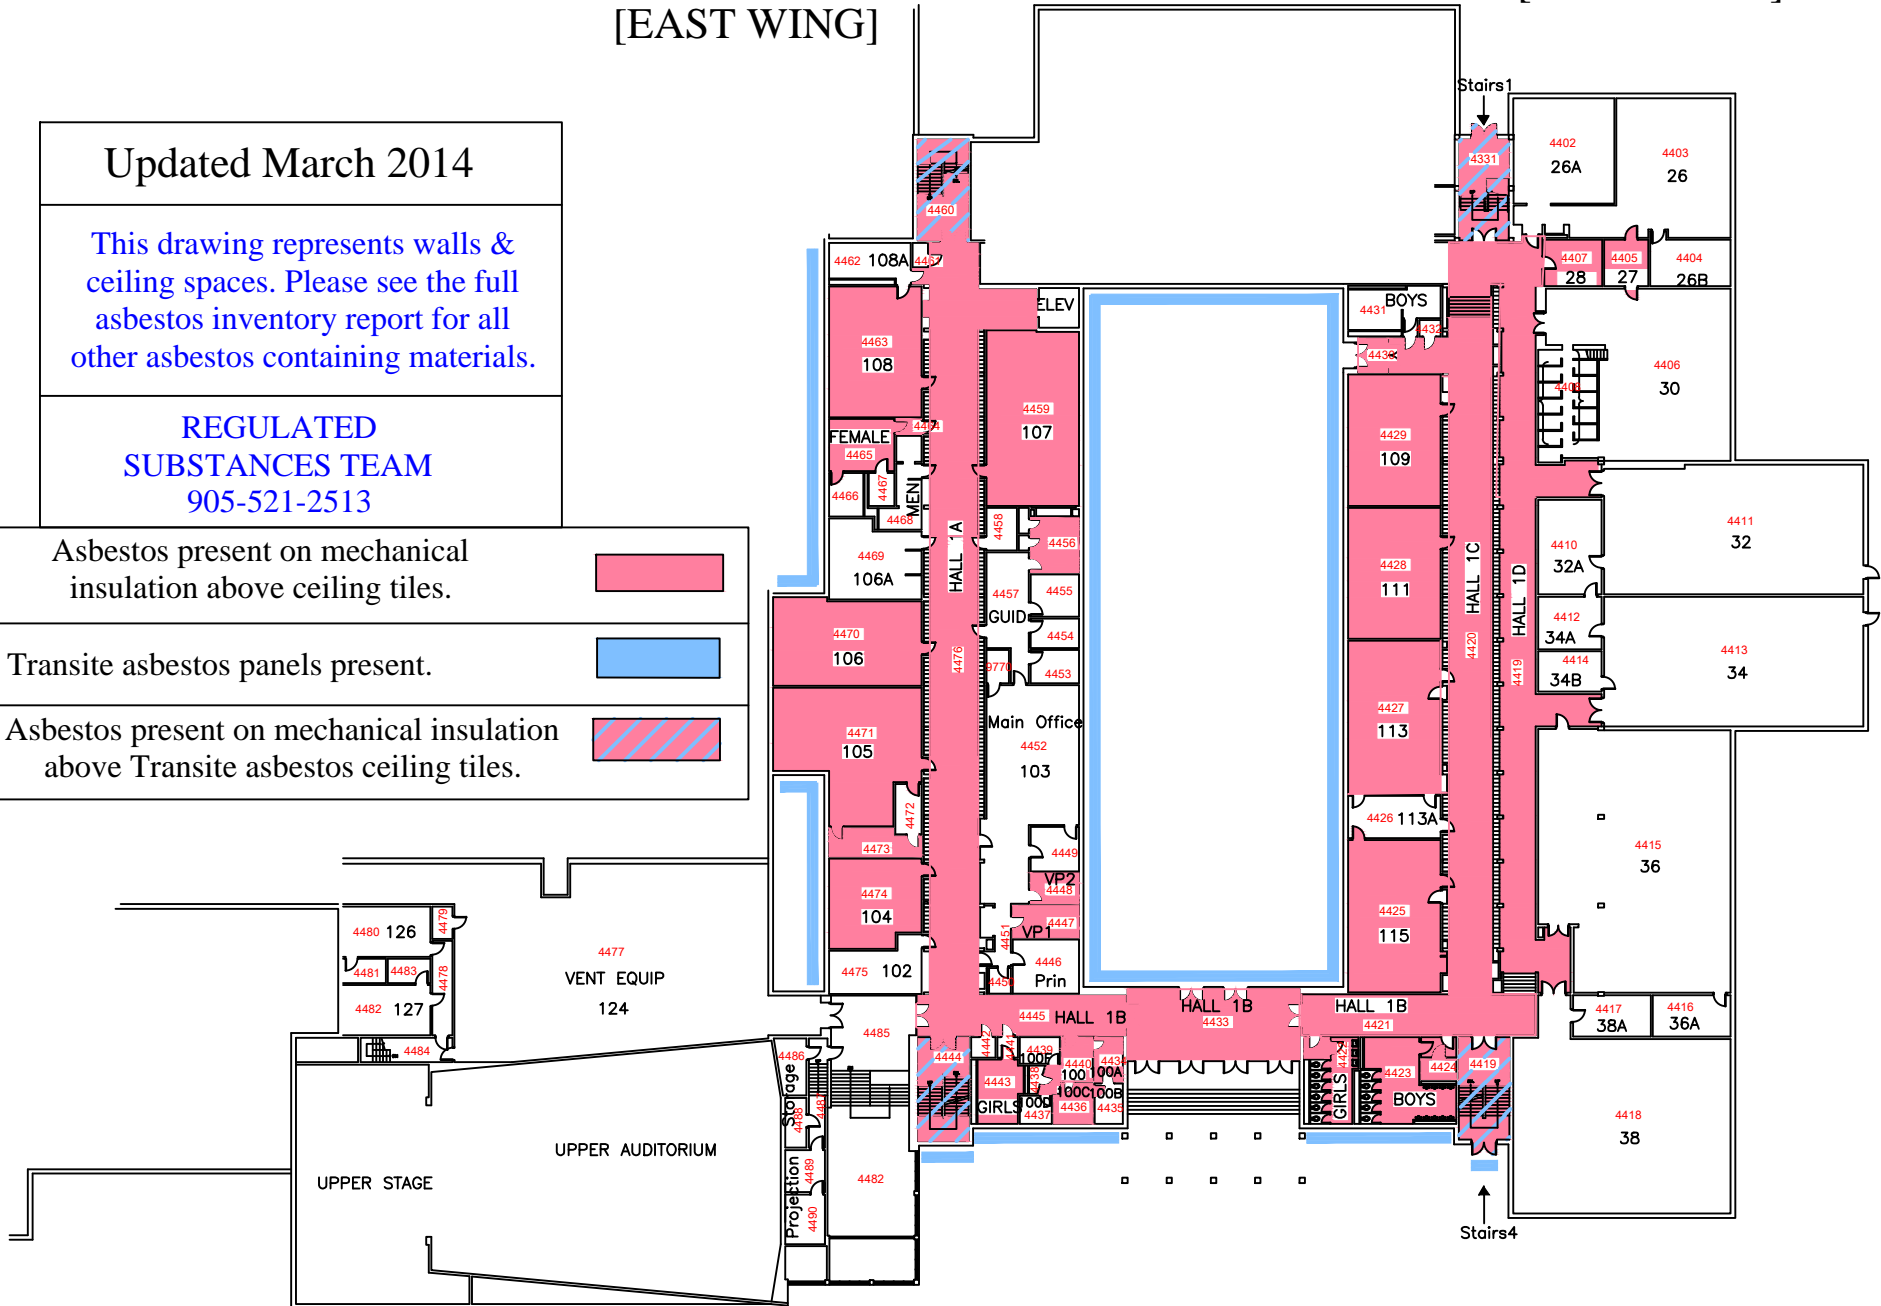
Asbestos present on mechanical insulation above Transite asbestos ceiling tiles.
