HAMILTON-WENTWORTH DISTRICT SCHOOL BOARD
FEASIBILITY STUDY and CONCEPT DESIGN

Westdale Secondary School
700 Main St. W, Hamilton, ON

November 2015

Westdale, Building ID 9158-1

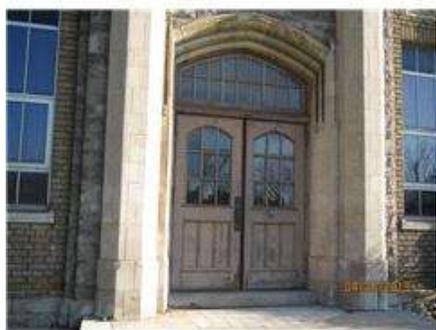
Condition Assessment 2013 - The majority of the exterior door assemblies are original, with worn finish, damaged frames, deteriorated door seals, single glazed vision lites and have exceeded their effective design rated life.

Apr 2013- Typical Original exterior door.

Recommendation 2013 - The majority of the exterior door assemblies are original and have exceeded their effective design rated life. Replacement of the door assemblies is recommended.

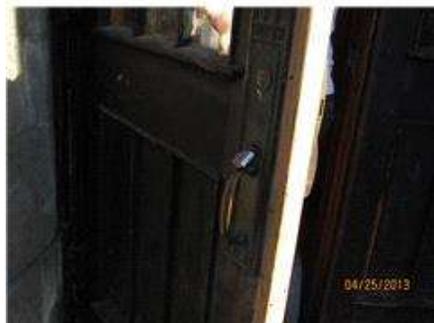
Apr 2013- Worn exterior door hardware.

2013 - It is recommended that the exterior door hardware should be replaced at the time the exterior doors are replaced.

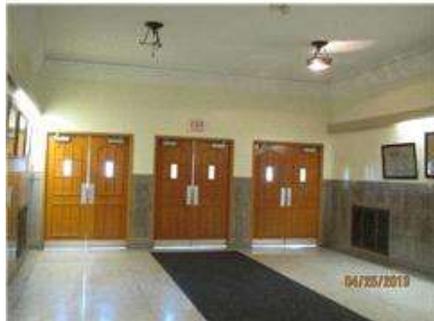
2013 - The interior doors have exceeded their effective design rated life with the majority of the doors exhibiting damage. Replacement of the interior doors is recommended.

Apr 2013- Original natural wood finish interior door.

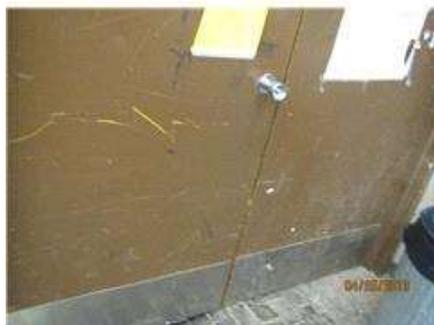
Apr 2013- Scratched painted hollow metal interior door.

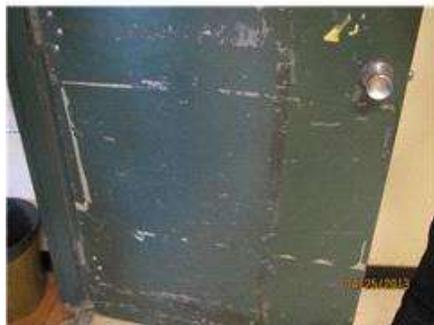
Apr 2013- scratched interior door.

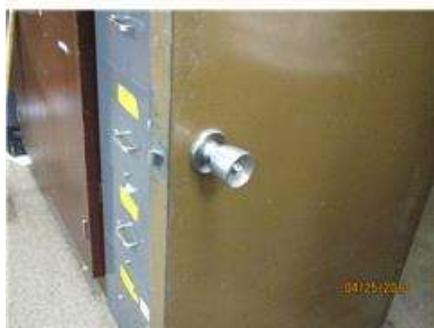
apr 2013- Typical interior door knob lock set.

Recommendation 2013 - Recommend replacing all interior door hardware at the same time the doors are replaced. OLD-The age of the interior door hardware is consistent with the interior door. Problems with door closures were indicated. Damaged door hinges, obsolete and corroded door hardware was identified. Replacement of the interior door hardware along with interior door is recommended.

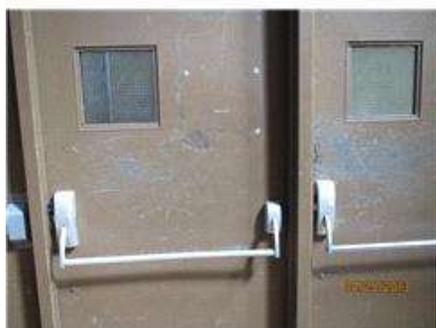
Apr 2013- Typical interior door push bar.

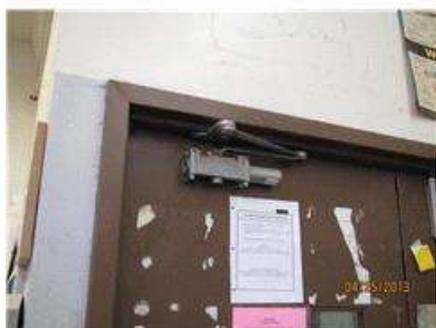
Apr 2013- Typical interior door closer.

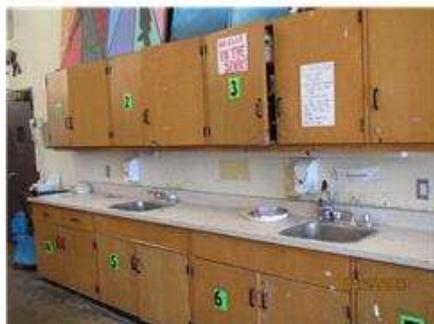
Apr 2013- Typical classroom millwork fitting.

Recommendation 2013 - Recommend that the original millwork and cabinetry be replaced as soon as possible

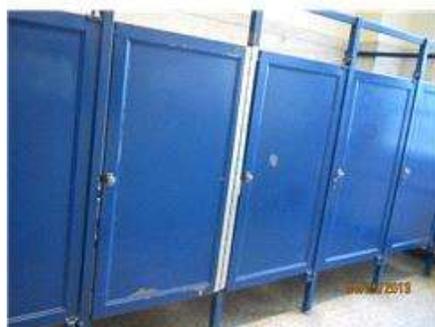
2013 - The original floor mounted painted toilet partitions have exceeded their effective rated design life. Replacement is recommended.

Apr 2013- Painted original washroom partition.

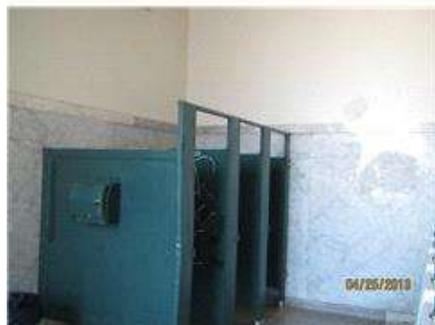
Apr 2013- Washroom partition.

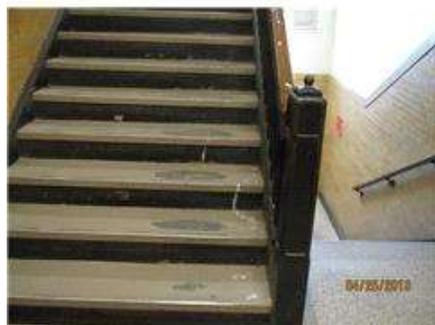
Apr 2013- Typical interior stairs finish.

Recommendation 2013 - Replacement of initial flight of the interior stairs including the rubber covering is recommended

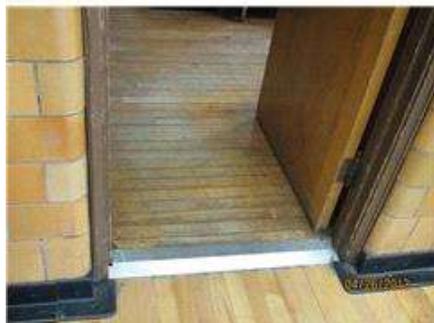
2013 - The hardwood strip flooring on GYM and Classrooms are in poor condition. Refinishing or replacement of the hardwood flooring is recommended.

Apr 2013- Worn Hard wood floor covering in the GYM area.

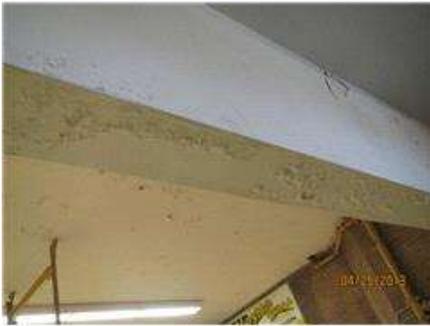
2013 - The painted finish to the exposed ceiling structure is worn looking. Refinishing is recommended as to update the appearance of the school.

Apr 2013- Water damaged Exposed ceiling in the Gym.

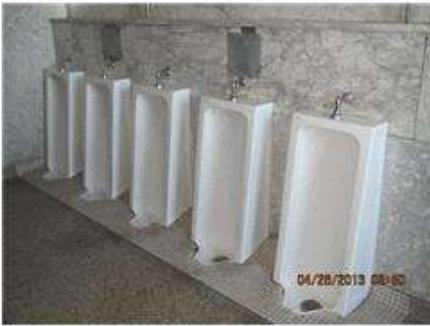
April 2013 - Typical Original Floor Mounted Urinals

2013 - Replacement of the original and aged plumbing fixtures in the building (85%) is recommended based on the age, condition and remaining useful life.

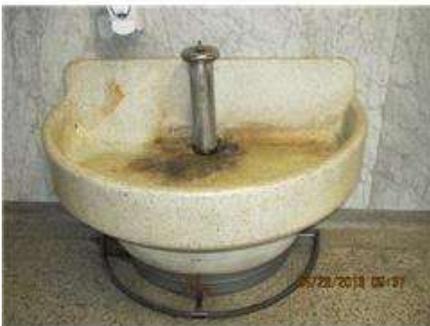
April 2013 - Typical Aged Bradley Basin

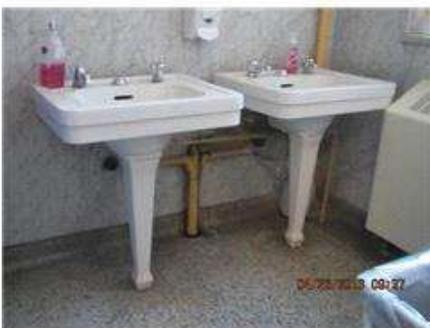
April 2013 - Aged Lavatories

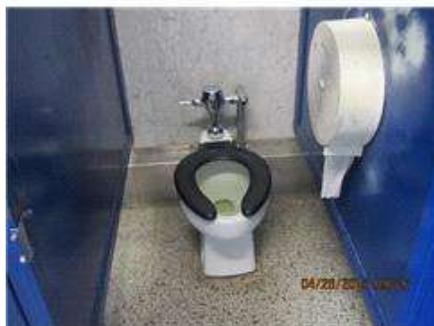
April 2013 - Typical Water Closets

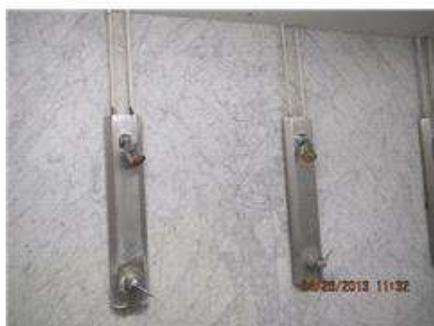
April 2013 - Ages Shower Fixtures - Boys Change Room

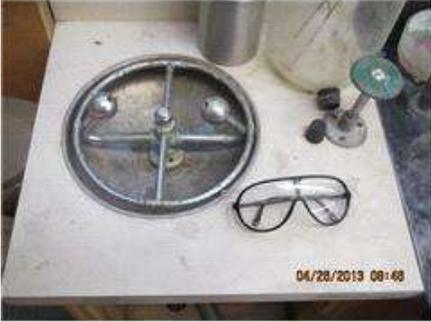
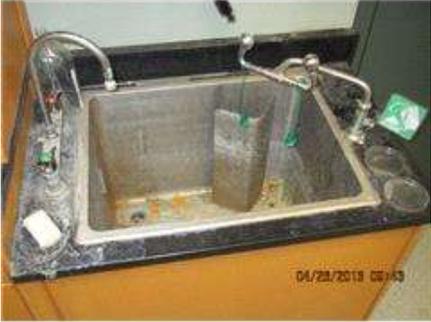
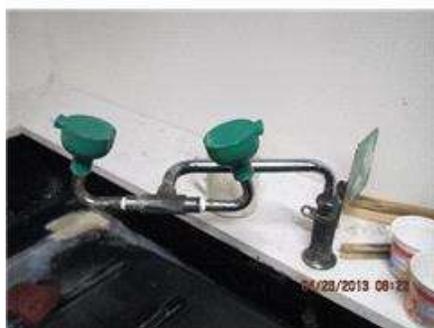
Condition Assessment 2013 - The majority of the eye wash stations appear to be over 20 years old and are in poor to fair condition.

April 2013 - Aged Eye Wash Station

2013 - Replacement of the aged eye wash stations is recommended to ensure functionality in case of emergency.

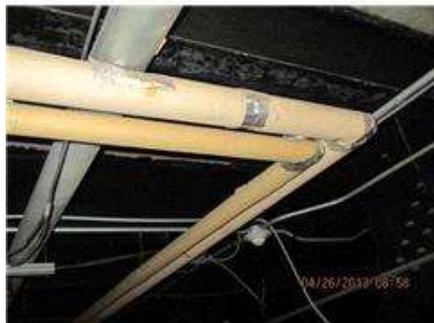
Condition Assessment 2013 - The domestic piping system is mostly concealed and therefore the current condition is not fully known. However due to the age, the expected wear and the theoretical useful life, the system is assessed as being in fair condition.

April 2013 - Aged Domestic Water Distribution Piping

2013 - Based on the age and theoretical useful life of the domestic water piping system replacement is recommended. A study is recommended to determine the current condition, remaining service life, current service requirements and the cost of replacement.

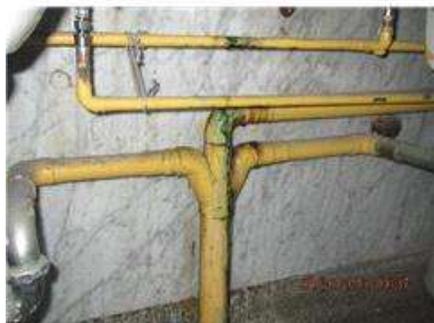
2013 - Much of the waste water distribution system is concealed with only small areas of the system being visible during the assessment. The visible sections of the piping were observed to be functional but aged. The waste water distribution system is past its rated useful life of 37 years.

April 2013 - Aged Sanitary Waste Water Piping

2013 - Planned replacement of the waste water distribution system is recommended based on age and condition.

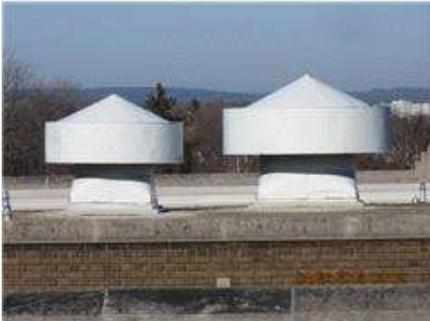
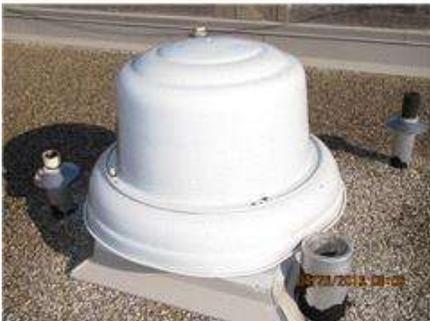
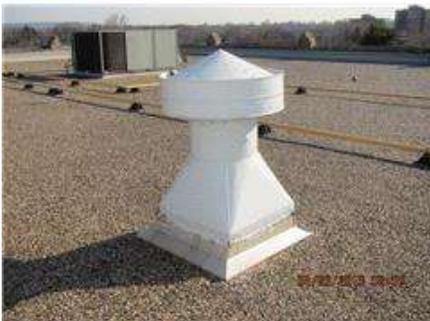
Condition Assessment 2013 - The rooftop exhaust fans are aged and many had worn and weathered casings. The fans are well maintained but are well past their intended useful life and are in fair condition overall.

April 2013 - Aged and Weathered Rooftop Exhaust Fans

April 2013 - Aged and Weathered Rooftop Exhaust Fan

2013 - The exhaust fans are operating past their expected useful lives and will likely require replacement as most are in fair condition.

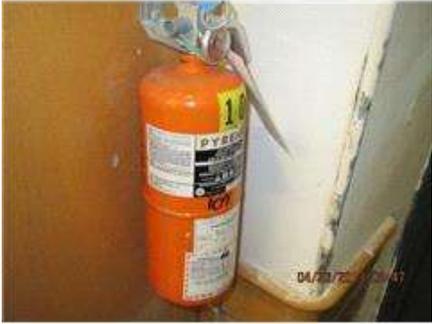
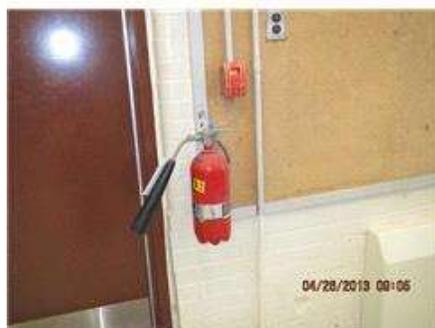
April 2013 - Typical Aged Fire Extinguisher

2013 - Based on the age and theoretical useful life of the fire extinguishers replacement of the outdated and aged fire extinguishers is recommended within the next three years.

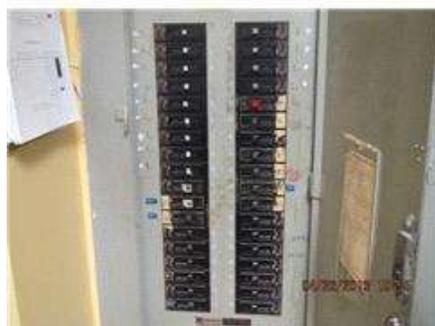
Condition Assessment 2013 - Although maintained properly, the switchboard and other assemblies including aged distribution panels, breaker, fuses and meters has exceeded the rated useful life and should be replaced due to age and for reliability.

April 2013 - Aged Panel Board

2013 - Replacement of the aged switchboards and other assemblies including aged distribution panels, breaker, fuses and meters of the building is recommended.

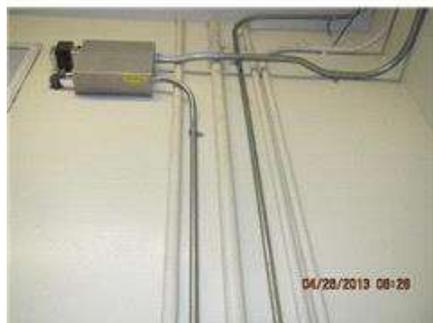
April 2013 - New and Aged Branch Wiring Conduit

2013 - Based on the age of the branch wiring, replacement is recommended. An in depth study should be conducted to determine the current condition, remaining useful life cost of replacement.

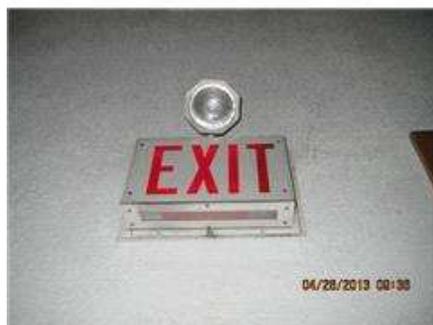
April 2013 - Aged Emergency Lighting Fixture

2013 - Replacement of existing aged emergency lighting lamps and fixtures with higher efficiency lamps and batteries is recommended.

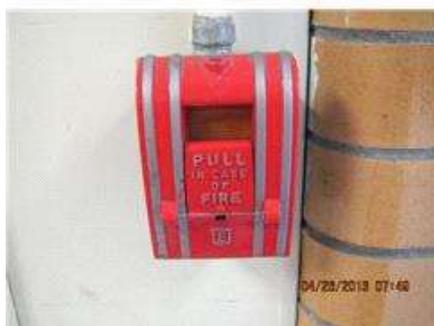
April 2013 - Aged Fire Alarm End Devices - Pull Station

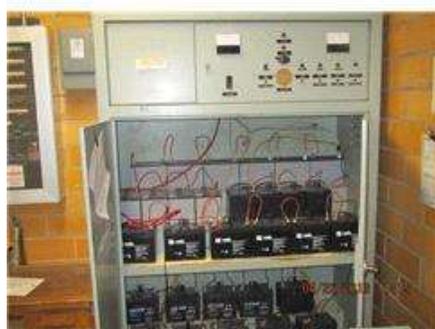
April 2013 - Emergency Lighting Battery Cabinet

2013 - Replacement of the emergency lighting wiring and associated aged components is recommended based on age and condition.

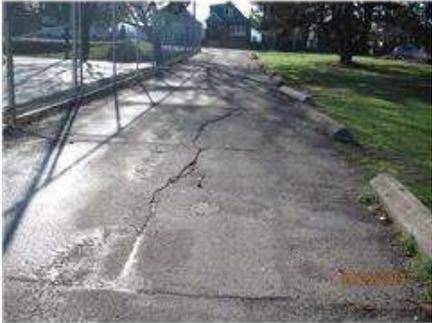
Recommendation 2013 - The asphalt paved roadway is showing signs of alligator cracking. Replacement planning is warranted.

Apr 2013- Asphalt paved roadway on northeast of the building.

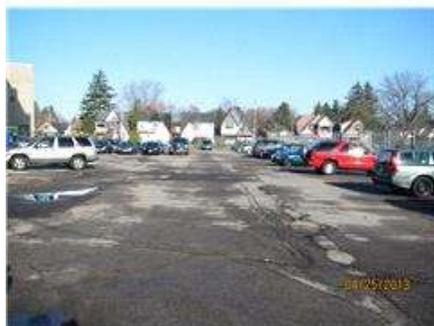
Recommendation 2013 - The asphalt paved parking lot is in poor condition with pot holes and alligator cracking. Reconstruction of the parking lot is recommended.

Apr 2013- Paved parking lot on the north side of the building.

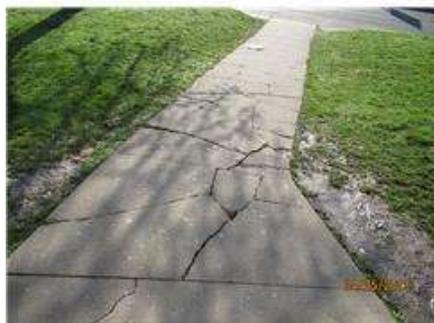
2013 - The concrete sidewalks are showing signs of uneven and cracked surfaces with signs of vegetation growth and spalling sections of concrete. Replacement is recommended.

Apr 2013- Cracked Concrete pedestrian on the south side of the building.

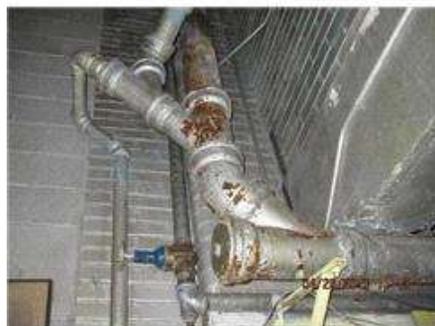
April 2013 - Rain Water Drainage Main

2013 - Planned replacement of the underground utilities is recommended based on the age of the systems compared to their theoretical useful life of 50 years.

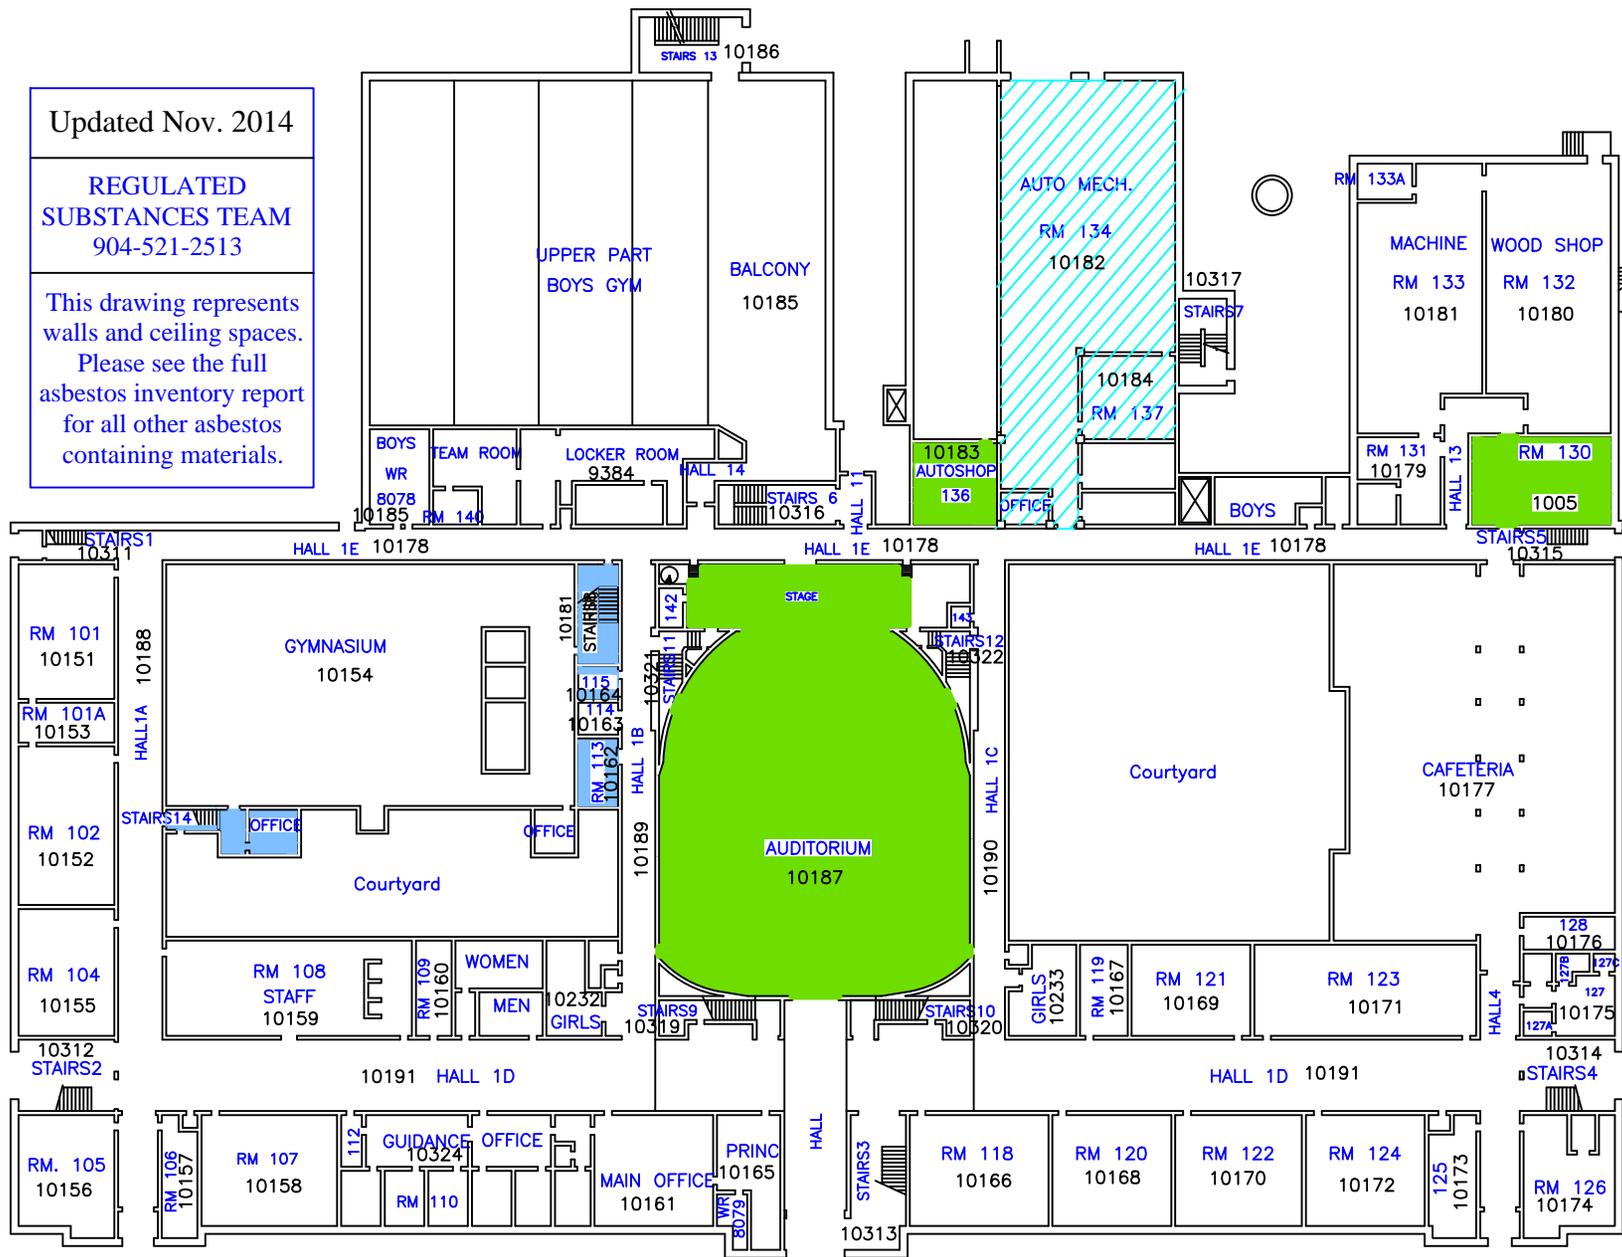
WESTDALE SECONDARY SCHOOL - FIRST FLOOR

Ceiling texture coat contains asbestos. 	Applied ceiling fireproofing contains Chrysotile asbestos. 	Transite asbestos ceiling tiles present.
--	--	---

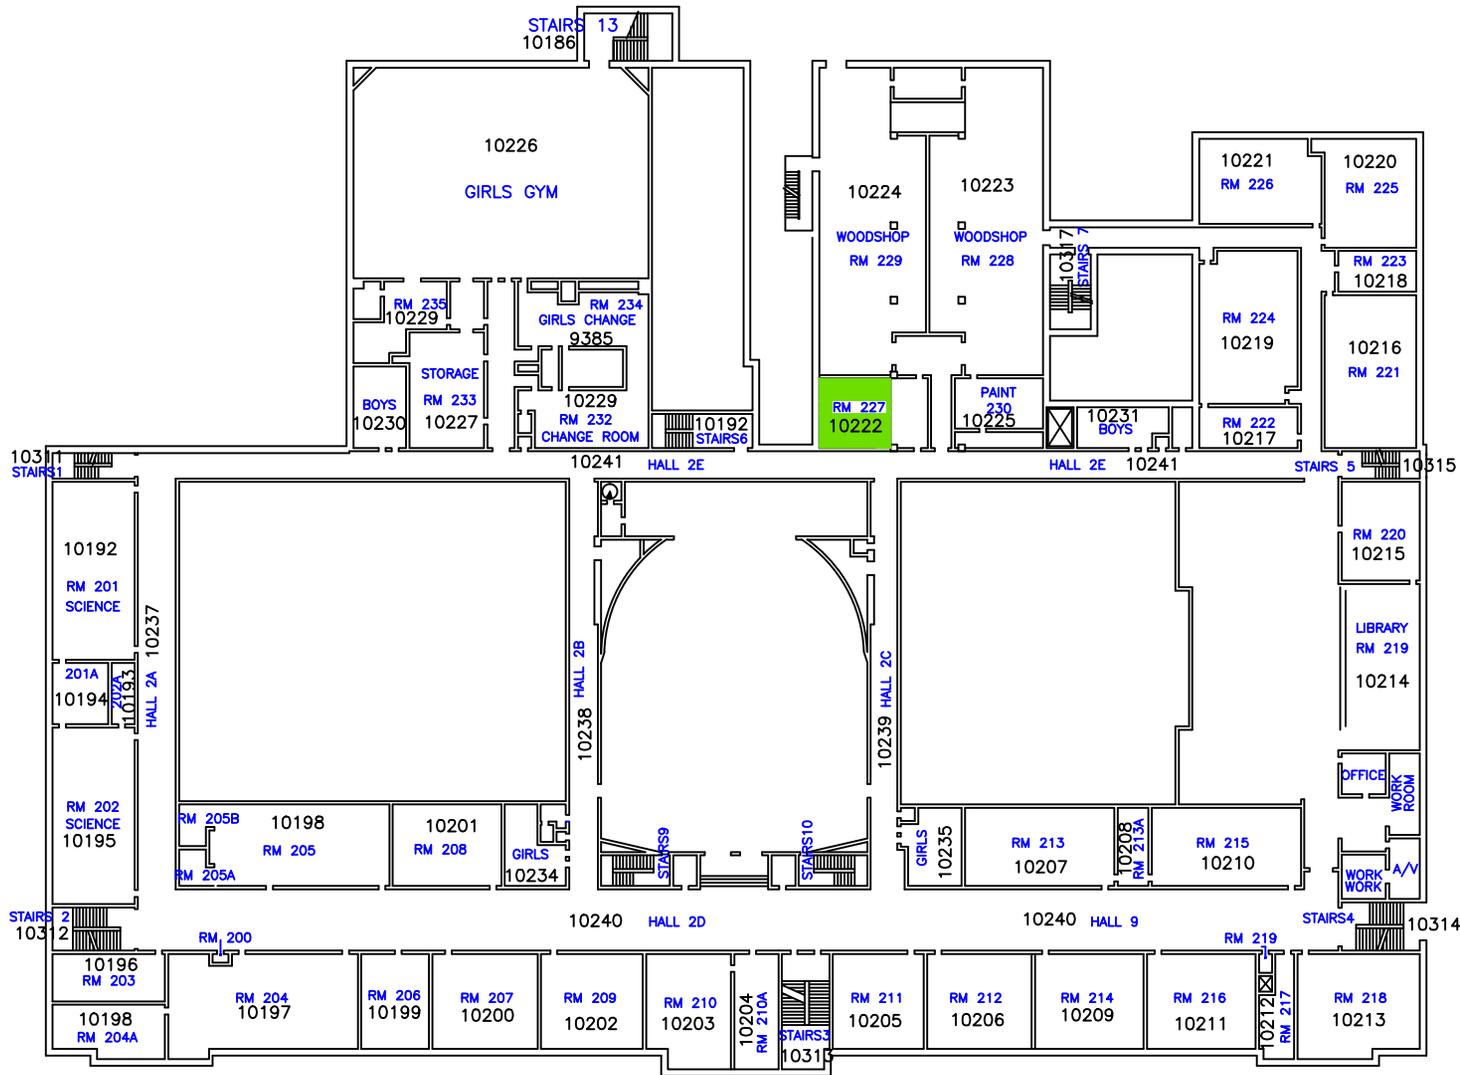
WESTDALE SECONDARY SCHOOL - SECOND FLOOR

Updated Nov. 2014 REGULATED SUBSTANCES TEAM 905-521-2513	This drawing represents walls and ceiling spaces. Please see the full asbestos inventory report for all other asbestos containing materials.	Ceiling texture coat contains asbestos.
---	--	---
