## **399 First Road West** Landfill Impact Assessment

## **D-4 Environmental Study**

**Project Location:** 399 First Road West Hamilton, ON

MTE File No.: 52543-100

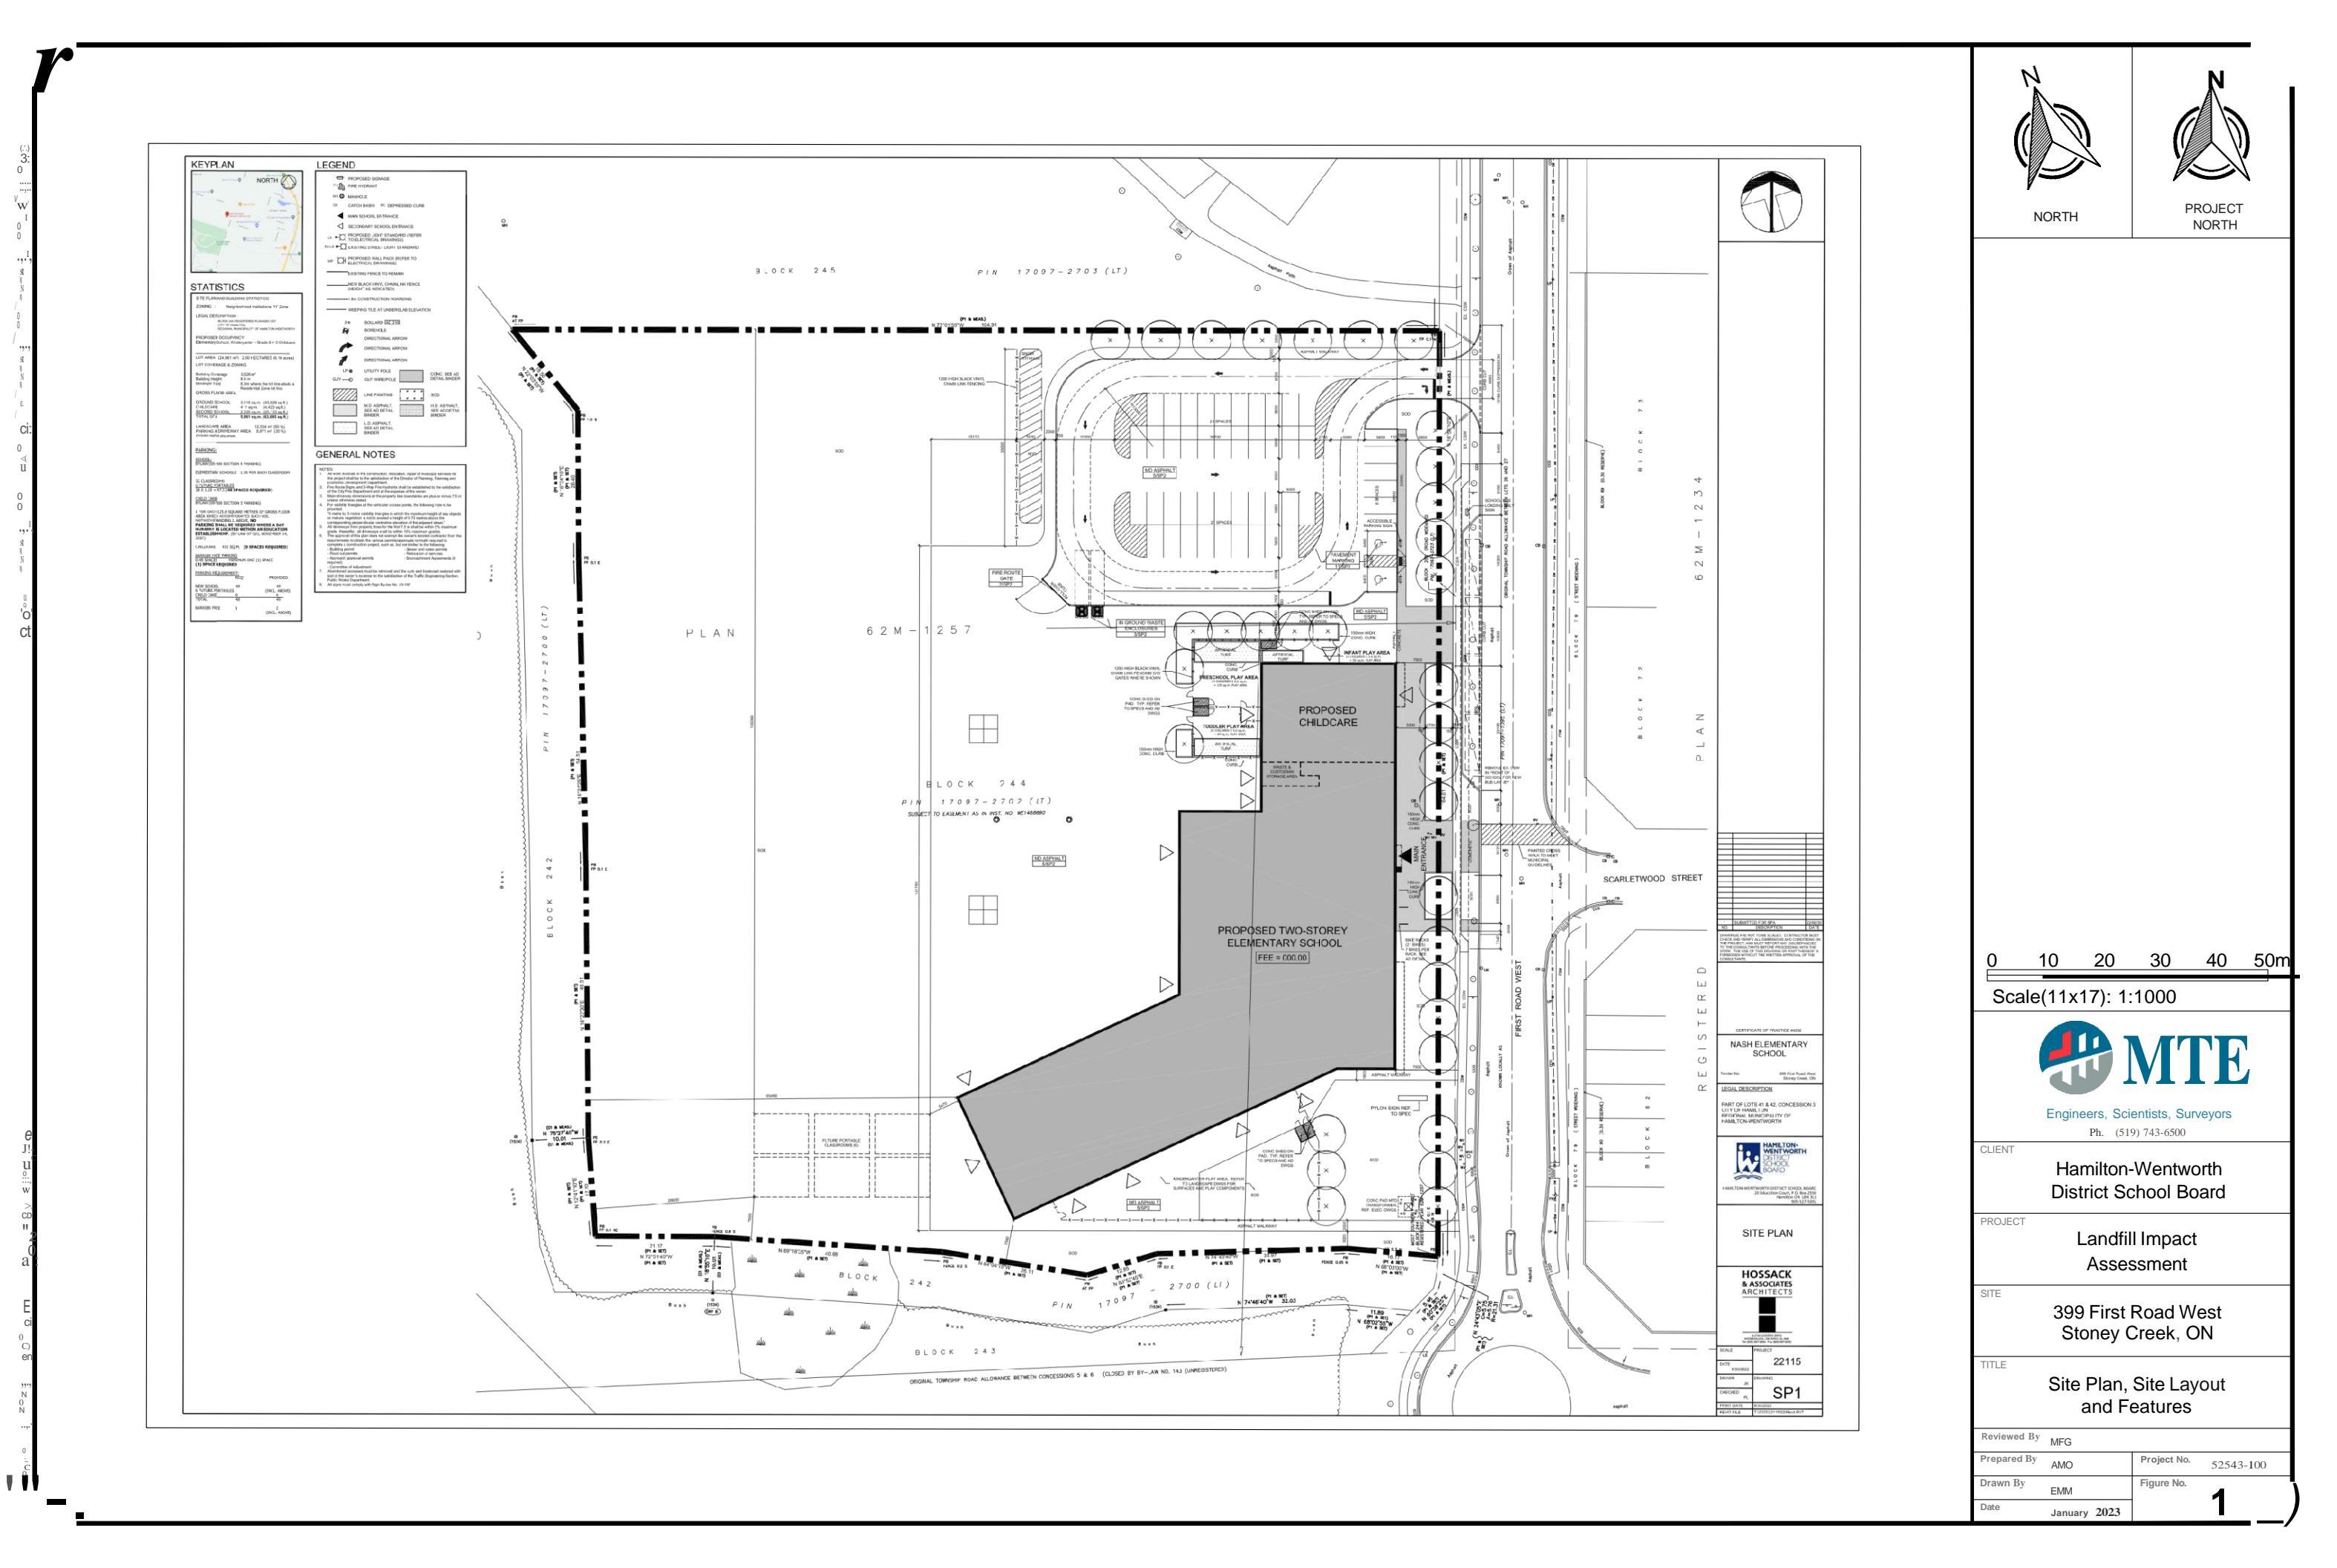
MTE Consultants Inc. (MTE) was retained by the Hamilton Wentworth District School Board to complete a landfill impact study for a proposed two-storey school on a vacant development parcel at 399 First Road West in Stoney Creek, Ontario (the "Site"). The proposed Site layout and features are shown on **Figure 1**.

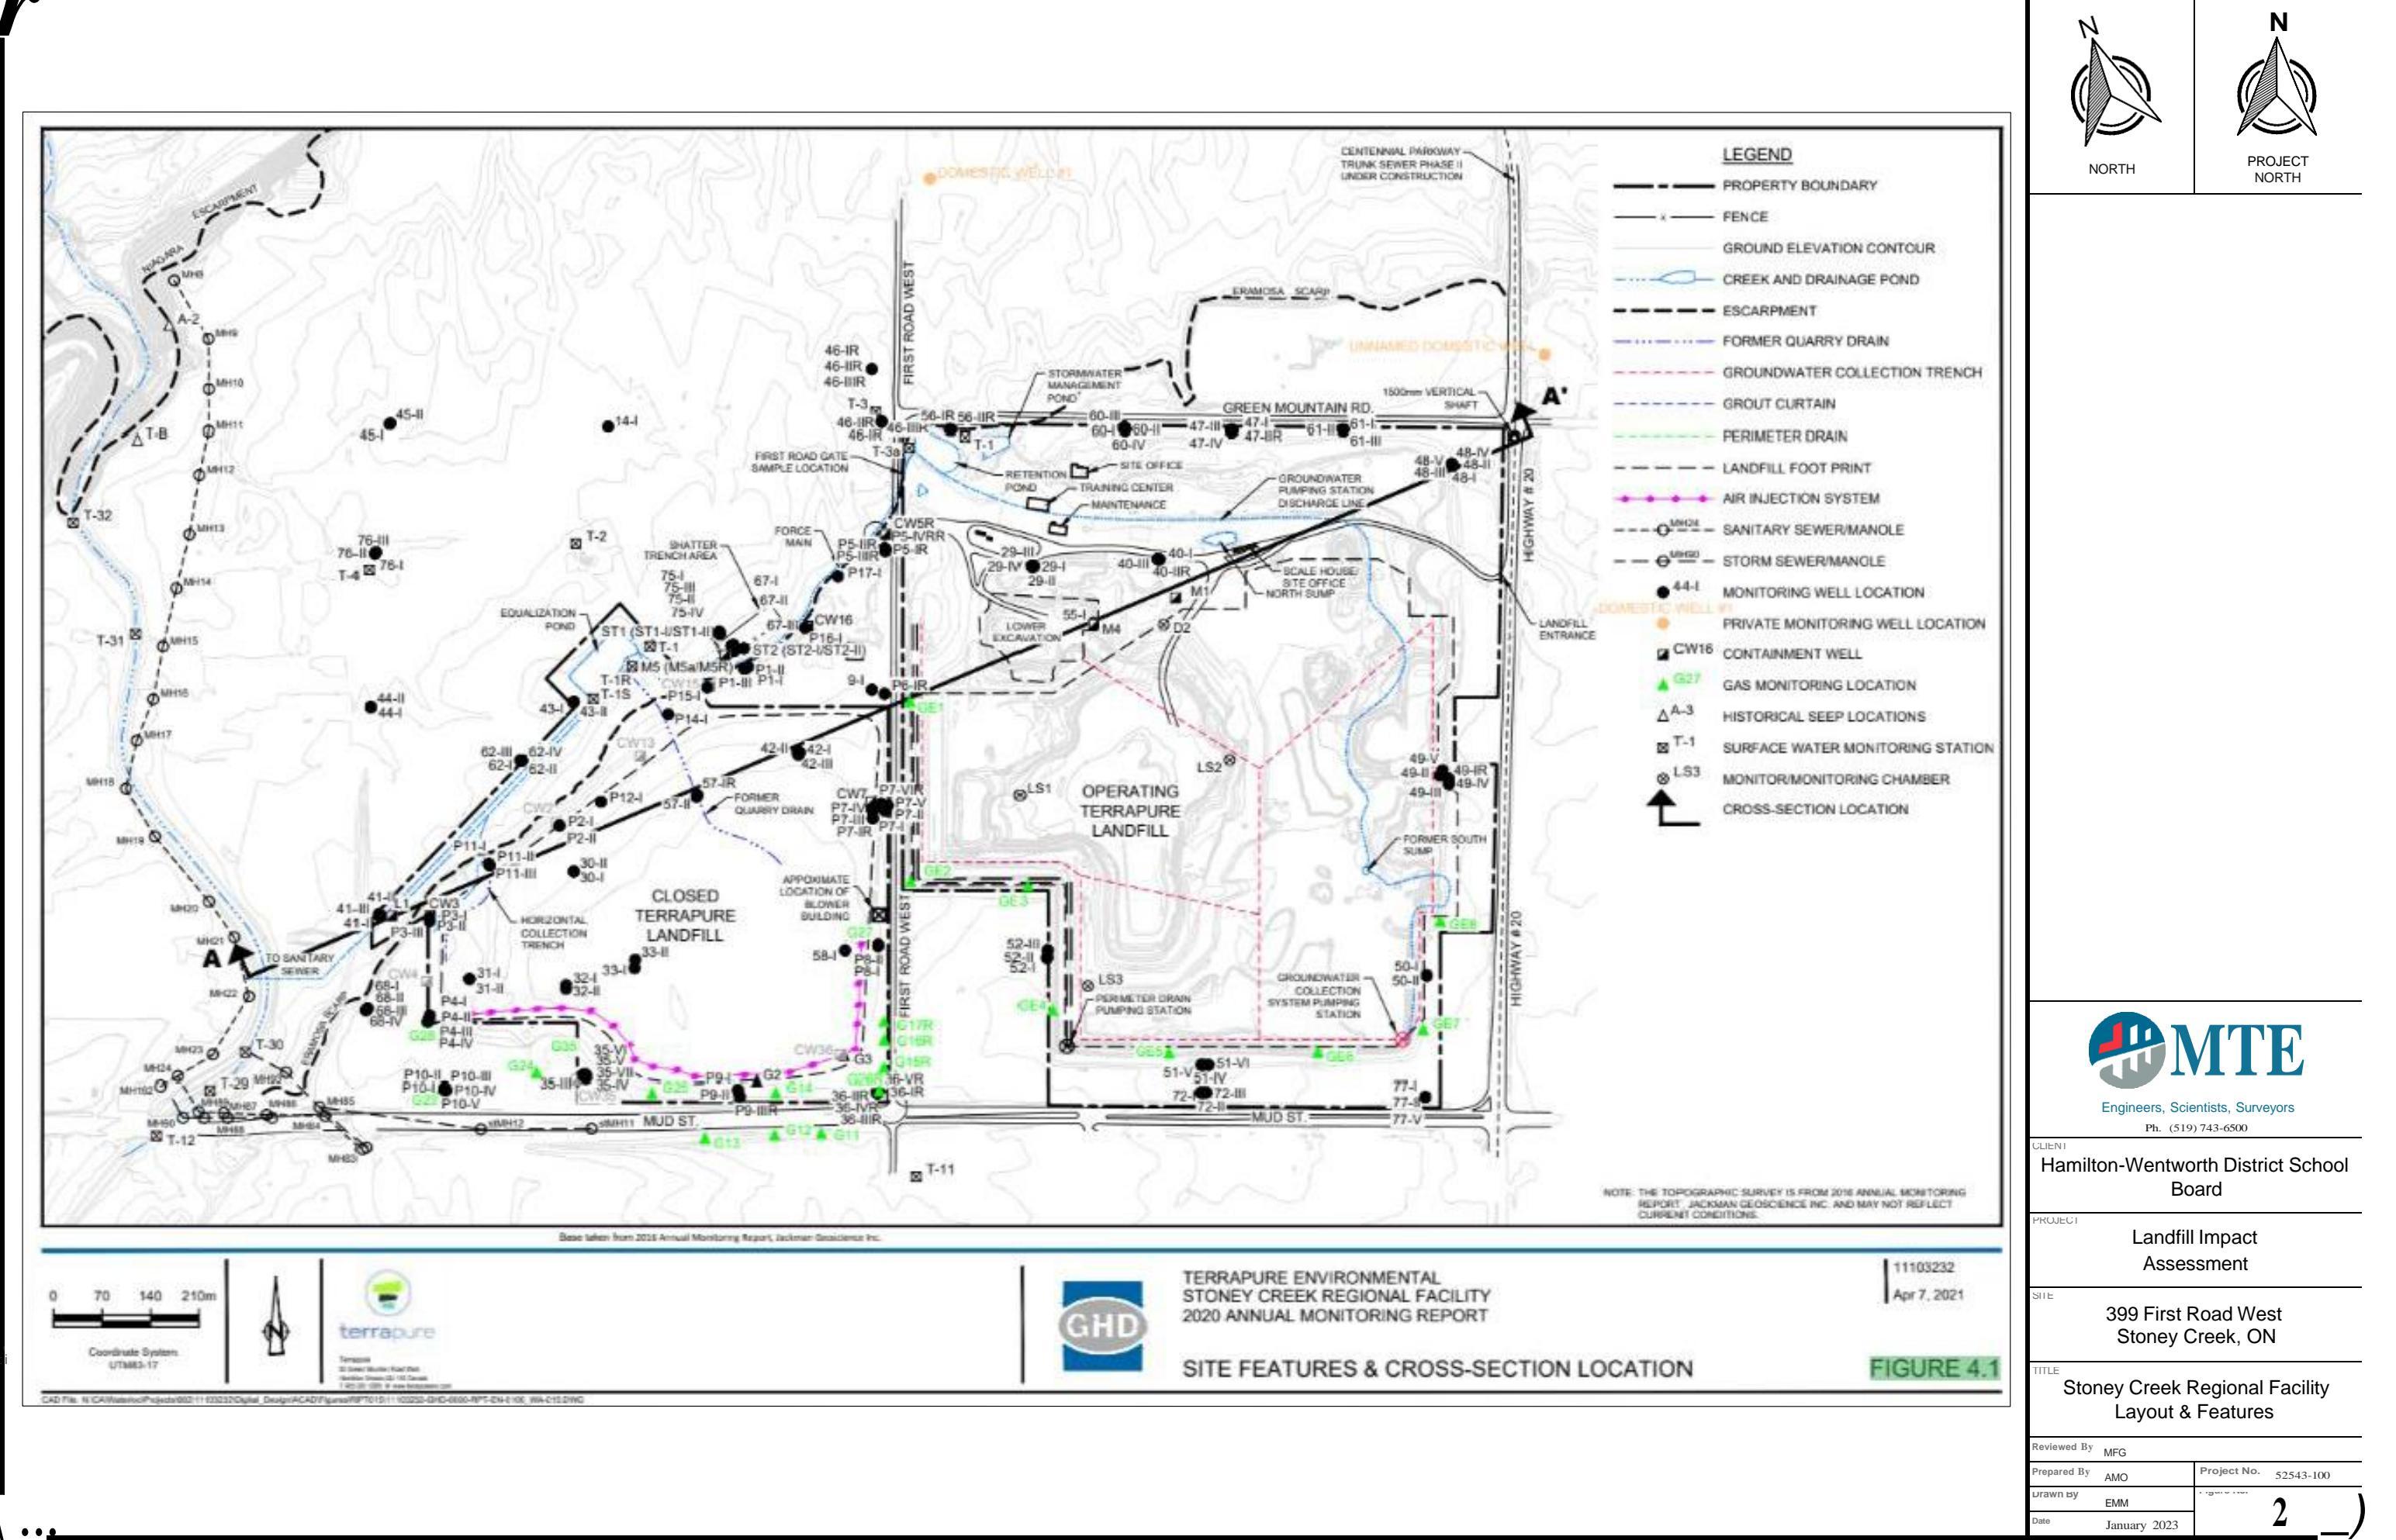
A plan of the GFL landfill is presented as Figure 2, taken from GHD, 2020.

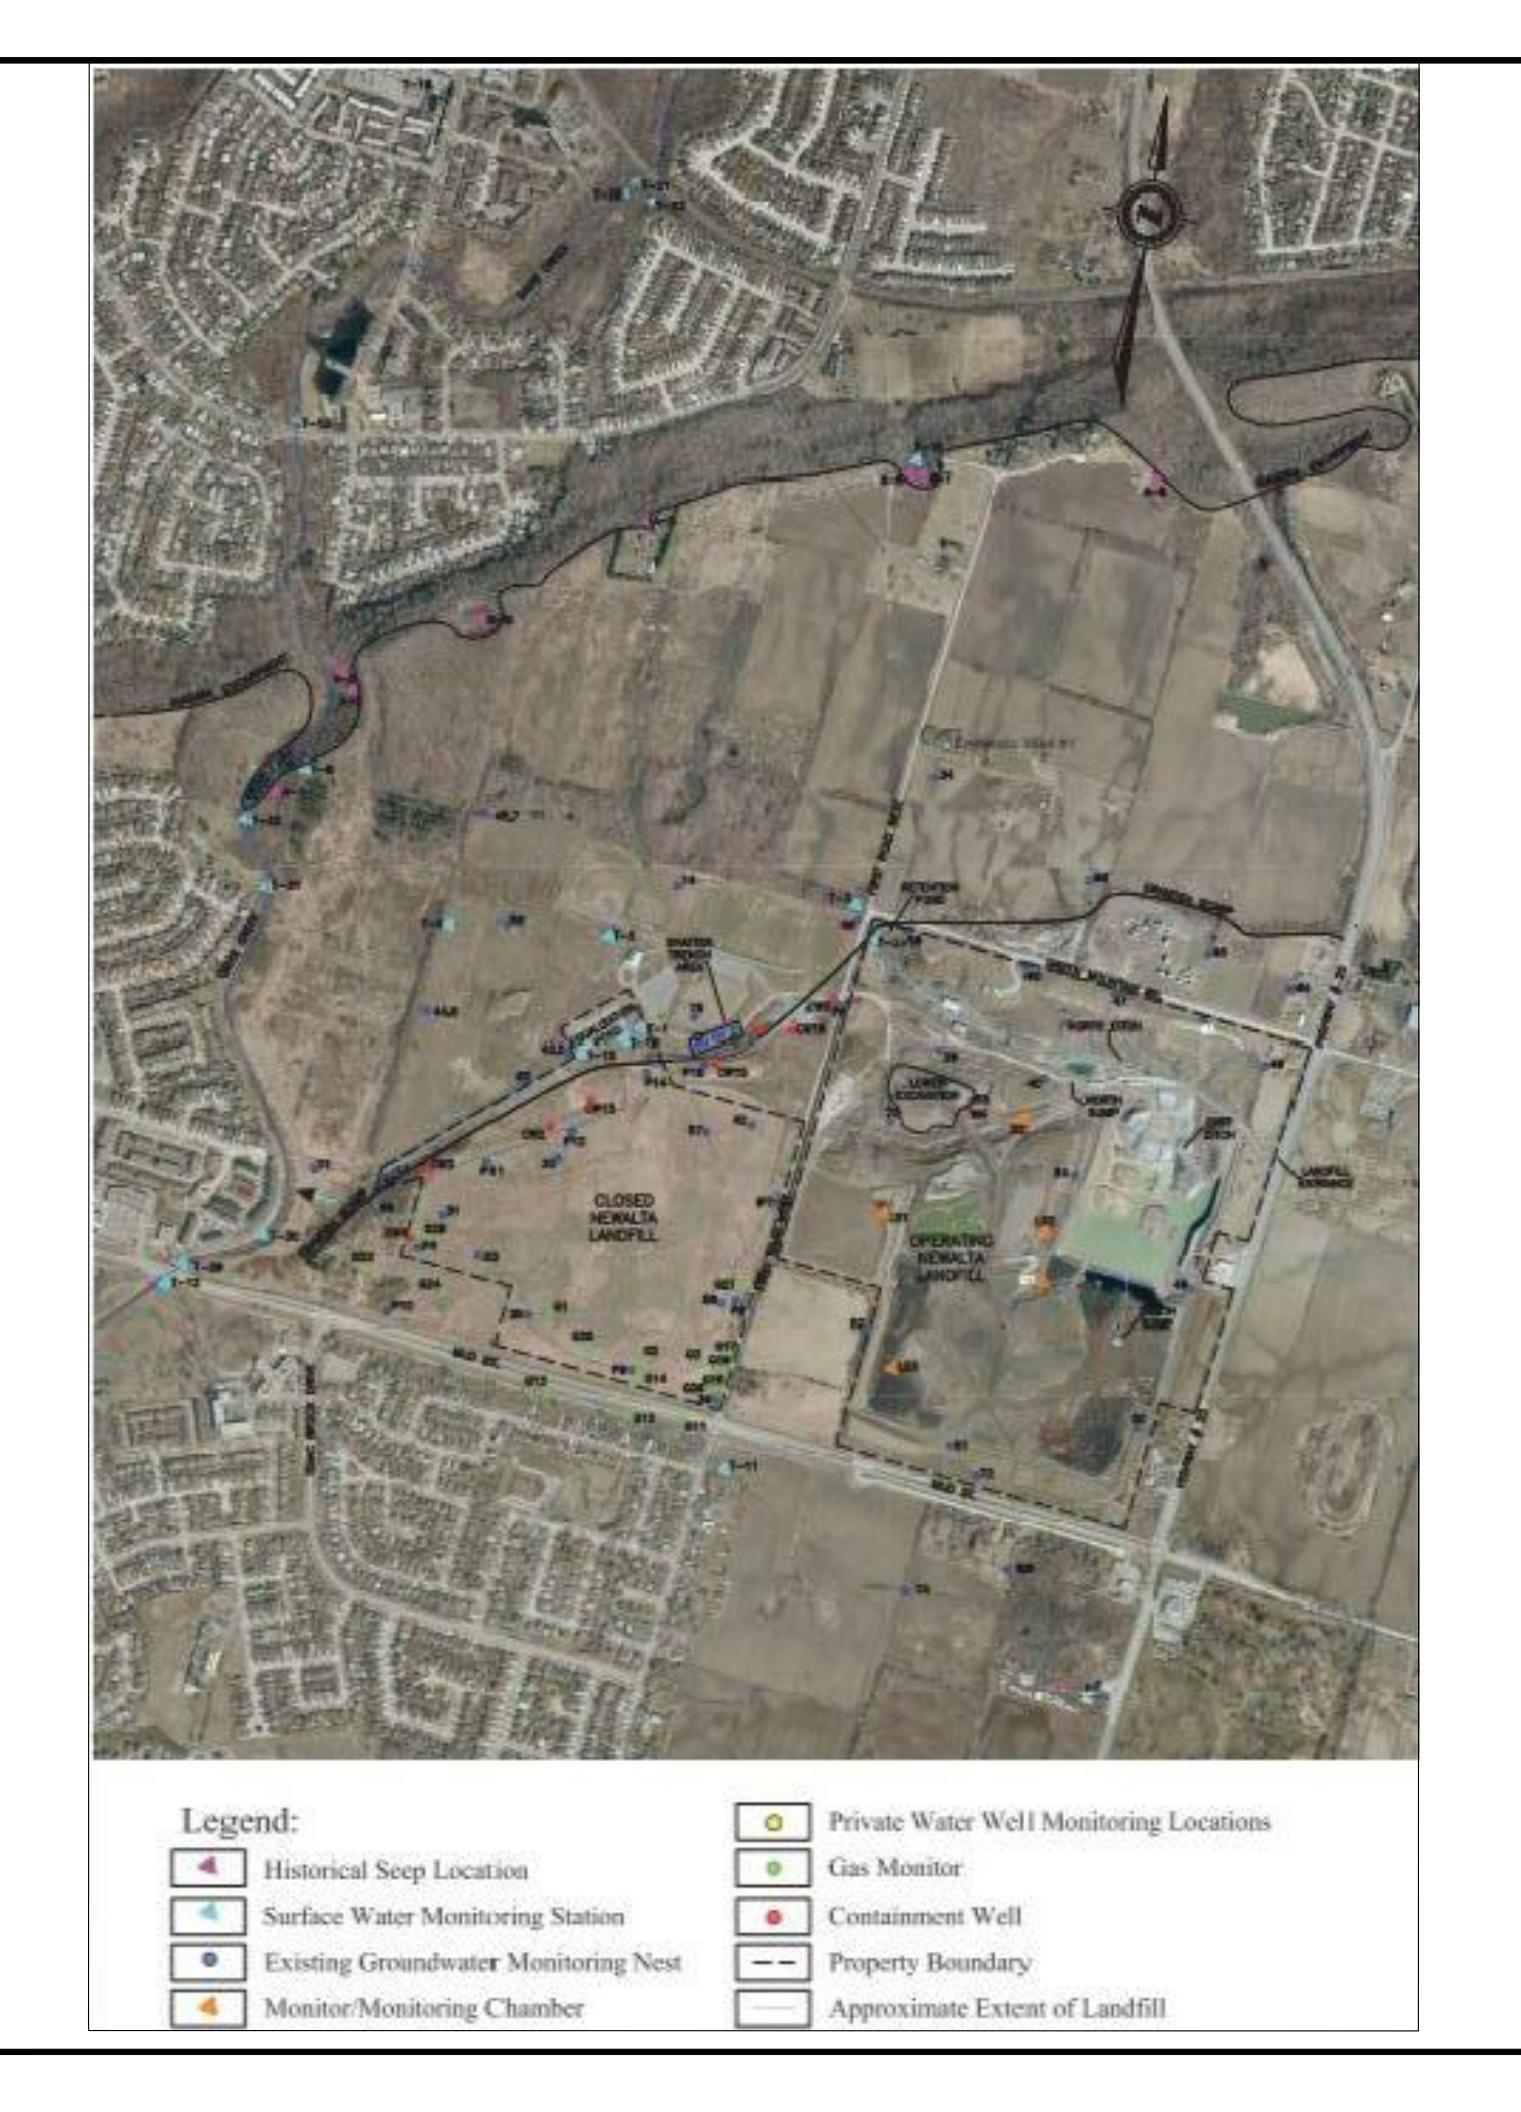
**MTE** Engineers, Scientists, Surveyors Ph. (519) 743-6500 Hamilton-Wentworth District School Board Landfill Impact Assessment 399 First Road West Stoney Creek, ON Monitoring Network Surround the Stoney Creek Regional Facility eviewed By MFC repared By Diect awn By EMM 3 January 2023

Both the closed landfill and active landfill were former quarries, and each has an extensive monitoring network as shown in **Figure 3.**
