HAMILTON WENTWORTH DISTRICT SCHOOL BOARD
FEASIBILITY STUDY AND CONCEPT DESIGN

ANCASTER HIGH SCHOOL
374 Jerseyville Rd West, Hamilton, ON

MAY 18, 2016

Condition Assessment

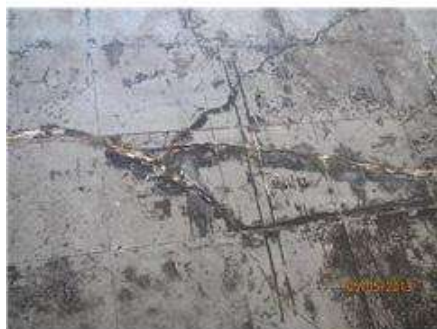
May 2019- Floor crack in the classroom of first floor east wing.

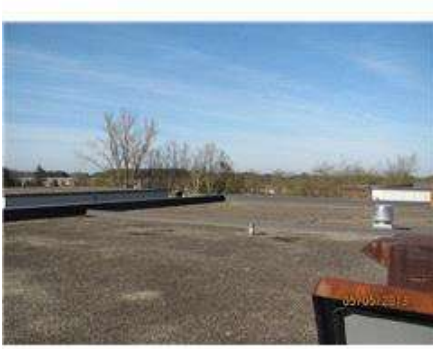
May 2013- Evidence of temporary repair of the BUR roof.

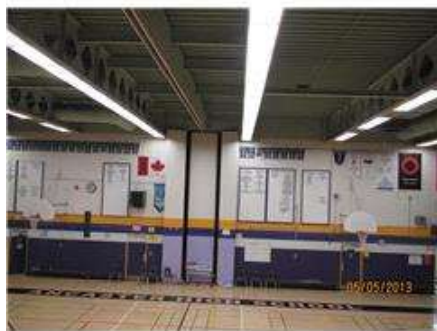
2013 - The moveable partition in the gymnasium is peeling, damaged, and has surpassed its expected useful life. Replacement is recommended.

May 2013- Deteriorated track of movable partition in the GYM.

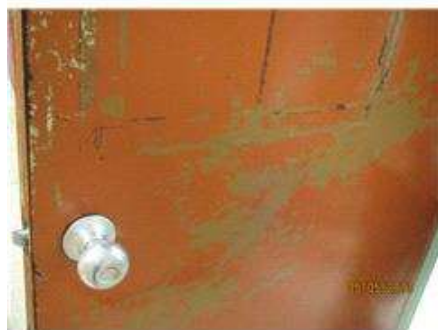
2013 - The interior wood veneer doors have exceeded their expected useful life with the majority of the doors exhibiting damage. Replacement of the interior doors is recommended.

May 2013- Typical wood interior door in the building.

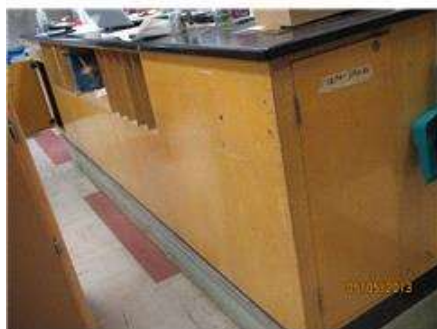
2013 - Recommend that the original millwork and cabinetry to be replaced.

May 2013- Typiocl millwork fitting in the second floor east wing Lab classrooms.

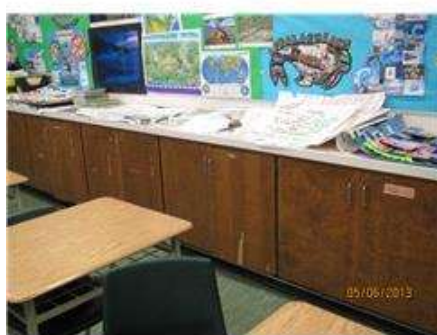
May 2013- Damaged millwork.

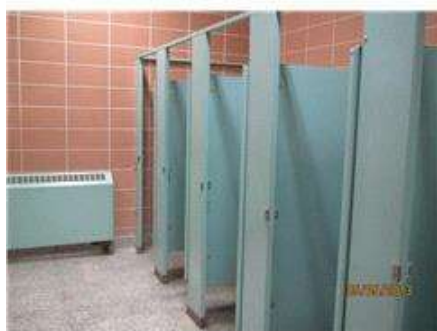
2013 - The original floor mounted painted toilet partitions have exceeded their expected useful life. Replacement is recommended.

May 2013- Worn washroom partition.

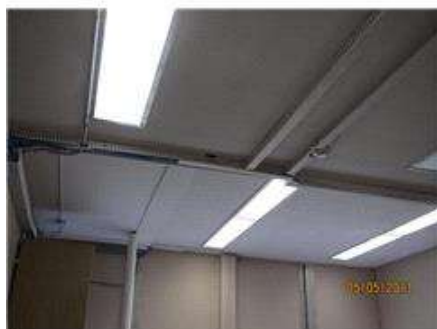
May 2013- Asbestos contain ceiling tile system.

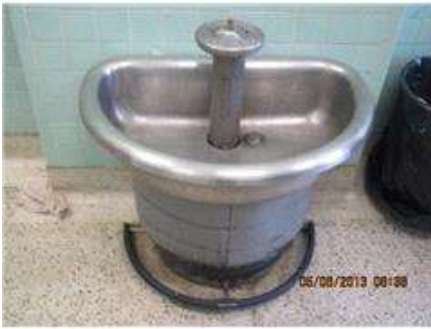
May 2013 - Aged Sink Fixtures

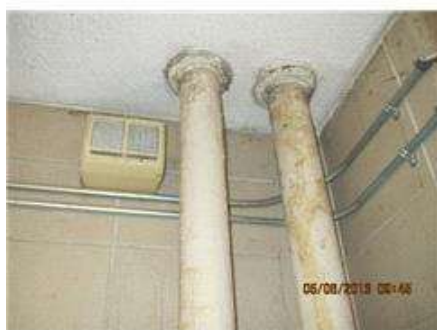
May 2013 - Original Sanitary Waste Piping

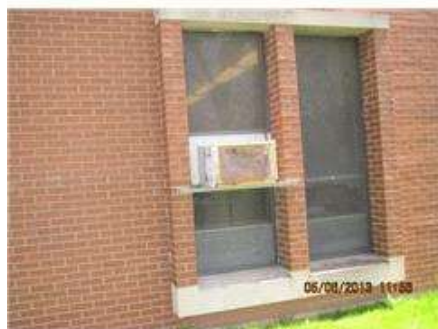
May 2013 - Aged Window AC

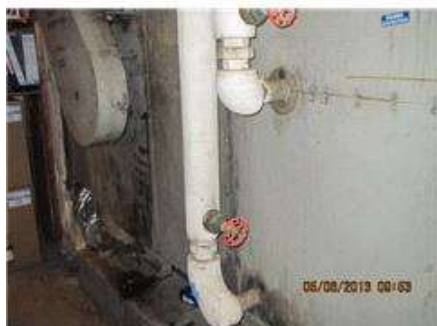
May 2013 - Aged Air Handling Units

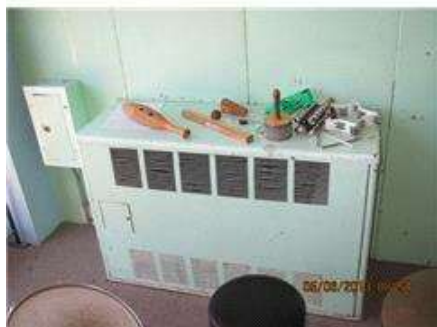
May 2013 - Original Forced Flow Heater

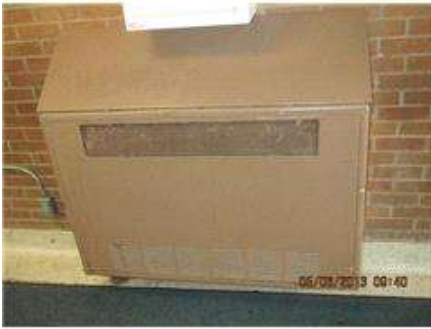
May 2013 - Aged Unit Heater

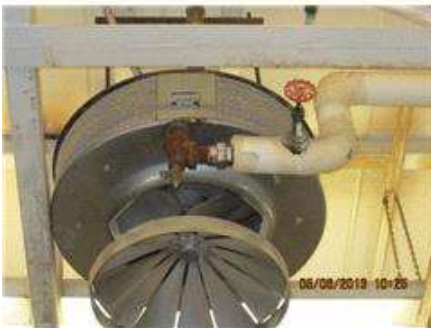
May 2013 - Aged Unit Ventilators

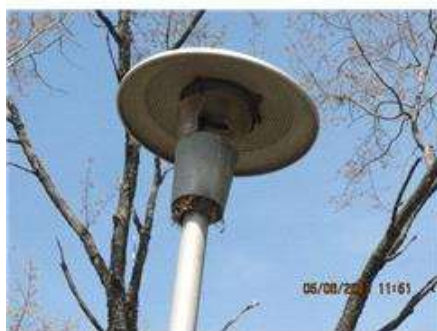
May 2013 - Aged Light Standards

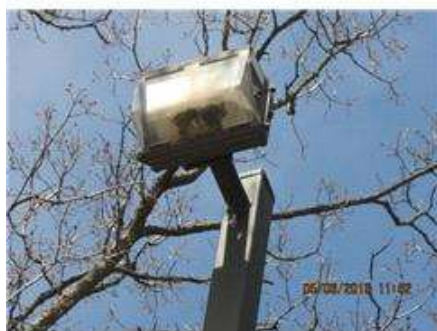
2013 - The exterior lamps and fixtures have exceeded their rated useful life and the lamps are not energy efficient and should be replaced with high efficient lamps. Original incandescent fixtures and wall-mounted HID fixtures were observed to be damaged or discoloured in some locations. Some of the lighting standards are aged and in fair condition.

2013 - The exterior lighting fixtures are original and appear to be functional at this time, but have surpassed their anticipated service life. Replacement of existing aged lamps and fixtures with higher efficiency lamps and fixtures is recommended.

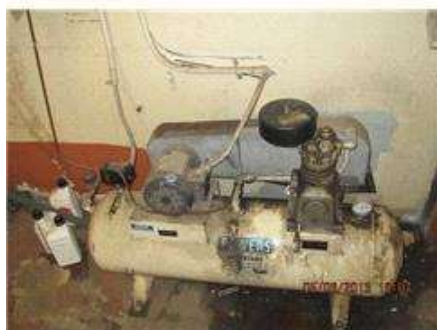
May 2013 - Aged Pneumatic Air Compressor

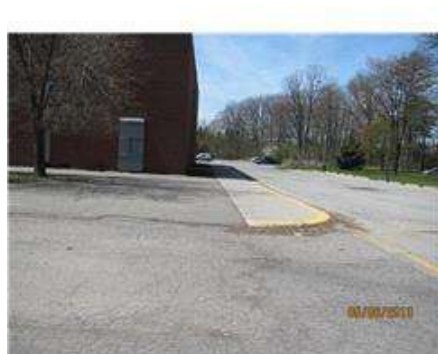
Condition Assessment 2013 - The asphalt paved roadway is exhibiting alligator cracking and some depressed areas.

May 2013- Asphalt paved roadway on the north side of the building.

May 2013- Evidence of Pot hole and, alligator cracking on the surface of the road.

2013 - The asphalt paved roadway is showing signs of alligator cracking. Replacement is recommended.

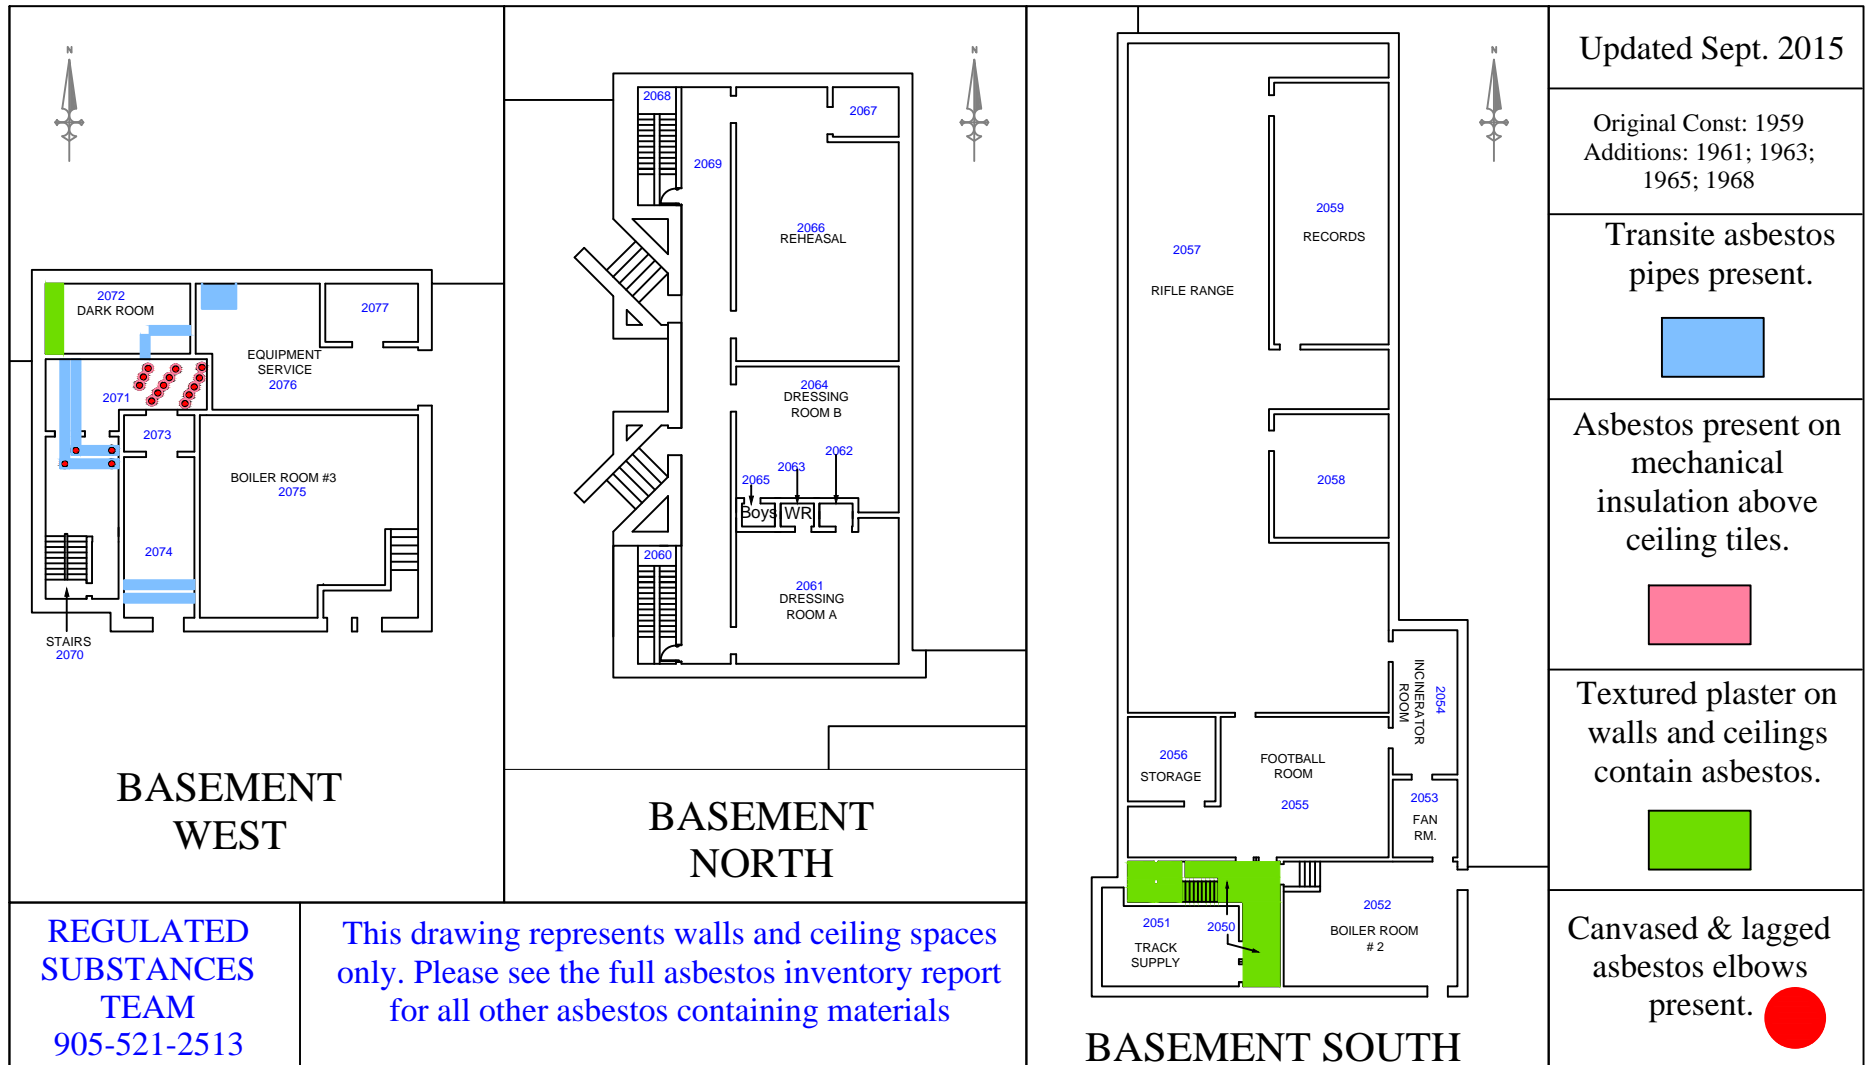
ANCASTER HIGH SCHOOL

<p>This drawing represents walls and ceiling spaces only. Please see the full asbestos inventory report for all other asbestos containing materials</p>	<p>REGULATED SUBSTANCES TEAM 905-521-2513</p>	<p>Asbestos elbows present above ceiling.</p>	<p>Tunnel access is restricted to Confined space protocol & Type 2 asbestos procedures.</p>
---	--	---	---

<p>Updated Sept. 2015</p>	<p>Transite asbestos panels present.</p>	<p>Asbestos present on mechanical insulation above Transite ceiling tiles.</p>	<p>Asbestos present on mechanical insulation above ceiling.</p>	<p>Plaster on walls and ceilings contains asbestos.</p>	<p>Tunnel access is restricted to Confined space protocol & Type 2 asbestos procedures.</p>
---------------------------	--	--	---	---	---
