HAMILTON WENTWORTH DISTRICT SCHOOL BOARD
FEASIBILITY STUDY AND CONCEPT DESIGN

DUNDAS VALLEY SECONDARY SCHOOL
310 Governors Road, Hamilton, ON

MAY 18, 2016

CS&PArchitects

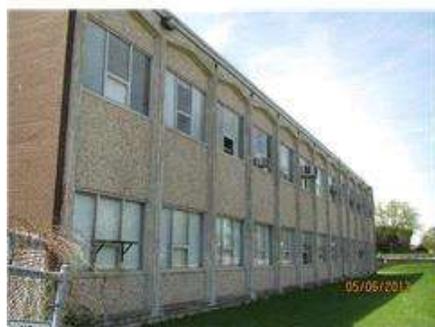
May 2013- Typical precast concrete r=exterior wall around the building envelop.

Recommendation 2013 - Recommend repairing is carried as soon as possible to avoid any damage to the building envelope

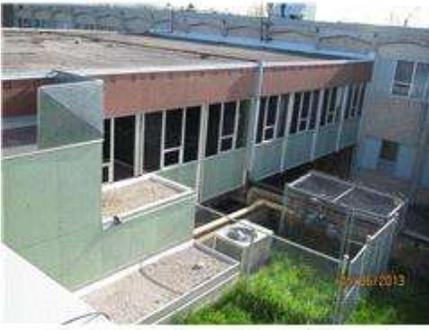
May 2013- Typical exterior building.

Recommendation 2013 - Due the condition of the exterior windows it is recommended that they be replaced.

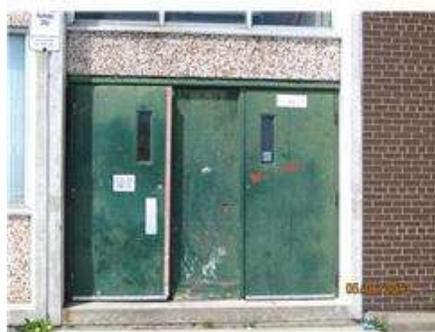
May 2013- Typical exterior door in the building.

Recommendation 2013 - The exterior door assemblies were observed to be aged and worn beyond useful life. Replacement of the door assemblies is suggested.

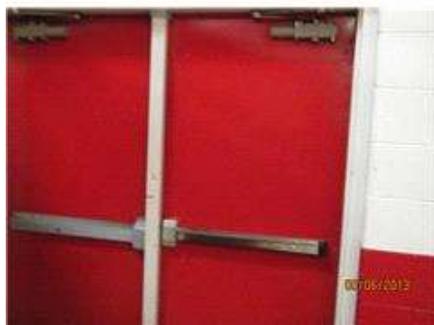
May 2013- Typical extrior door hardware.

2013 - The aged and worn exterior door hardware is suggested be replaced in conjunction with exterior door replacement.

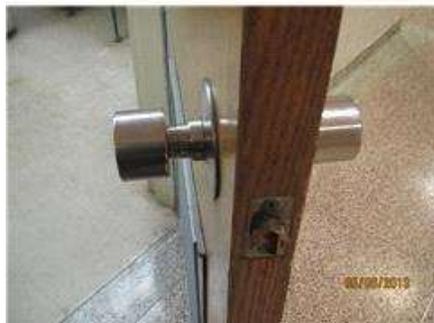
May 2013- Typical interior door hardware.

2013 - The majority of hardware was observed to be aged and worn beyond useful life. Replacement of interior door hardware in conjunction with door replacement is suggested.

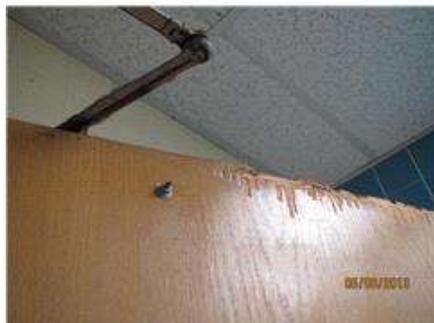
May 2013- Typical interior door closer.

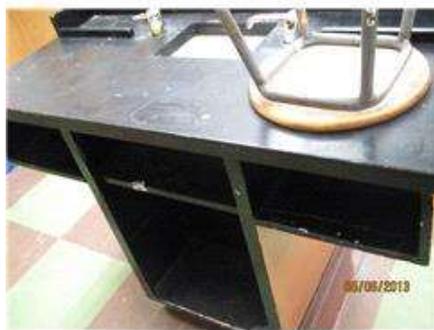
May 2013- Typical millwork fitting in the science classrooms.

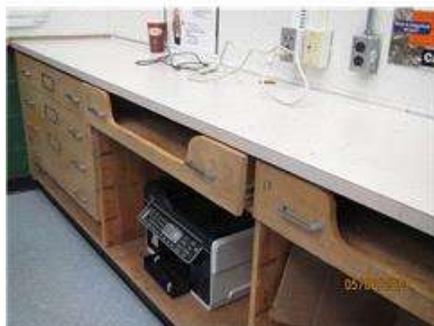
May 2013- Worm millwork in the classrooms.

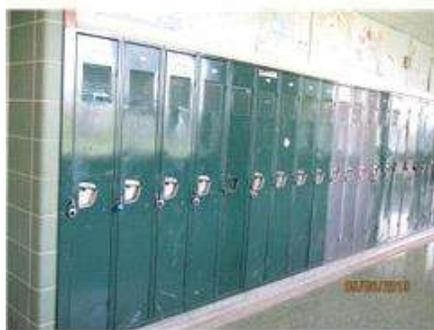
May 2013- Typical painted original lockers.

Recommendation 2013 - Recommend lockers to be replaced.

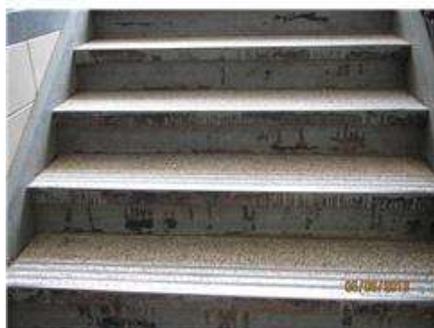
May 2013- Typical interior stairs in the school.

Recommendation 2013 - Replacement of initial flight of the interior stairs including the rubber covering is recommended

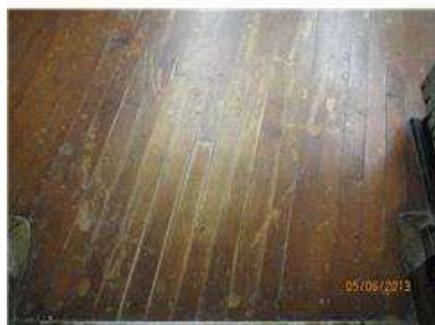
May 2013- Hardwood flooring in the construction technology classroom.

2013 - It is suggested that the hardwood flooring be refinished or replaced. OLD-Worn and deteriorated hardwood floors were observed in the school. Restoration of all hardwood floors is recommended.

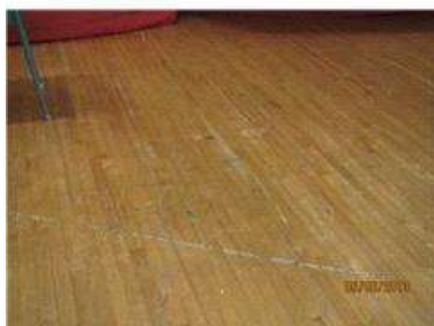
May 2013- Hardwood floor covering on the stage.

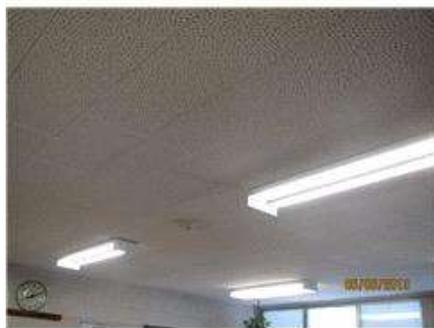
May 2013- Asbestos contains ceiling tiles.

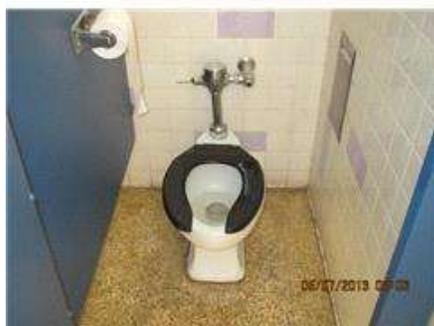
May 2013 - Typical Tankless Water Closets

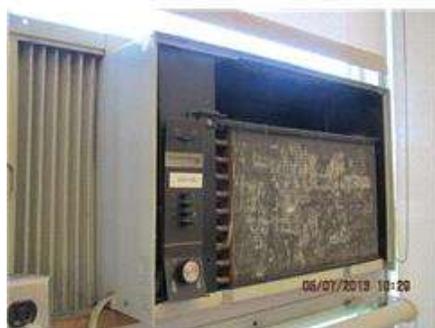
May 2013 - Aged and Undersized Window A/C Unit

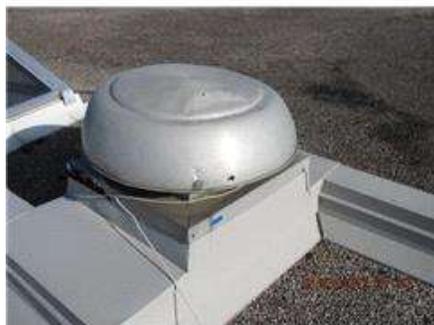
May 2013 - Aged Rooftop Exhaust Fan - Addition 1

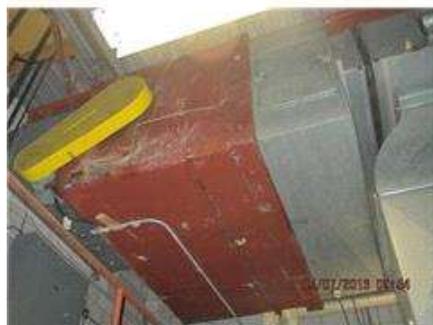
May 2013 - Gym Air Handler

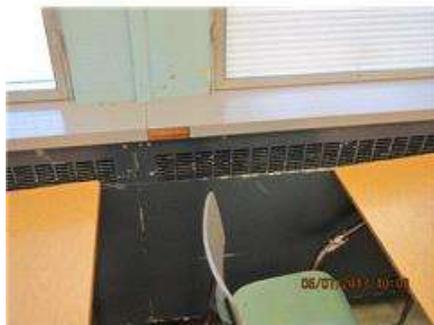
May 2013 - Original Fin Tube Radiators in Classrooms

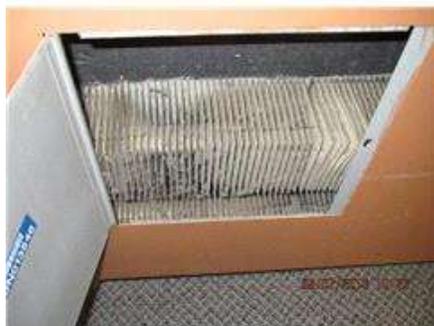
May 2013 - Original Dirty Fin tube Radiators

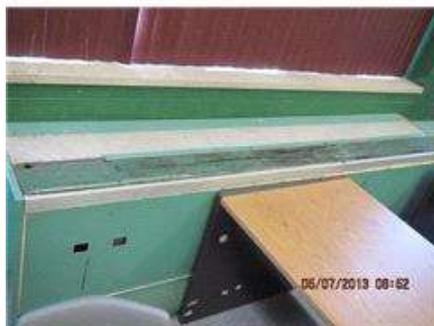
May 2013 - Typical Unit Ventilator in Classrooms of Circular Section of School

Recommendation 2013 - Replacement of the aged unit ventilators is recommended. Consideration should be made to replace them with high energy efficient units.

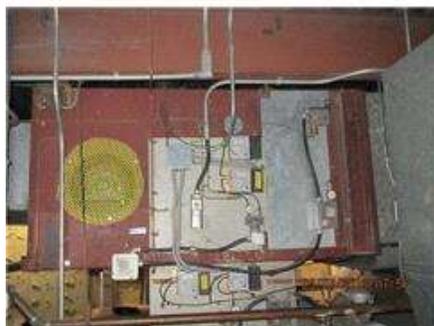
May 2013 - Pneumatic HVAC Controls

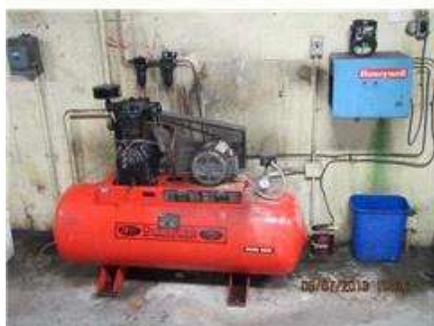
May 2013 - Pneumatic System Air Compressor

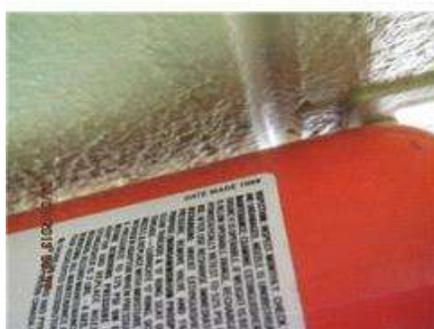
May 2013 - Aged Fire Extinguishers - Manufactured 1988

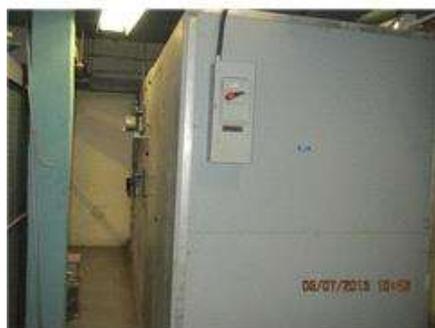
Condition Assessment 2013 - Although maintained properly, the switchboard and other assemblies including main distribution panel, breaker, fuses and meters has exceeded the useful life and should be replaced due to age and reliability.

May 2013 - Original Main Switchboard

Recommendation 2013 - Replacement of the aged switchboard and other assemblies including main distribution panel, breaker, fuses and meters of the building is recommended.

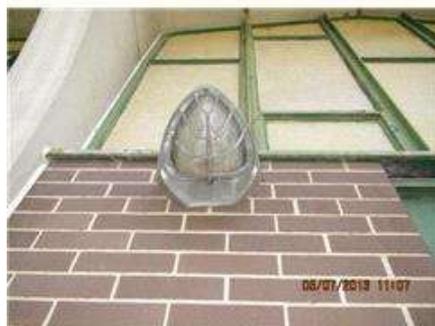
Condition Assessment 2013 - The exterior lamps and fixtures have exceeded their rated useful life and the lamps are not energy efficient and should be replaced with high efficient lamps. Original incandescent fixtures were observed at entrance soffits, while wall-mounted fixtures were observed to be damaged or discoloured in some locations. Lighting standards are in good condition.

May 2013 - Original Wall Mounted Lighting Fixture

2013 - The exterior lighting fixtures are original and appear to be functional at this time, but have surpassed their anticipated service life. Replacement of existing aged lamps and fixtures with higher efficiency lamps and fixtures is recommended.

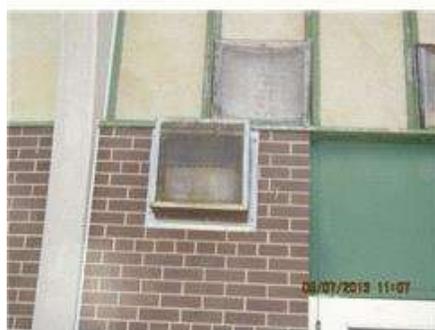
May 2013 - Typical Aged Wall Mounted Lighting Fixtures

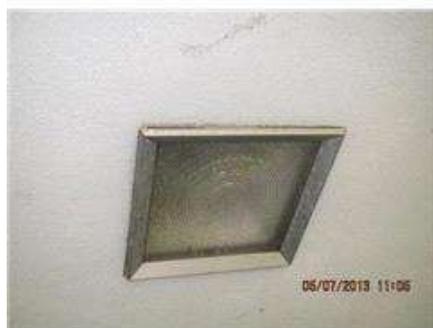
May 2013 - Aged Soffit Lighting Fixtures

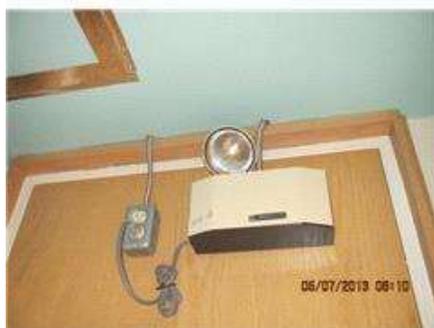
Condition Assessment 2013 - The majority of the emergency lighting fixtures are in good condition (80%). Some emergency lighting fixtures are older than 1998 and are in fair to poor condition (20%). There is a battery bank for the emergency lighting system which is aged, corroded and in poor condition.

May 2013 - Aged Emergency Lighting Fixture

Recommendation 2013 - Replacement of the battery bank and existing aged emergency lighting fixtures with higher efficiency lamps and batteries is recommended.

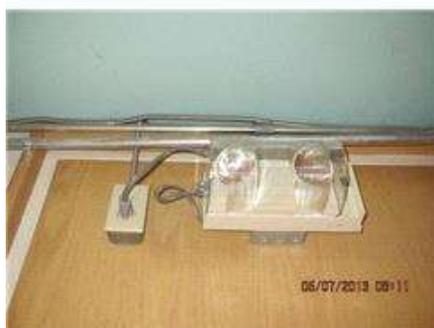
May 2013 - Newer Emergency Lighting Fixture

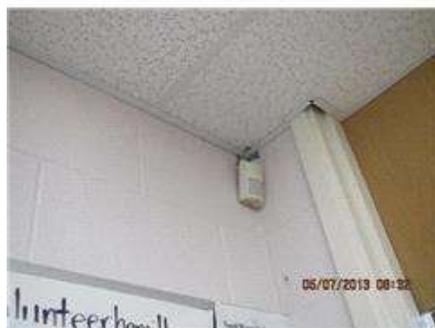
2013 - The security system is currently functioning as intended, with no major deficiencies reported. Overall, due to age and electrical wear the system is in fair condition.

May 2013 - Security System Motion Detector

2013 - Based on age and theoretical useful life the planned replacement of the security system is recommended.

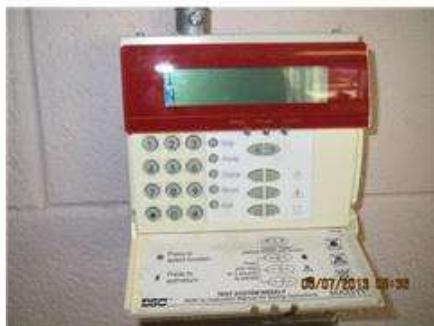
May 2013 - Security System Keypad

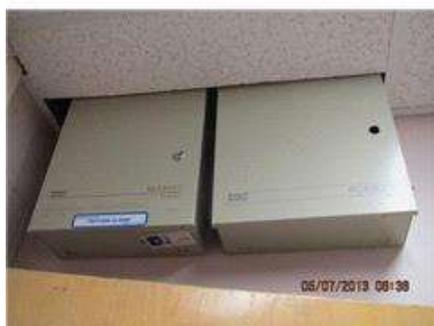
May 2013 - Security System Panel

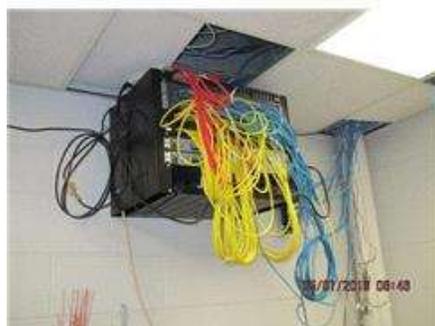
Condition Assessment 2013 - The school's IT system is functioning well without complaints. However, due to the rapid growth in technology the theoretical life of the IT system is 10 years. Based on the theoretical life, the school's IT system is in fair condition and is past its rated useful life.

May 2013 - Information Technology Equipment

2013 - Planned replacement of the school's IT system is recommended to keep the system up to date and in working condition.

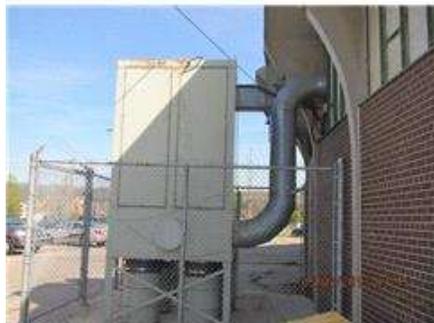
2013 - The dust collector was reported to be to be working fairly well with minor issues reported. The dust collector is located outside and being exposed to the elements minor rust was visible during the time of assessment.

May 2013 - Dust Collector

2013 - Planned replacement of the dust collector is recommended in the next 5 years.

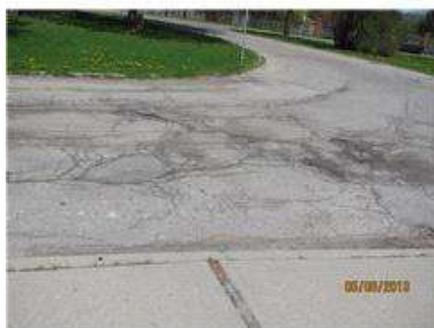
2013 - The asphalt paved roadway is exhibiting alligator cracking and some depressed areas.

May 2013- Roadway on the North side of the building.

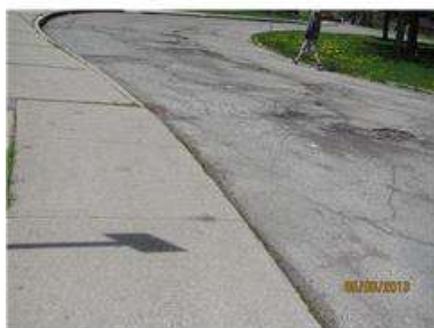
May 2013- Roadway on the North side of the building.

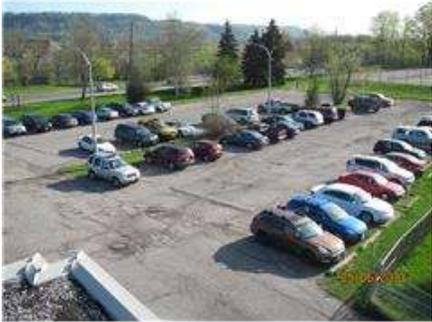
2013 - The asphalt-paved parking lot is in poor condition with pot holes and alligator cracking. Reconstruction of the parking lot is recommended.

May 2013- Parking lot on the northeast side of the building.

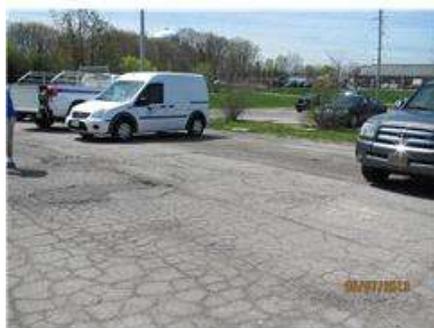
May 2013- Parking lot on the west side of the building.

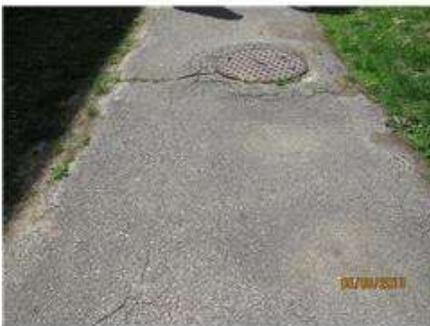
May 2013- Asphalt paved pedestrian.
