HAMILTON-WENTWORTH DISTRICT SCHOOL BOARD
FEASIBILITY STUDY and CONCEPT DESIGN

Westmount Secondary School
39 Montcalm Drive, Hamilton, ON

November 2015

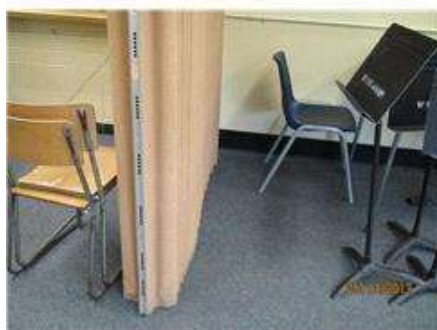
Element Instance : C1010 Partitions - Original Building

Description 2013 - Moveable folding gym partition wall.

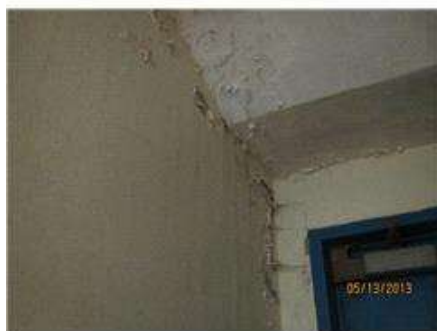
Condition Assessment 2013 - The glazed wall coating in the Stair cases are stained.

May 2013- Stained glazed wall covering in the stair case 1150.

Recommendation 2013 - The glazed wall tiles are stained. Full replacement is warranted.

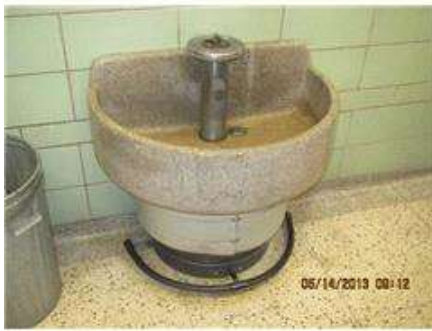
May 2013 - Aged Bradley Basins - Shops

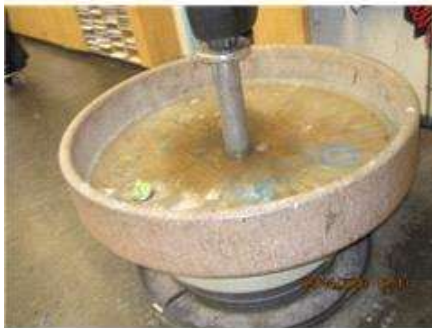
May 2013 - Aged Shower Fixtures

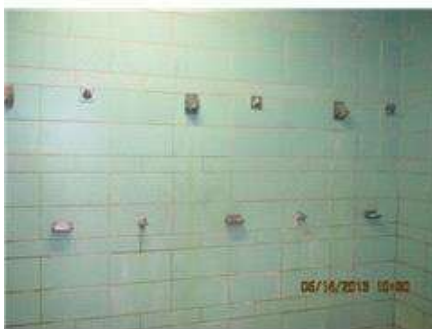
May 2013 - Wall Mounted Water Closets

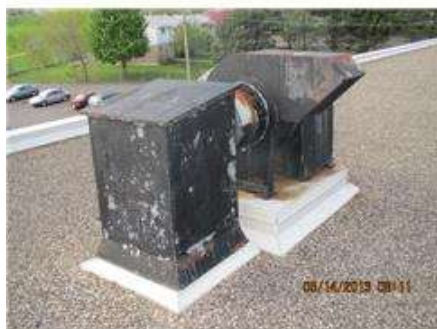
May 2013 - Typical Aged Rooftop Exhaust Fan

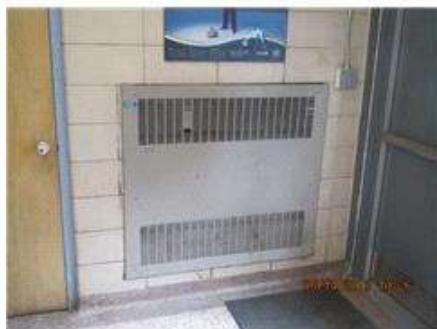
May 2013 - Original Forced Flow Heater - Stairwells

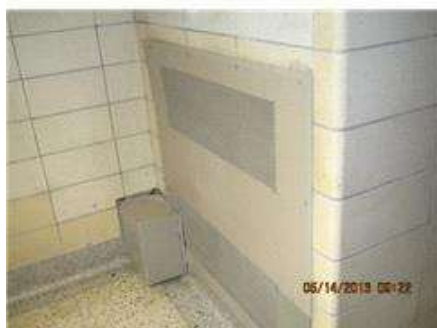
May 2013 - Unit Ventilators - Office

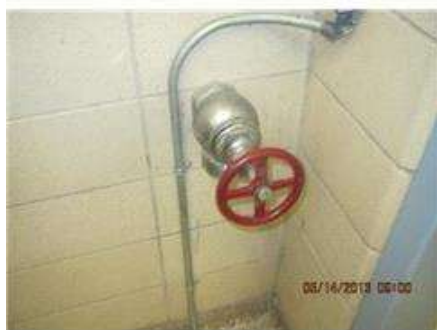
May 2013 - Original Standpipe System Piping

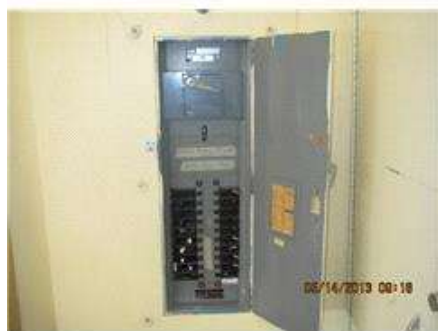
May 2013 - Original Secondary Switchgear
